HERITAGE MANAGEMENT PLAN

**Reserve Bank of Australia Head Office
65 Martin Place
SYDNEY NSW 2000**

**DRAFT ISSUED FOR COMMENT
8 NOVEMBER 2019**

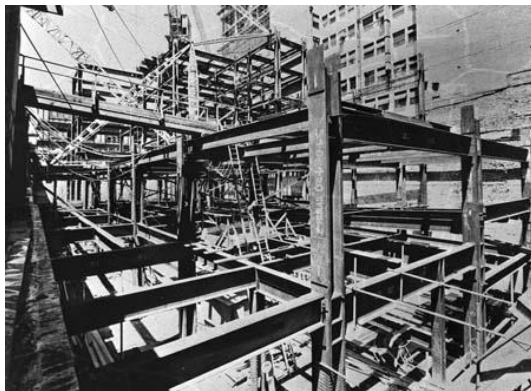
Figure 4 – View of the steel framed construction of the Reserve Bank of Australia Head office building, c1962. Source: National Archives of Australia.

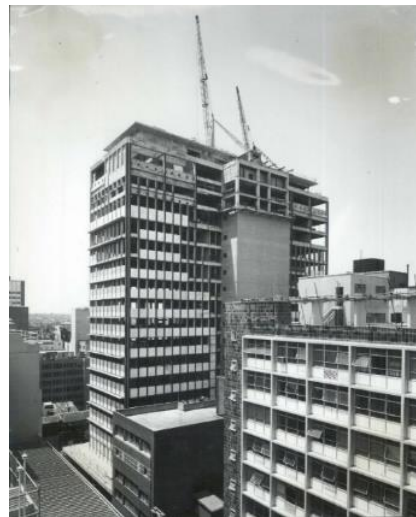
Figure 5 - View of the south and west elevations during construction c1962. Source: National Archives of Australia

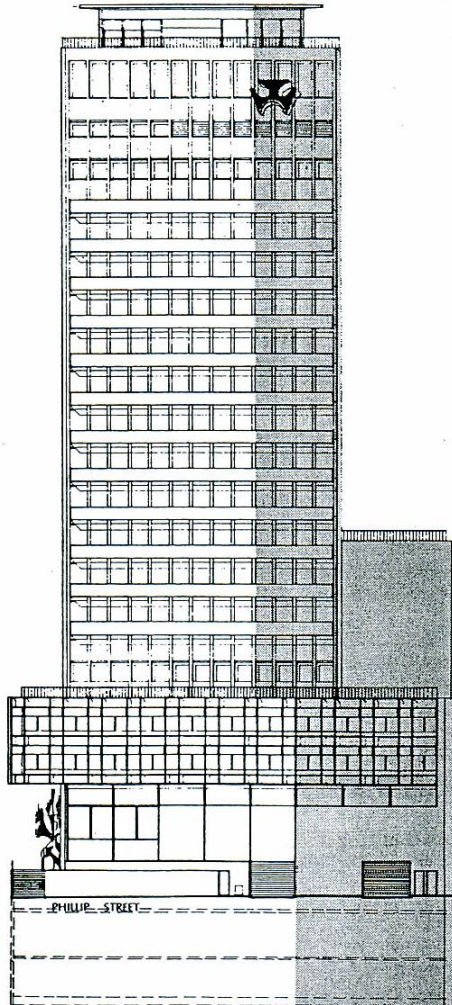
Figure 8 – Diagram showing the Phillip Street elevation. The shaded area indicates the location of the addition constructed in the late 1970s, and the dedicated services/plant spaces. Note the addition accommodating the services finished at Level 7.
Source: Currency No. 5 Vol 17 May 1976 p12

The works were designed to maintain the rhythm of the original window and stone façade on the east and west elevations, giving the Reserve Bank an increased presence in Macquarie Street and Phillip Street without increasing the height of the building.

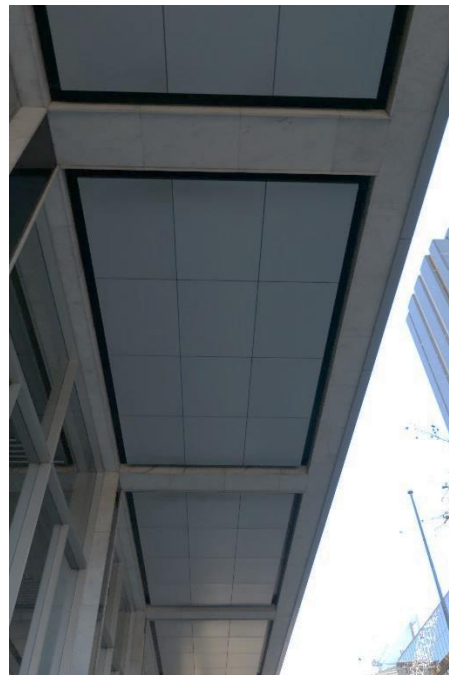
Figure 13 – General view of the podium soffit adjacent to the north side of the RBA Head Office entry. Note the original suspended marble soffit was replaced in c2001.

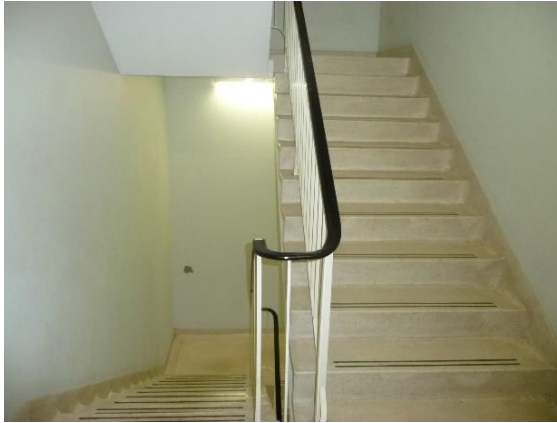
Figure 16 – Example of fire stair finishes and painted steel balustrades within the RBA Head office building.

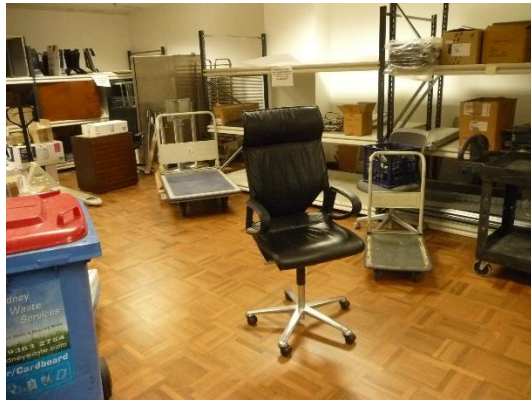
Figure 18 - Typical basement finishes.

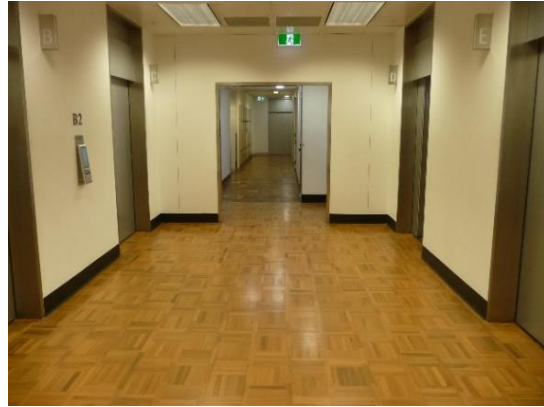
Figure 19 – Typical painted rendered finishes at Basement Levels 1 and 2.

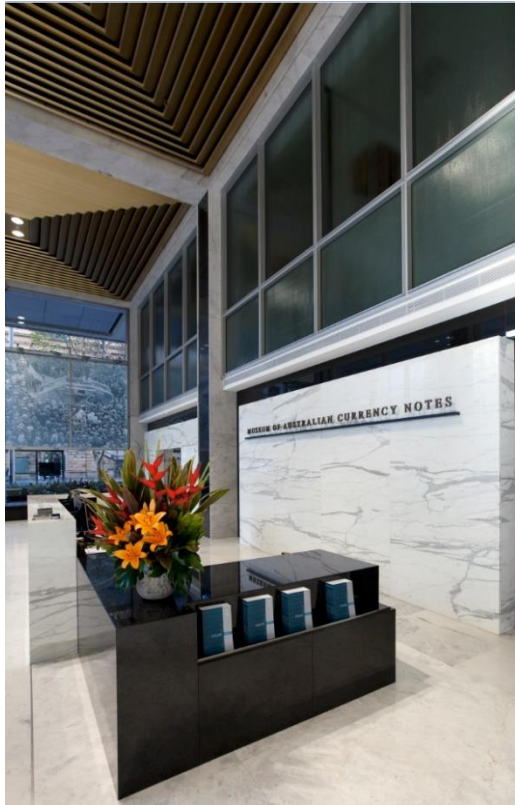
Figure 20 - View of the ground floor vestibule and museum entrance area c2002 showing the surviving original finishes and the wall mural by Mr Bim Hilder.

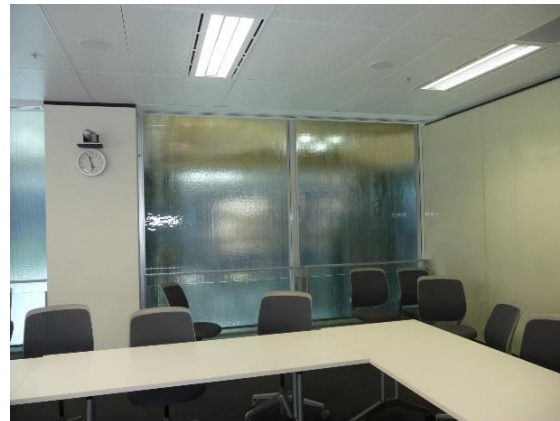
Figure 22 - Typical Mezzanine office fit out. Note the full-height textured glass forming the north wall of the mezzanine level is visible from within the ground floor vestibule.

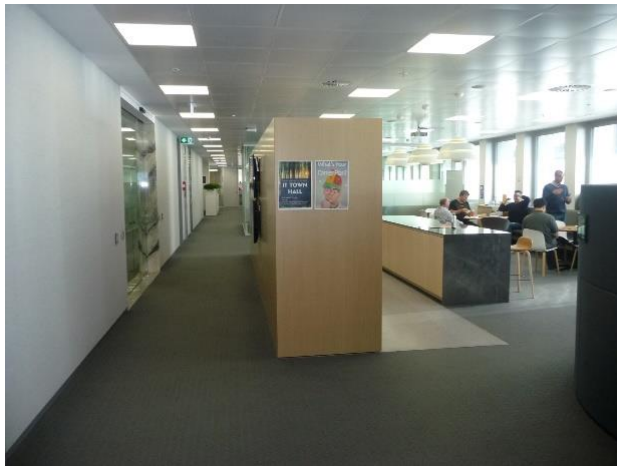
Figure 23 – Example of ceiling, wall and floor finishes at Level 6 installed in 2016.

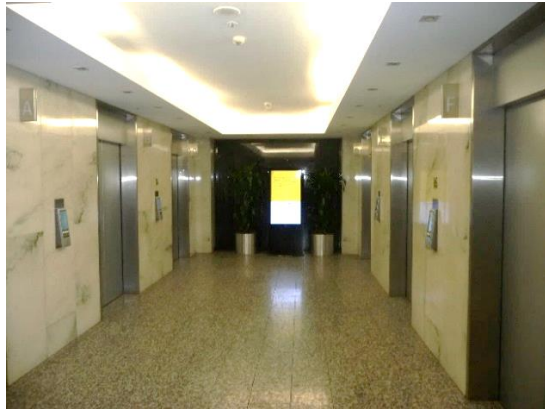
Figure 24 - Level 16 lift lobby showing the original marble wall finishes.

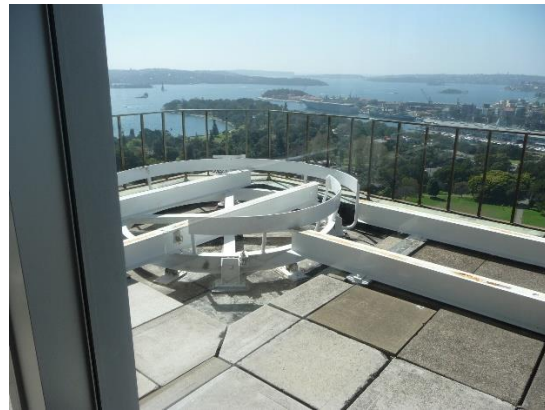
Figure 29 - General view showing the concrete pavers and access equipment for servicing the exterior of the RBA building.

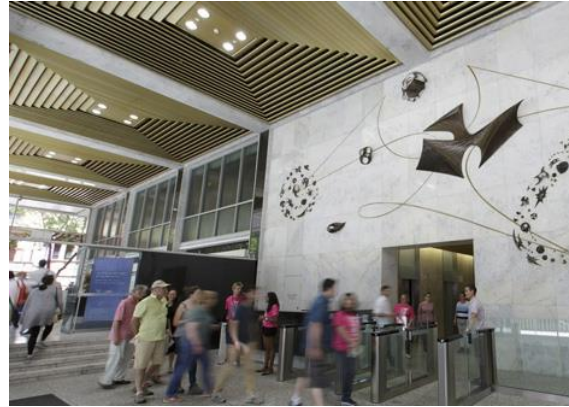
Figure 46 - View of the ground floor lobby showing security barriers installed c2009. (Source: Sydney Living Museums)

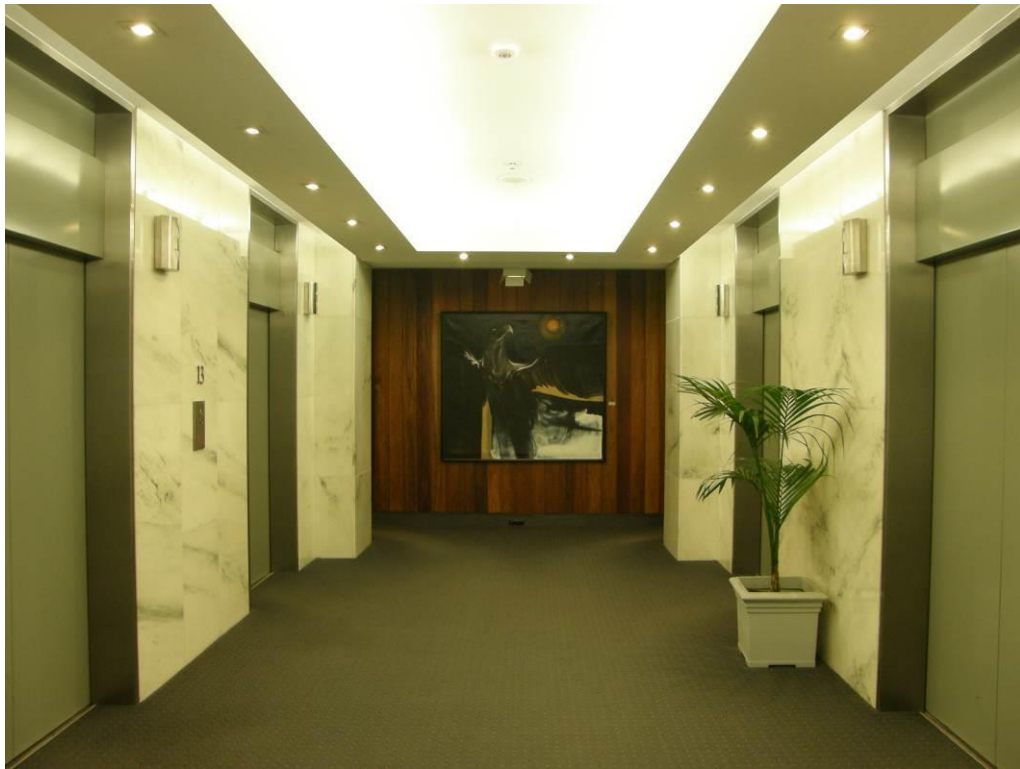
Figure 47 - Typical office level lift lobby showing original (1964) marble wall finishes and timber wall panelling. The original ceiling was replaced c2000.

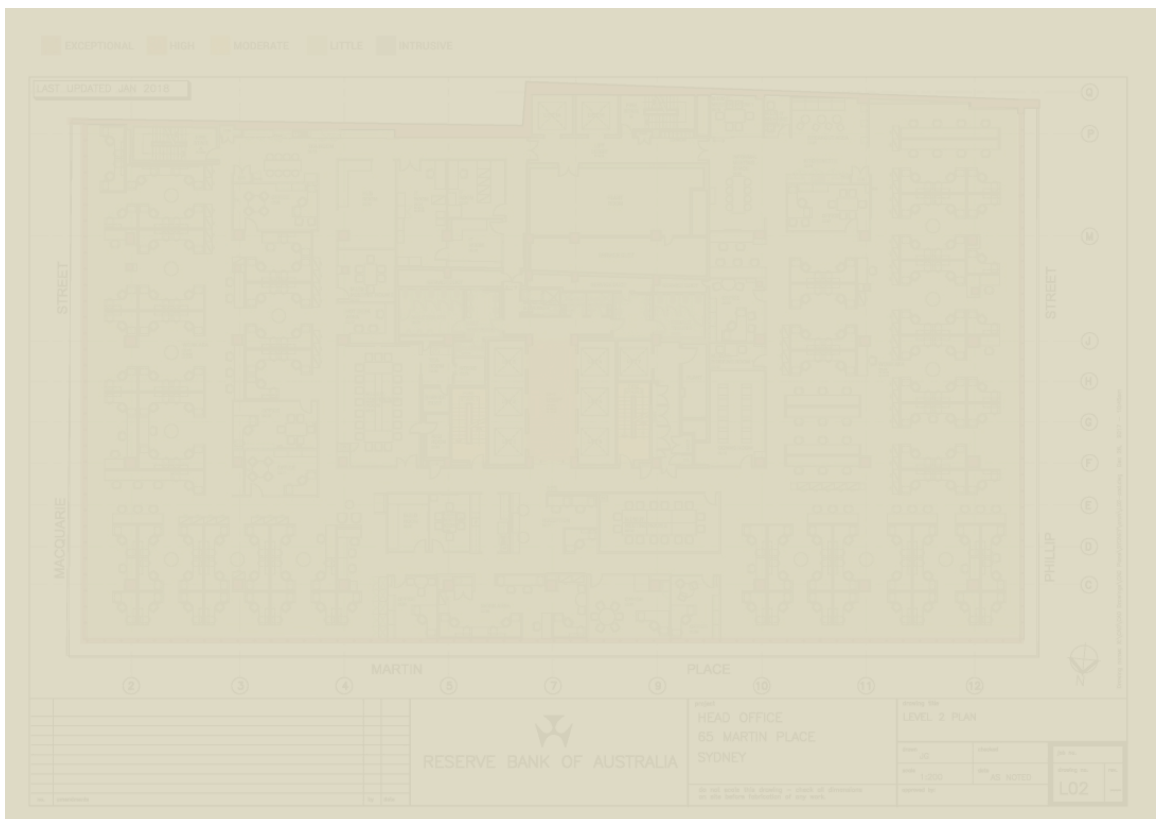
Figure 62: Level 2 – Gradings of Significance diagram

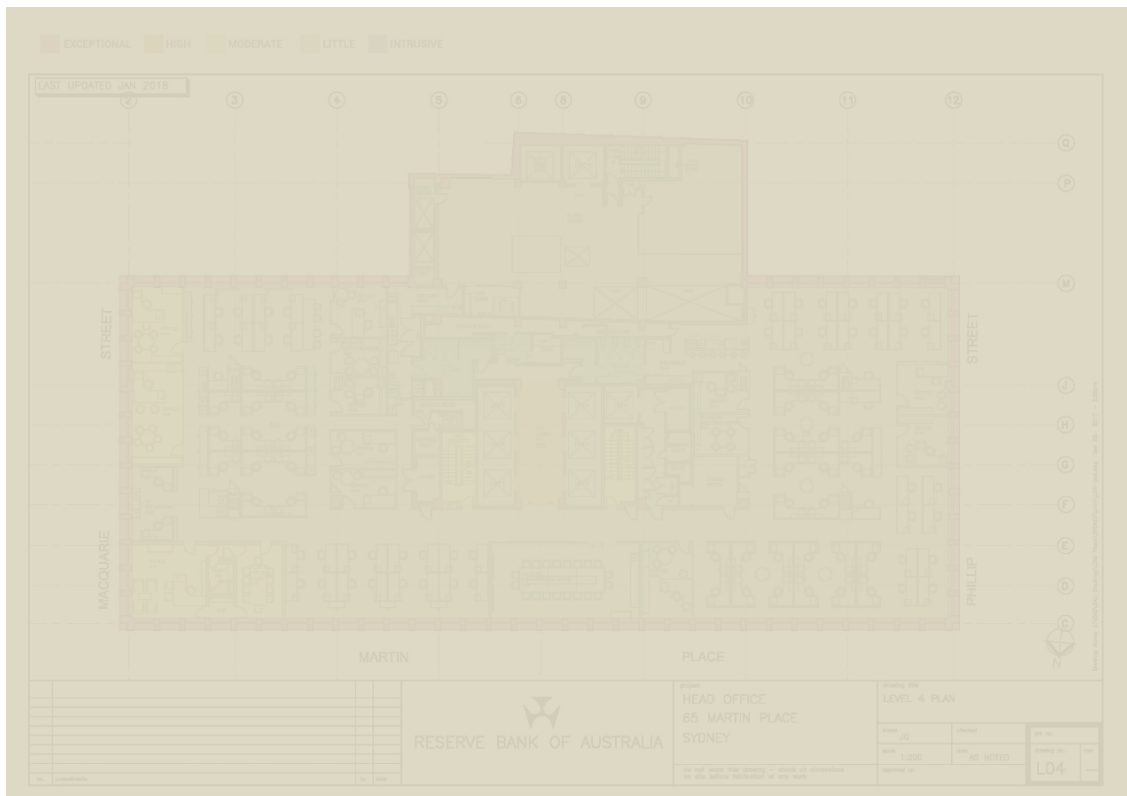
Figure 64: Level 4 – Gradings of Significance diagram

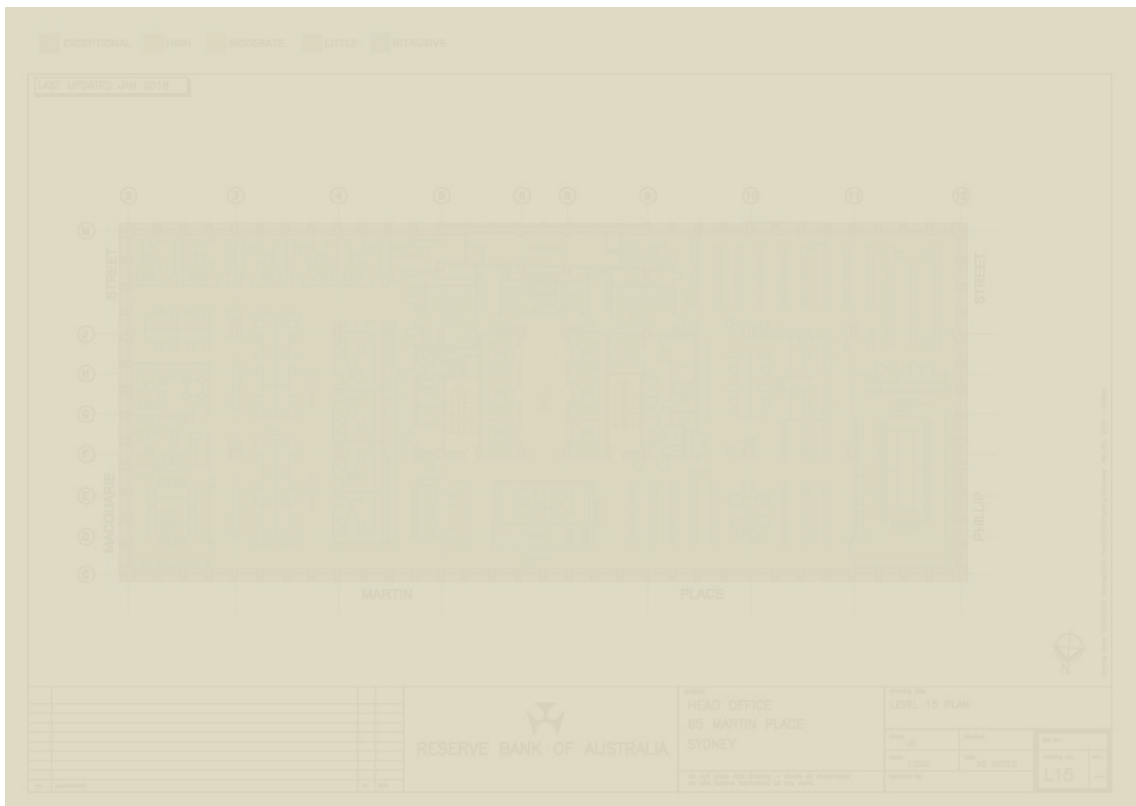
Figure 72: Level 15 – Gradings of Significance diagram

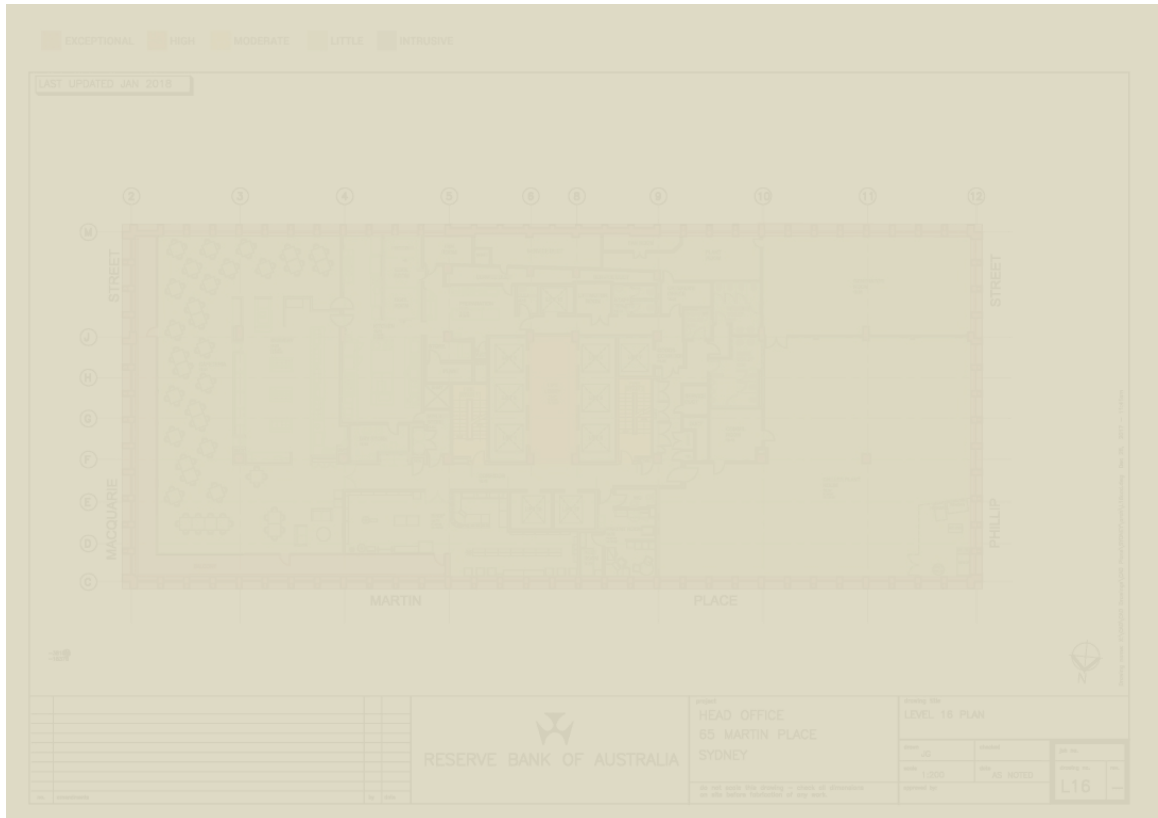
Figure 73: Level 16 – Gradings of Significance diagram

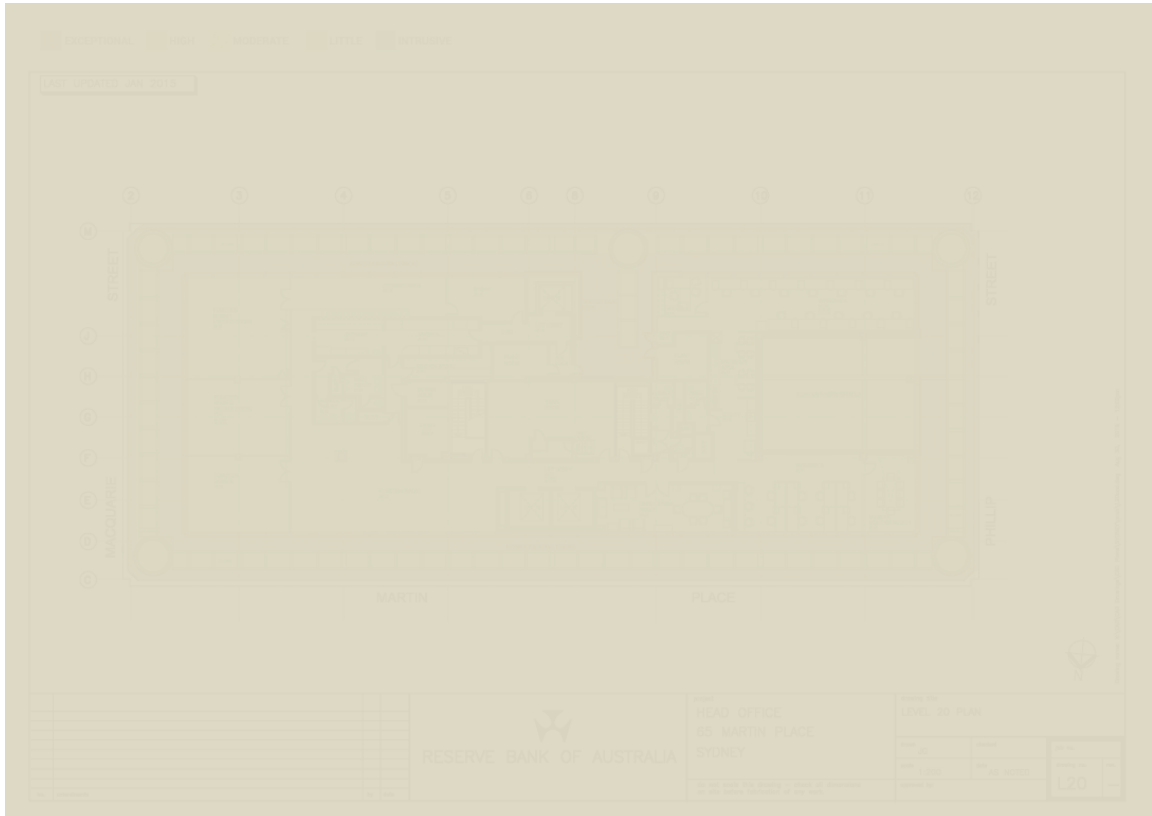
Figure 77: Level 20 – Gradings of Significance diagram
