**PRELIMINARY DOCUMENTATION
ADDITIONAL INFORMATION REQUEST
EPBC (2024/10052)**

**Reserve Bank of Australia Head Office
65 Martin Place, SYDNEY NSW 2000**

3 July 2025

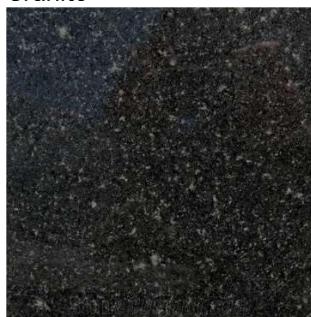
The original dark vertical stone bands are of Adelaide Black Imperial granite. This material meets the required structural criteria, is still available in sufficient quantities from an operational quarry and so is proposed to be used again. No alternatives are being considered for the vertical stone band components of the facade.

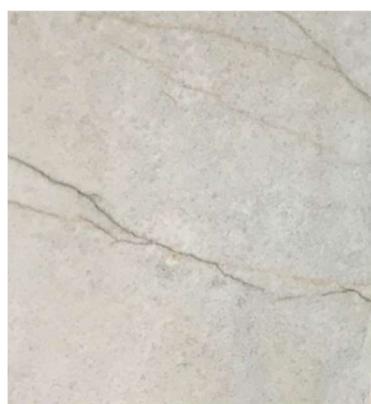
STONE VARIETIES CONSIDERED:**Wombeyan Grey (original material)**

Location: Wombeyan, NSW

Material type: Crystalline Marble

Strength: the material is softer than others recommended in this report, and it is known to be brittle when under stress. For this reason, the marble is susceptible to fractures along veins if exposed to the weather for some time, making external applications less desirable.

- The previous test results for Wombeyan marble were considered standard for a marble, however it is known to weaken around the veins (mud veins) with exposure to weather. The material is also considered to be brittle under stress.
- Inconsistency between the microscopic structure of the marble crystals allowed moisture and possible organic matter into the marble, leaving the marble vulnerable to expansion, softening and failure.
- Due to concrete cancer in the building, spalled concrete chips where dislodged and gathered into the rear cavity of façade fixing brackets, eventually forcing pressure on external cladding in the pin locations.
- Pin installation further weakened the material allowing to open and crack and allow debris into crevices.
- Original elastomeric jointing material failed by hardening, allowing ingress of water to track behind the stone worsening the above issues.

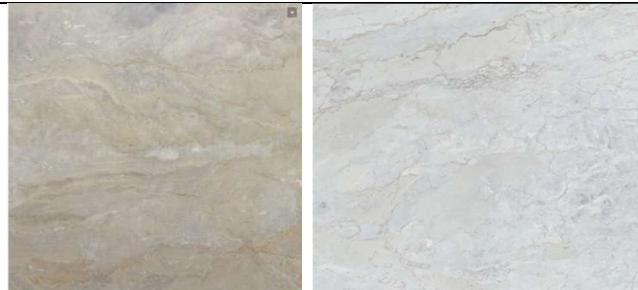
Austral Dream Marble

Location: Pilbara, WA

Material: Dolomitic Marble

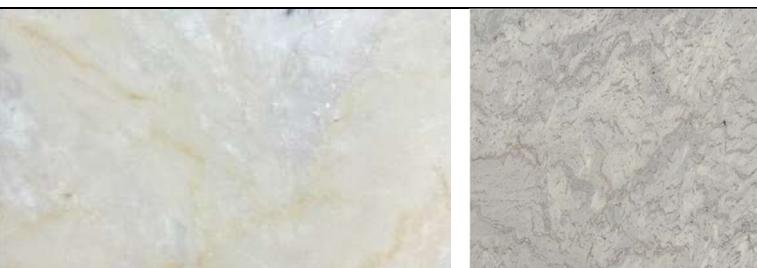
Variant: Austral Pearl Grey (right hand image)

Location: Pilbara, WA

Material type: Dolomitic Marble

- Austral Pearl is currently an in-demand product due to its dolomitic marble properties that are superior in strength and yet still provide the aesthetics of a marble.
- Stock on the quarry floor is expansive for both colour variants however further resource is currently being quarried out on demand. Large quantities allow for colour selection amongst blocks to best suit the project.
- Due to the uniform movement across the material and neutral palette, it lends itself to use across a large project.
- Austral Pearl Grey – appears to be tonally close in nature to the Wombeyan Blue Marble currently in-situ.

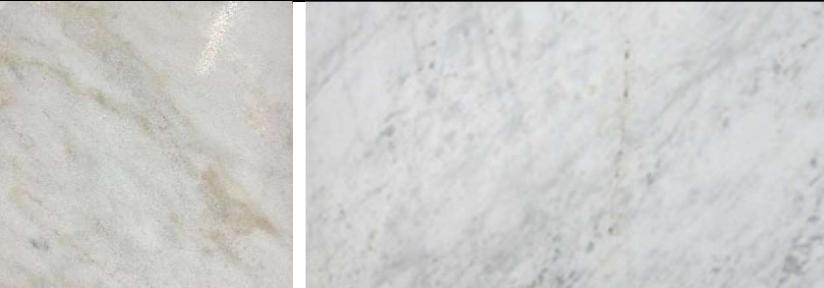
Bianca Mist Marble

Location: Chillagoe, QLD

Material type: Crystalline Marble

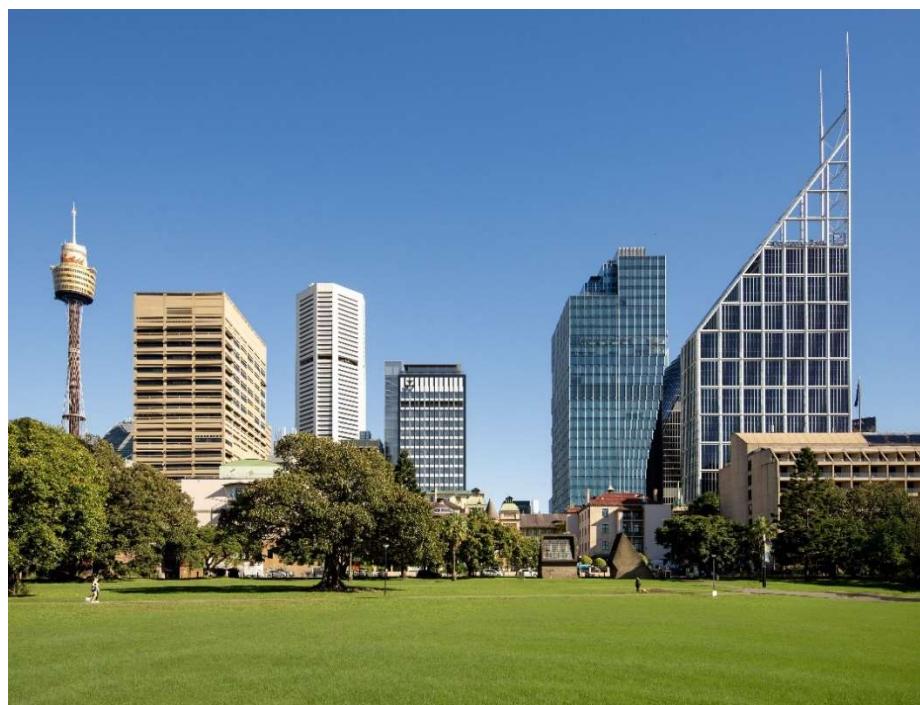
Figure 2 - Visualization of the project from The Domain, demonstrating the surrounding built forms, as well as the relationship of the proposed southern services core and roof top pavilion. These two elements are not readily visible from the surrounding streetscapes. (Source: Architectus)

The location of the subject building, with three street frontages, results in a design that is essentially appreciated 'in the round', with the southern services core being located at the rear of the building and largely hidden from view. Whilst the location of later (current) and proposed services cores have been altered from the 1964 layout, the original operational intent driving the location of this building component, namely being on the southern side of the building, remains the optimal visual and operational outcome.

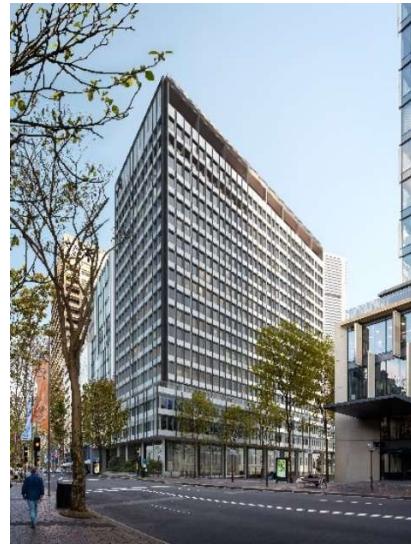
Figure 3 - Northeast

Following investigations into the range of available stones (refer to section 4.2), it was determined that there are clearly acceptable options that meet the required criteria, however in terms of this exercise, the visual appearance between the options is essentially similar. For this reason, a single set of visualisations have been provided, and the appearance of the stone has been based on a high-resolution image of the Austral Dream stone option.

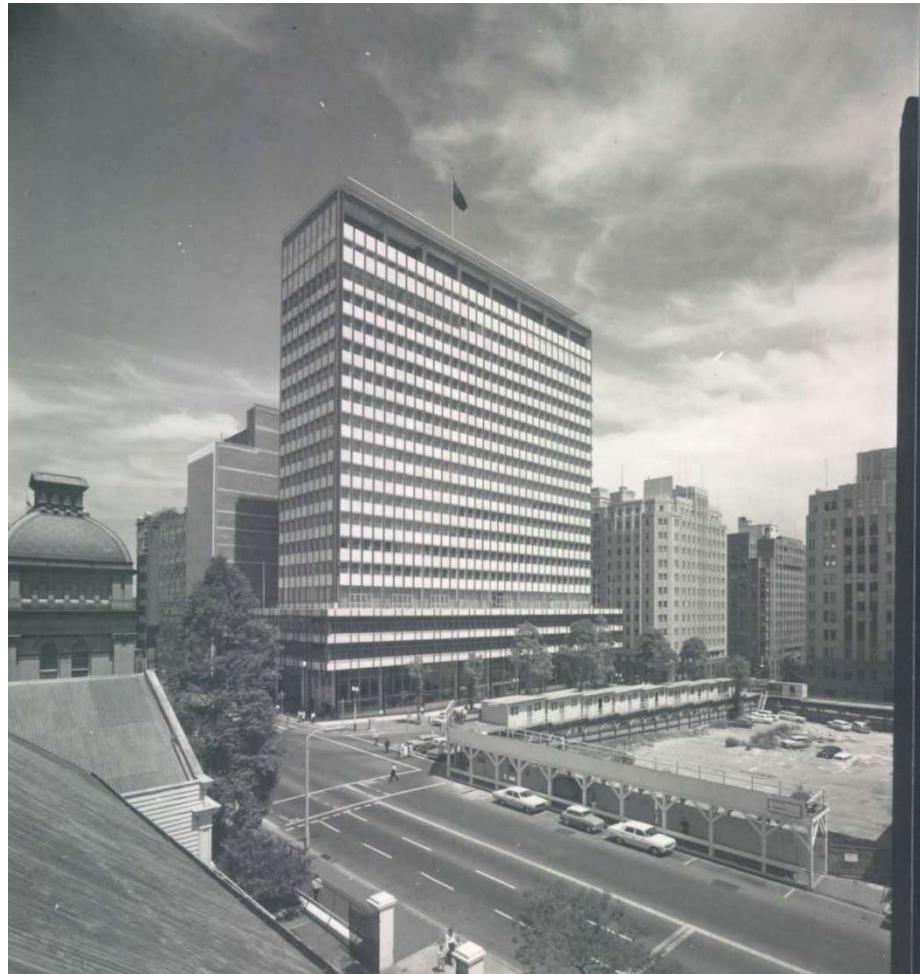
Figure 7 – c1970 view of the building, with the adjacent site cleared for the construction of the (former) Westpac building – now demolished and replaced with 60 Martin Place. (Source: RBA Archives)

current urban development surrounding the site, when the building was constructed, it clearly dominated the corner position both in terms of scale as well as its Modern and forthright architectural expression, as shown in Figure 7 below.

A significant change in the urban context that now needs to be taken into consideration is that in 1964, this was the tallest building in the area, as demonstrated in Figure 7. Today the roof forms a fifth elevation, visible to all those occupying the upper floors in nearby buildings. Raising the height of the roof top pavilion would improve both the quality of the pavilion space as well as high level views of the building.

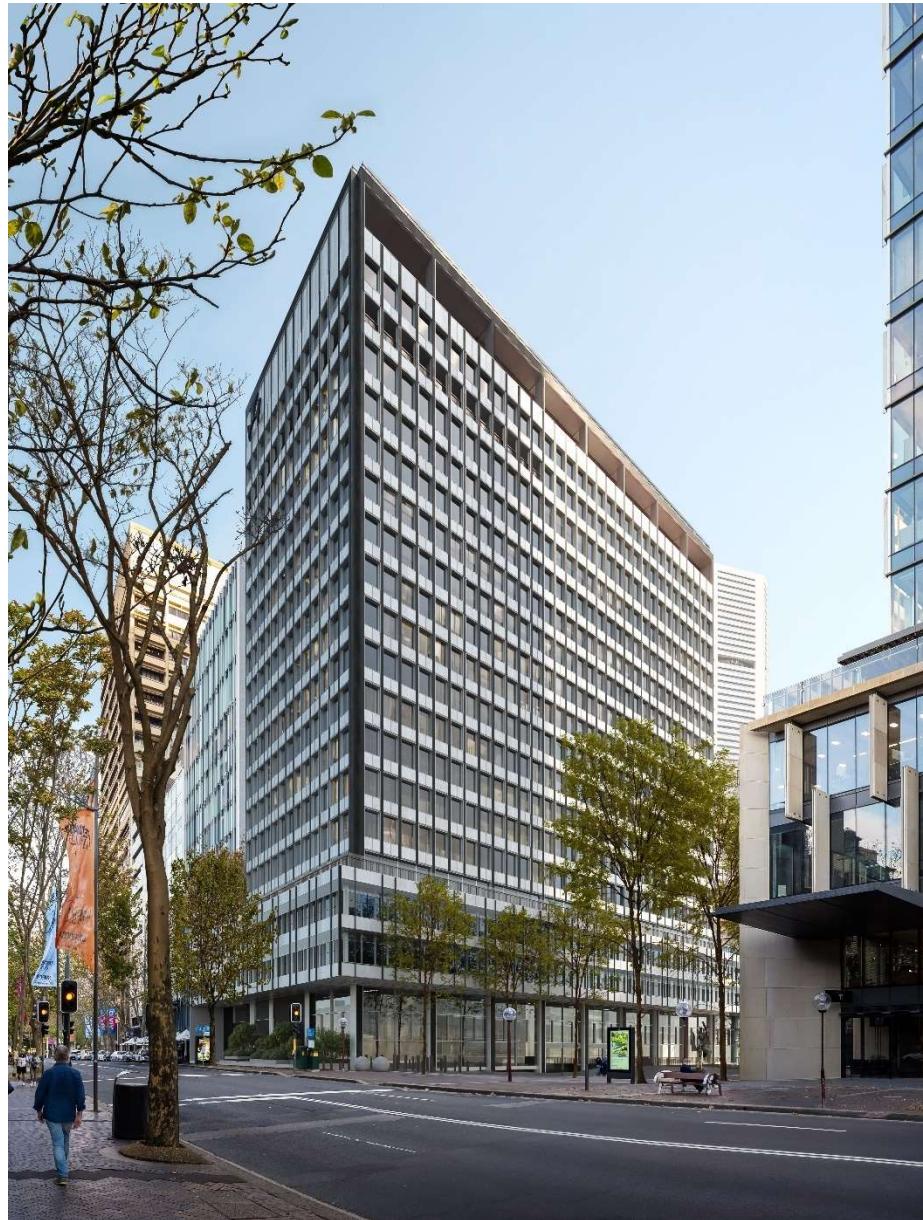
Figure 8 - Visualization of the Martin Place presentation of the building from Macquarie Street. (Source: Architectus)

Key to the buildings contribution to Martin Place is the relationship with the ground floor lobby and external walkway and plinth. Where the Phillip and Macquarie Street elevations meet the ground in a functional way, the expansive double height glass windows along the full width of the elevation, with full height glazed returns at each end, is one of the significant original design features of the building. Not only architecturally distinctive, this feature is also an intentional statement broadcasting the optimism and desire for transparency by the newly established organisation.

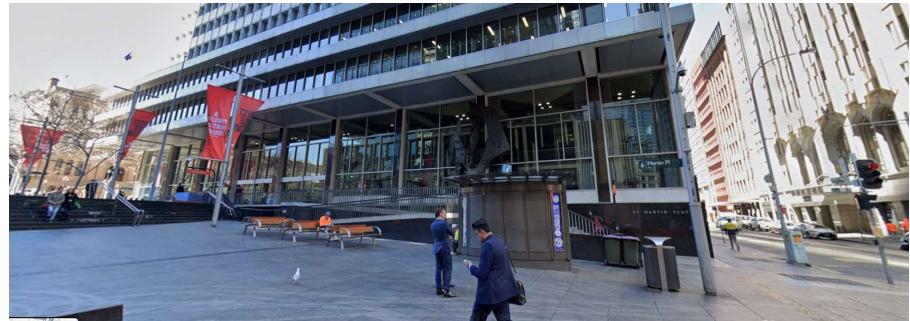
Figure 9 - Later public interventions into the forecourt area, including posts, ramp, seating and kiosk structures etc. (Source: Google Streetview)

The area immediately in front of the building on Martin Place, has since its original construction, become the venue for a range of public domain interventions. These include rubbish bins, light/flag/security camera poles, seating, ramps, kiosks and most significantly, an entry point to the Martin Place underground railway station. All of these elements have diminished the relationship of the building entry and the public domain. Upgrading of this area is highly desirable, however outside the scope of this project and contingent on City of Sydney involvement.

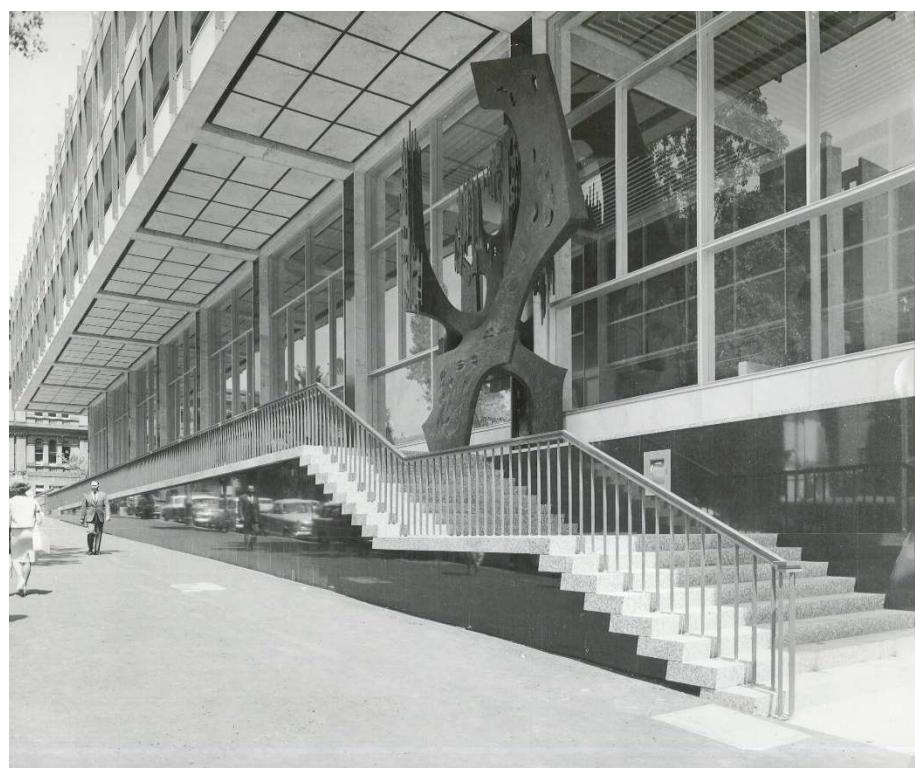
Figure 10 - Image of the clean lines of the original plinth interface with Martin Place. (Source: RBA Archives)

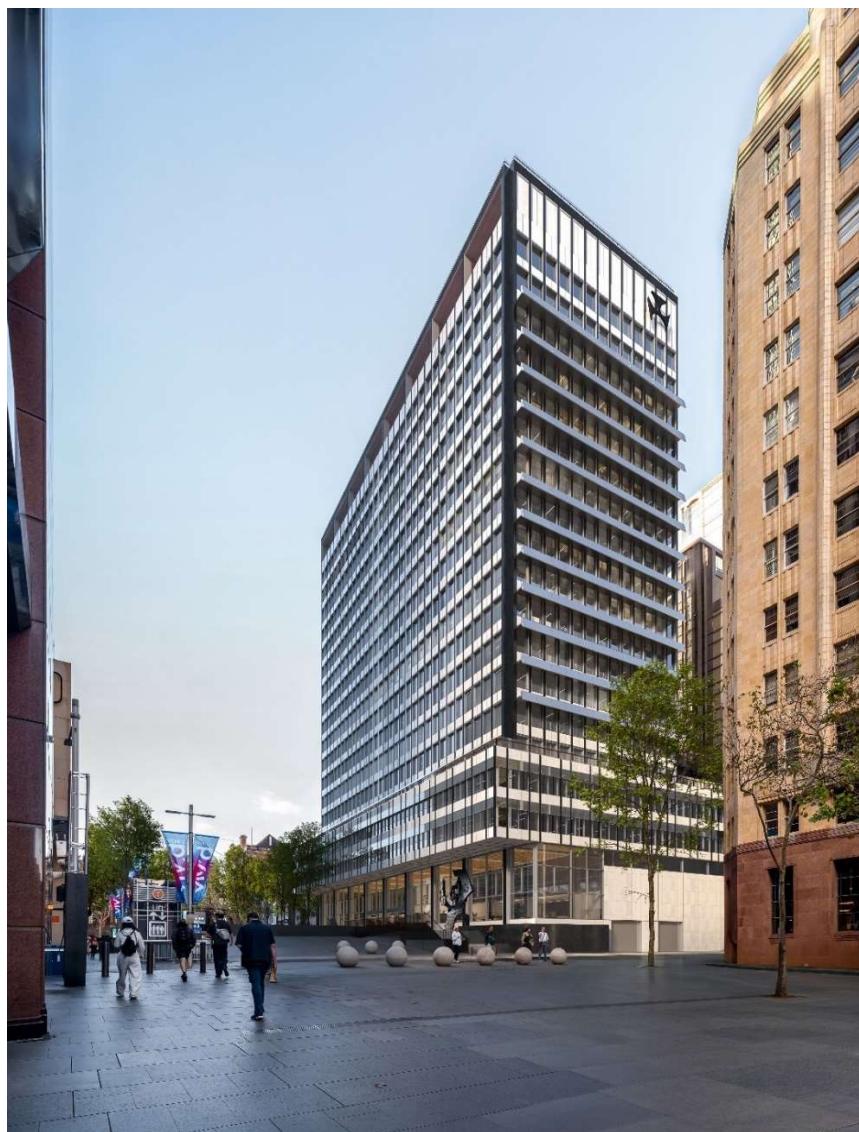
Figure 15 - Visualisation of the northwestern corner of the building from Martin Place, below Phillip Street. Note: the train station entry and various public domain structures have been removed for clarity. (Source: Architectus)

Travelling along Phillip Street north and south, views are oblique and confined, with pedestrian views being limited to angled and indirect views. For these reasons the viewpoint for the visualisation, Figure 15 below, is from Martin Place to provide a clear view of the Phillip Street elevation.

- the overall form and scale of the building is retained,
- the characteristic 'tartan' pattern, materiality and International Modern aesthetic is retained, and
- lost design elements will be recaptured, enhancing the building presentation, including
 - the restored Gordon Andrews designed logo
 - accurately reconstructed sun hoods and
 - reconstructed podium blades and sunscreen features.

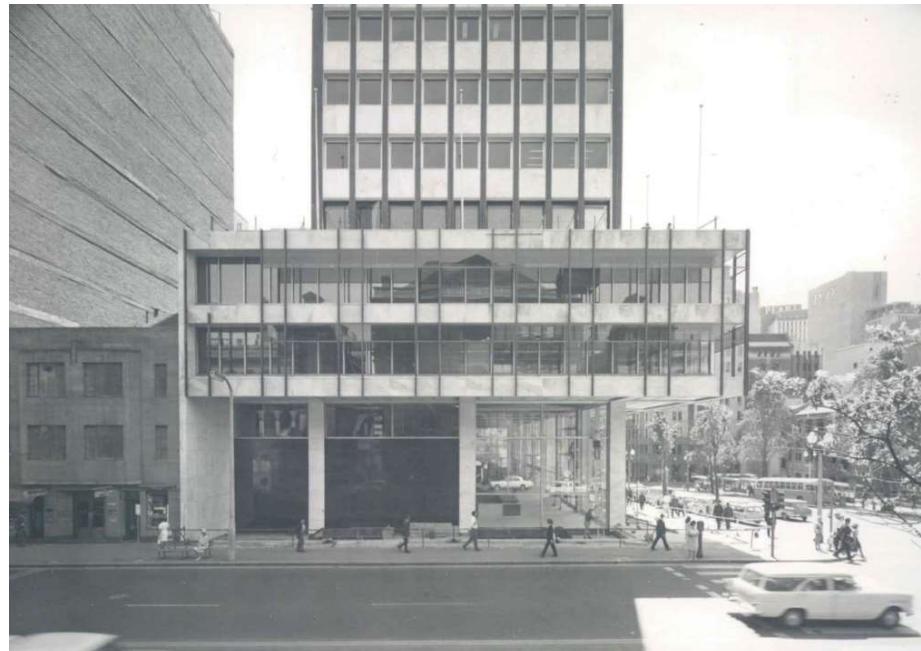
Figure 17 – Macquarie Street view of the podium during construction. The garden was not yet completed. (RBA Archives)

At street level the building façade includes secondary access points into the building as well as providing code compliant access to the proposed substation to be located into the basement.

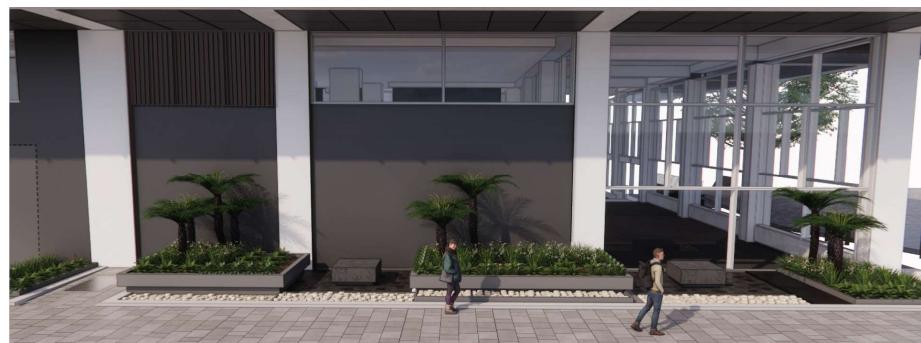
Figure 18 - Illustration describing the refurbished Michael Munro gardens. (Source: Architectus)

On the northeastern corner of the site, at street level, the Michael Munro Garden is located below the podium overhang. The garden and its components have been modified over time in response to changing conditions, including the addition of street trees which block out sun to the garden, and changing maintenance requirements which are triggered by a range of vandal and security issues.

The proposal includes the restoration and upgrading of the garden enhancing the presentation of the building edge and its contribution to the Macquarie Street streetscape.

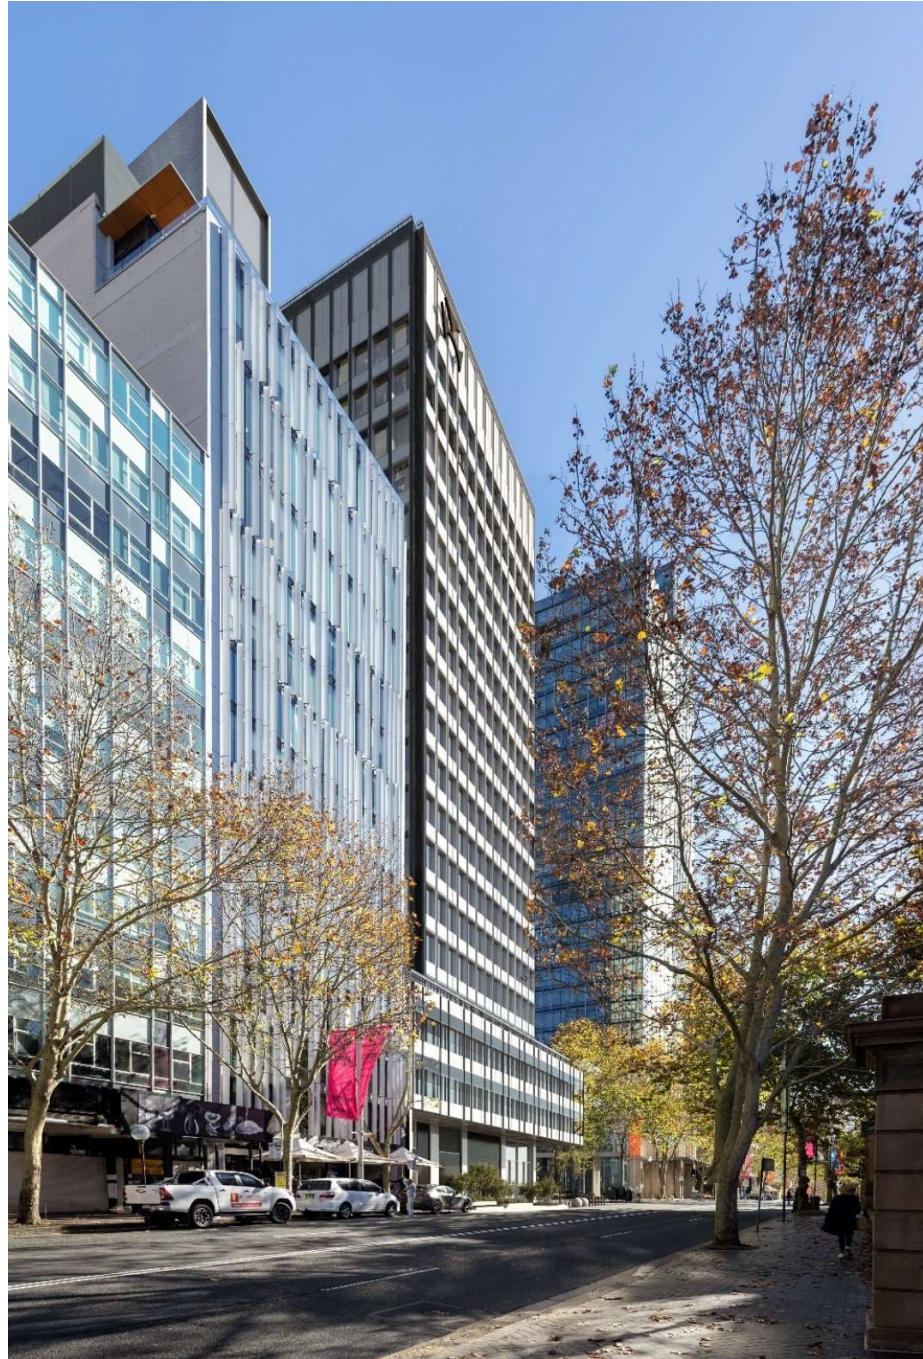
Figure 19 - View north, capturing the proposed RBA building and its context in the western street wall of upper Macquarie Street. The heritage listed William Bland Centre, dating from a similar era to the 1964 RBA building, is at the left-hand edge of the image. (Source: Architectus)

The visualisation at Figure 19 below captures a hint of the past in the sandstone pillar from Hyde Park Barracks across Macquarie Street, whilst illustrating the current day context comprising the contemporary 60 Martin Place and later buildings, including the Modernist influenced (heritage listed) William Bland Centre, forming the adjacent streetwall to the south of the site. The render illustrates the relative building heights fronting Macquarie Street, and the stepping of the building heights which contribute to a more human scaled streetwall facing onto the historic precinct with views over the heritage buildings to the open landscape of The Domain beyond.

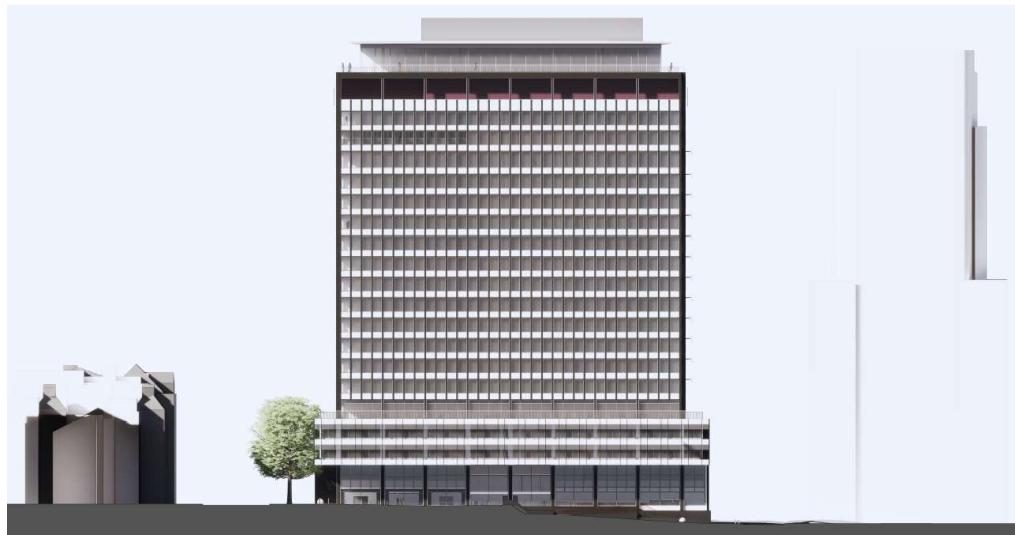
Figure 21 – Diagram of the northern facade, illustrating the relationship between the entry level, the podium and the tower components. Also shown is the 'tartan' pattern applied across the tower facade, and the relationship of the lift over run and rooftop pavilion. (Source: Architectus)

The intention for the new facade is to closely match the original design and materiality to recreate the 'tartan' facade composition and recapture the International Modernist aesthetic of the building.

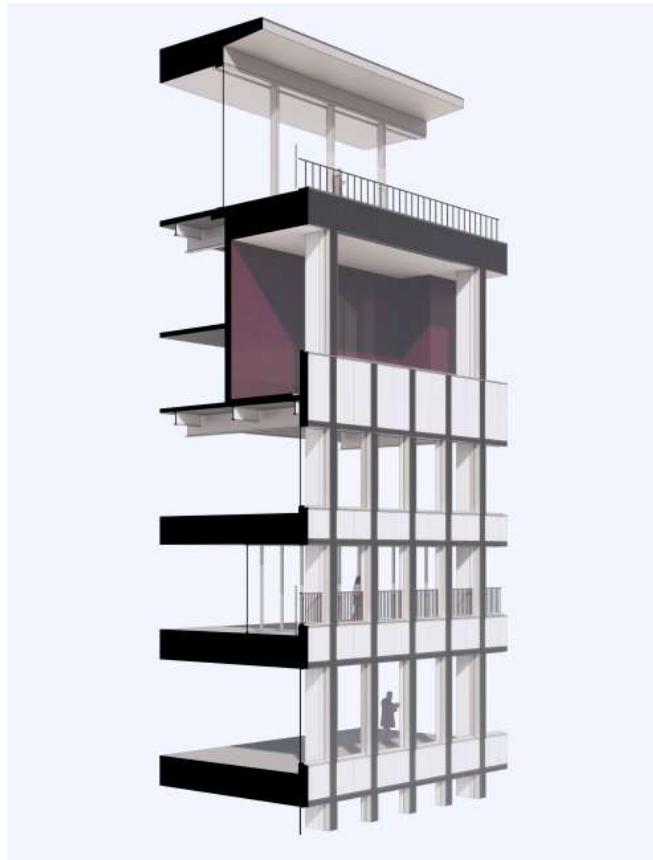
Figure 22 - Indicative section through upper levels 15 through 20 and the roof top pavilion of the building. The plum-coloured glazed tiles to the outside of the original plant rooms will be conserved. (Source: Architectus)

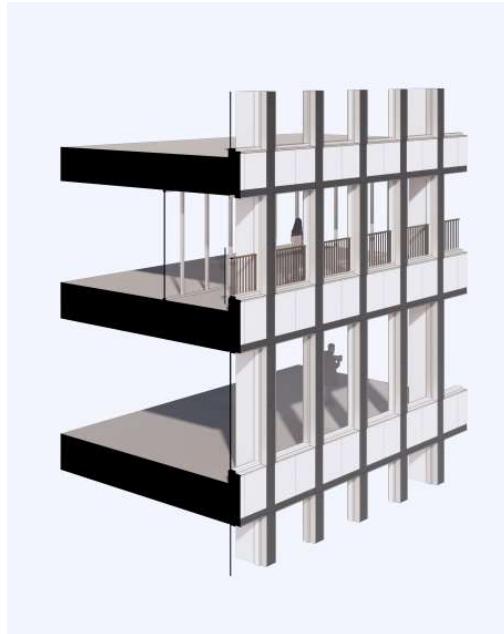
Figure 23 - Diagram demonstrating proposed window proportions, including the framing of the openings to the balcony at level 16. (Source: Architectus)

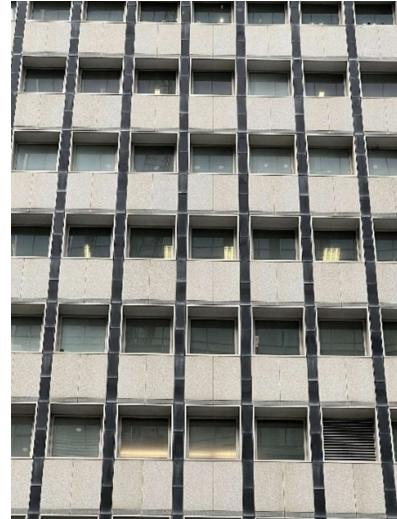
Figure 24 - View of the later overclad replicating the original layout pattern below. The relationship between the narrow, dark verticals and alternating horizontal bands of windows and lighter stone panels that create the 'tartan' effect is clear. (Source: NBRS 2023)

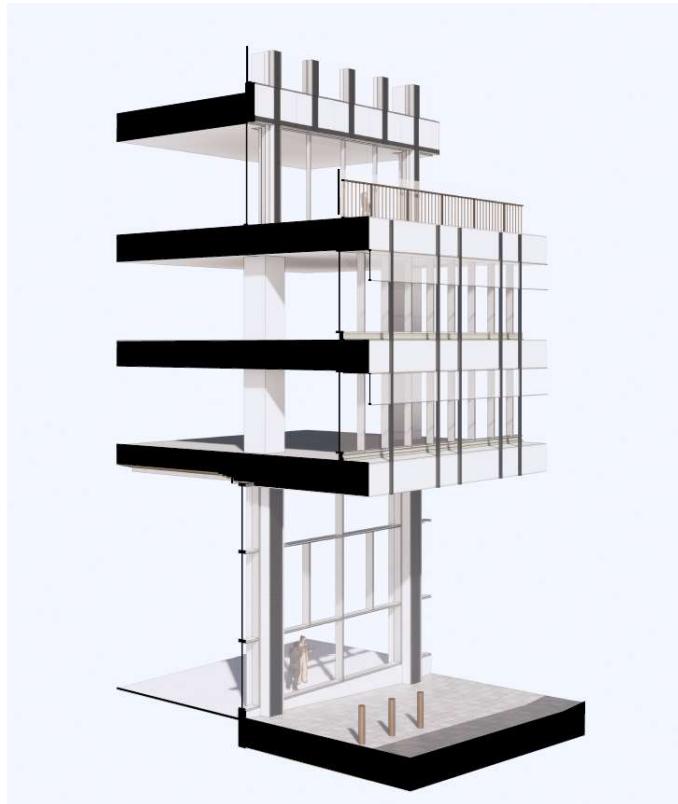
Figure 25 - Section demonstrating the articulation between the podium, the ground level and tower portions of the building. (Source: Architectus)

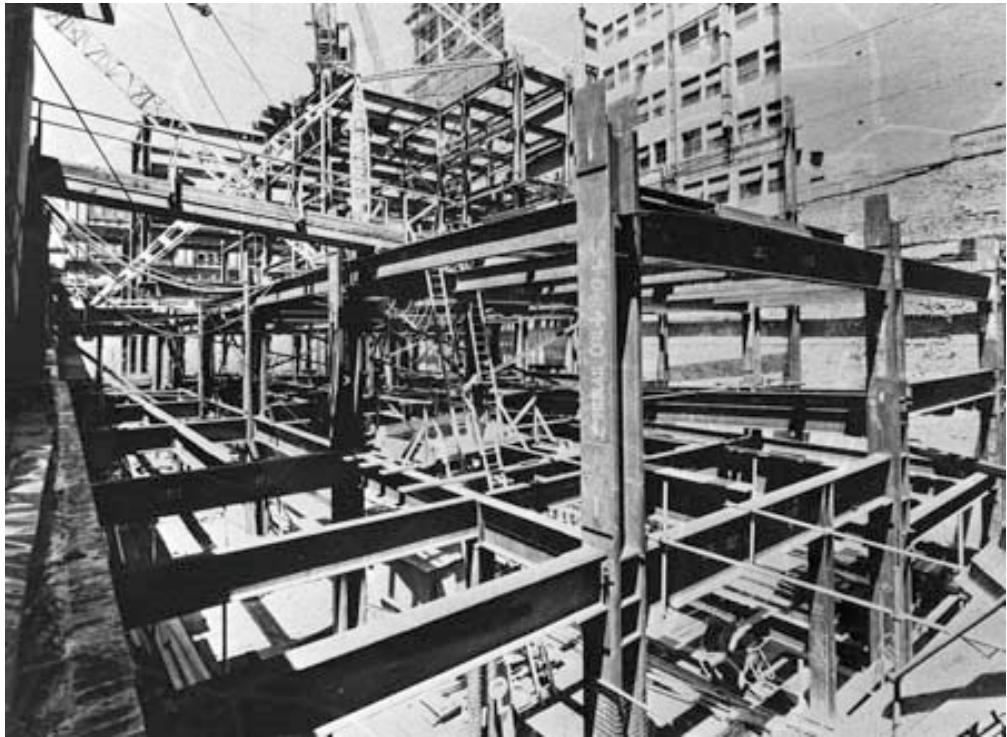
Figure 3 – View of the steel framed construction of the Reserve Bank of Australia Head office building, c1962. Source: National Archives of Australia

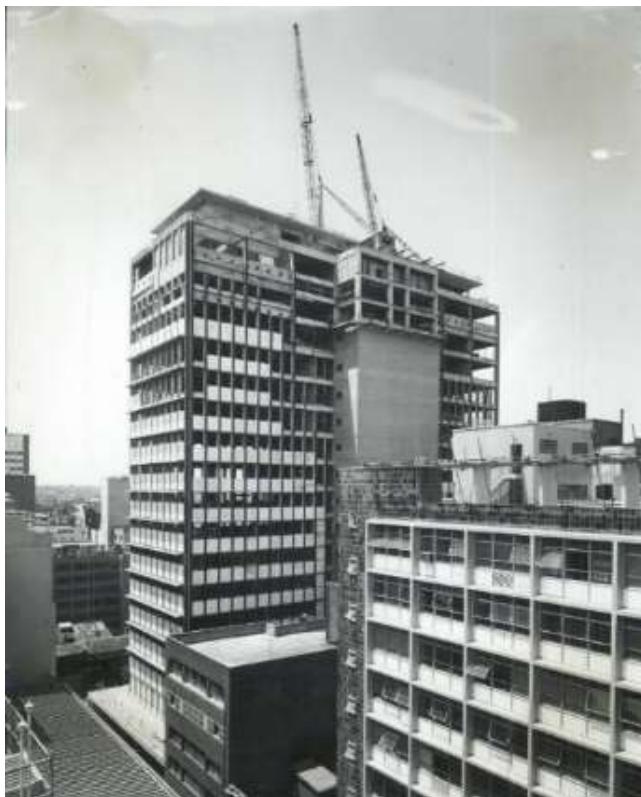
Figure 4 - View of the south and west elevations during construction c1962. Source: National Archives of Australia

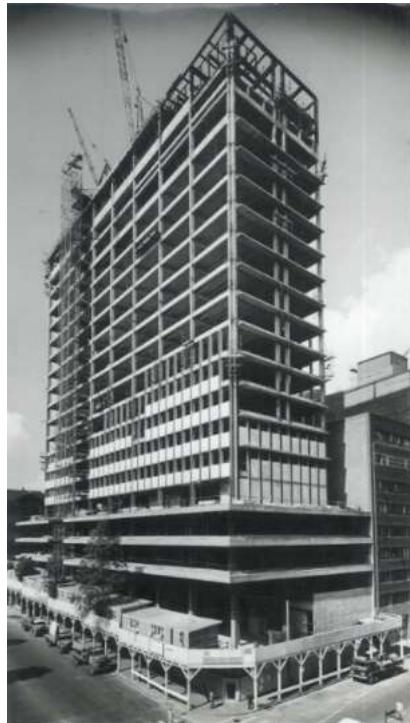
Figure 5 -View of the northwest corner of the RBA Head Office showing the original marble panels being installed to the north and west elevations, c1962. Source: National Archives of Australia.

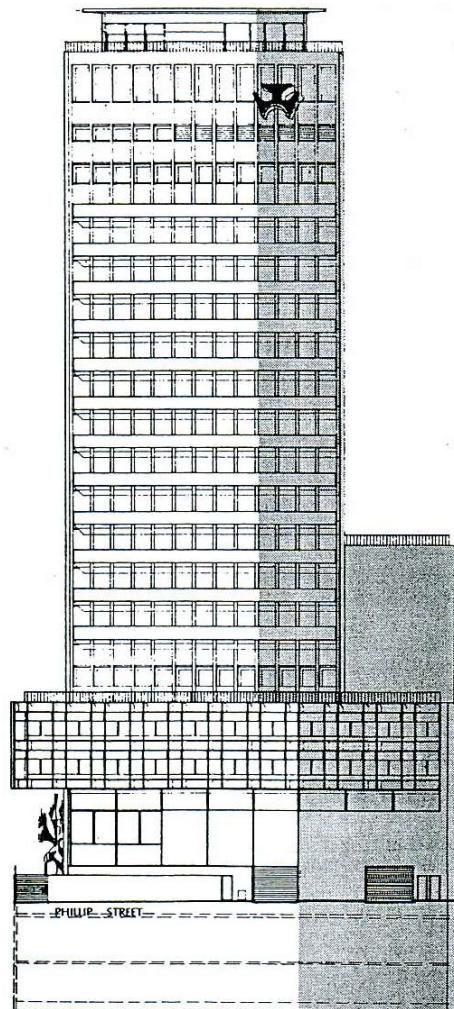
Figure 7 – Diagram showing the Phillip Street elevation. The shaded area indicates the location of the addition constructed in the late 1970s, and the dedicated services/plant spaces. Note the addition accommodating the services finished at Level 7.

Works involved substantial additions on each floor to incorporate the adjacent site to the south. The effect of the changes was to increase the depth of the building by nearly one third increasing its presence on both Macquarie Street and Phillip Street (See Figure 7) and to provide additional service areas at basement and podium levels were also provided.

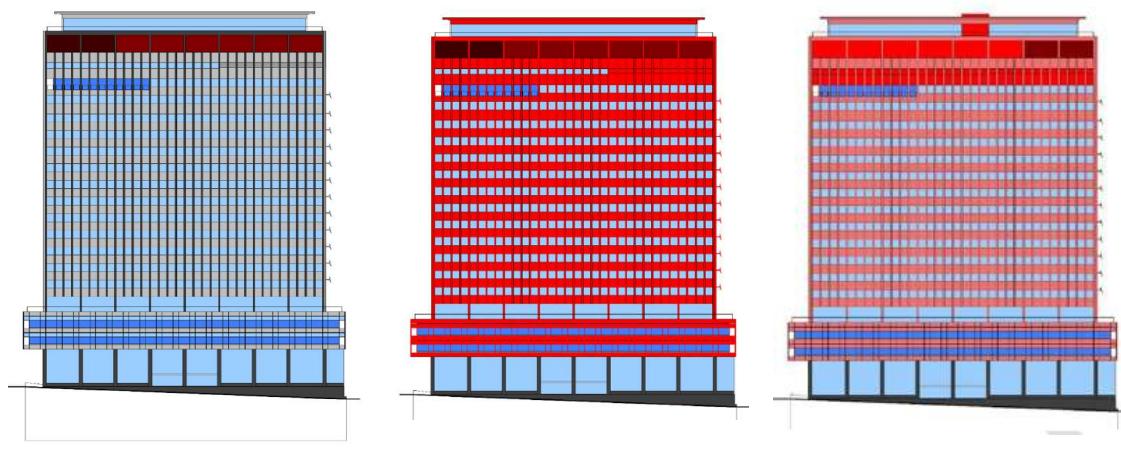
The following diagrams and images compare the 1964, c2000 and c2023 façades to identify the level of external change to the building façade, areas of changes are shaded red.

C1964
The original facade

c1990
External changes included the overcladding of the whole building, removal of the RBA logos and sunblades to the padoiom.

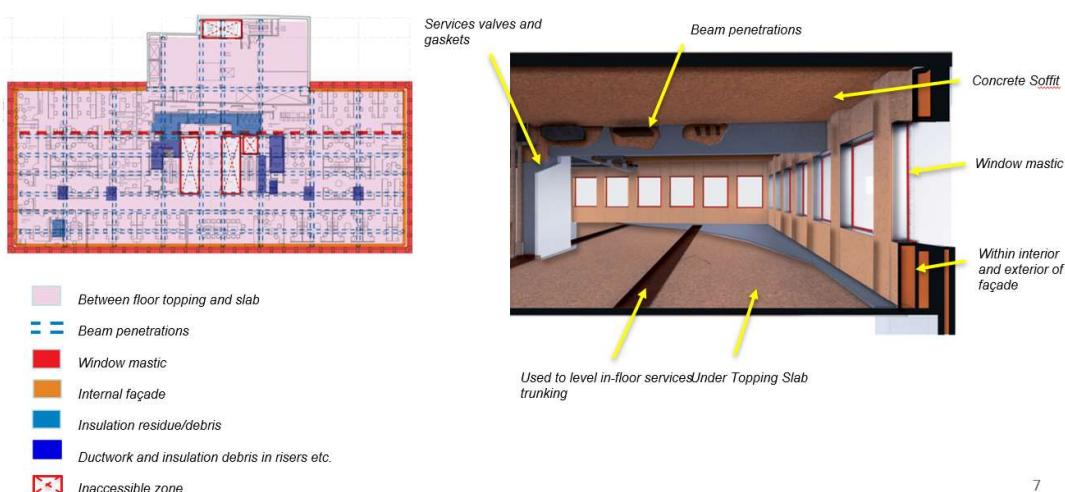
The following diagrams indicate the extensive nature of the hazardous material discovered to be embedded throughout the building, in the façade and in the concrete encasing of the steel columns and beams, as well as the concrete slabs between all floors.

Figure 13 - Diagram illustrating location and extent of asbestos through the building structure. (Source: Architectus)

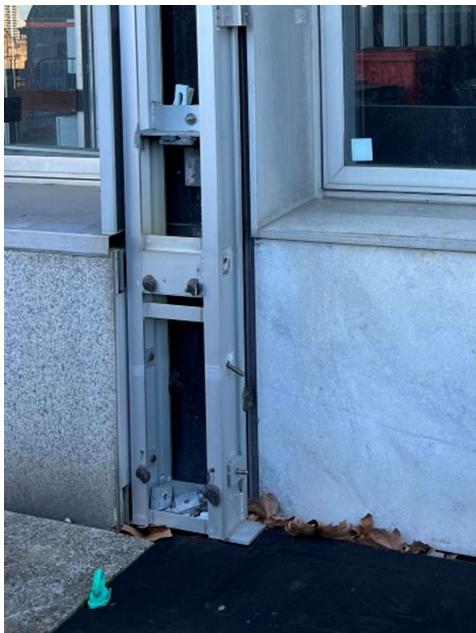
Detail on the western façade where a portion of the 1990's overcladding has been removed revealing the original sill profile and stone panel (to the right of the overcladding support framing)

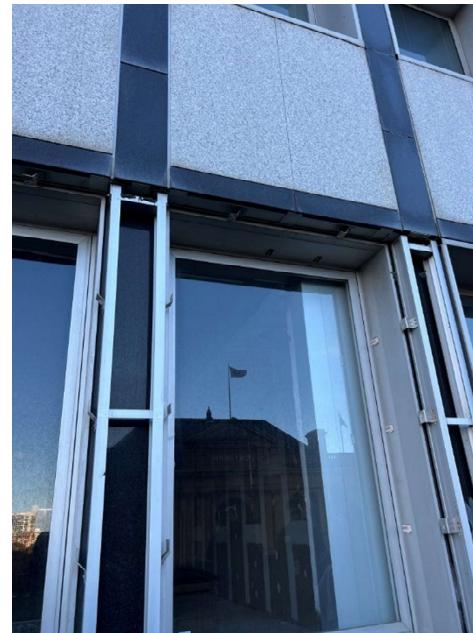
Detail of where the overcladding to the head and reveal of the windows has been removed. The secondary frame used to support the overcladding pushes out the face of the building, and the depth of the reveal, in the order of 100mm.

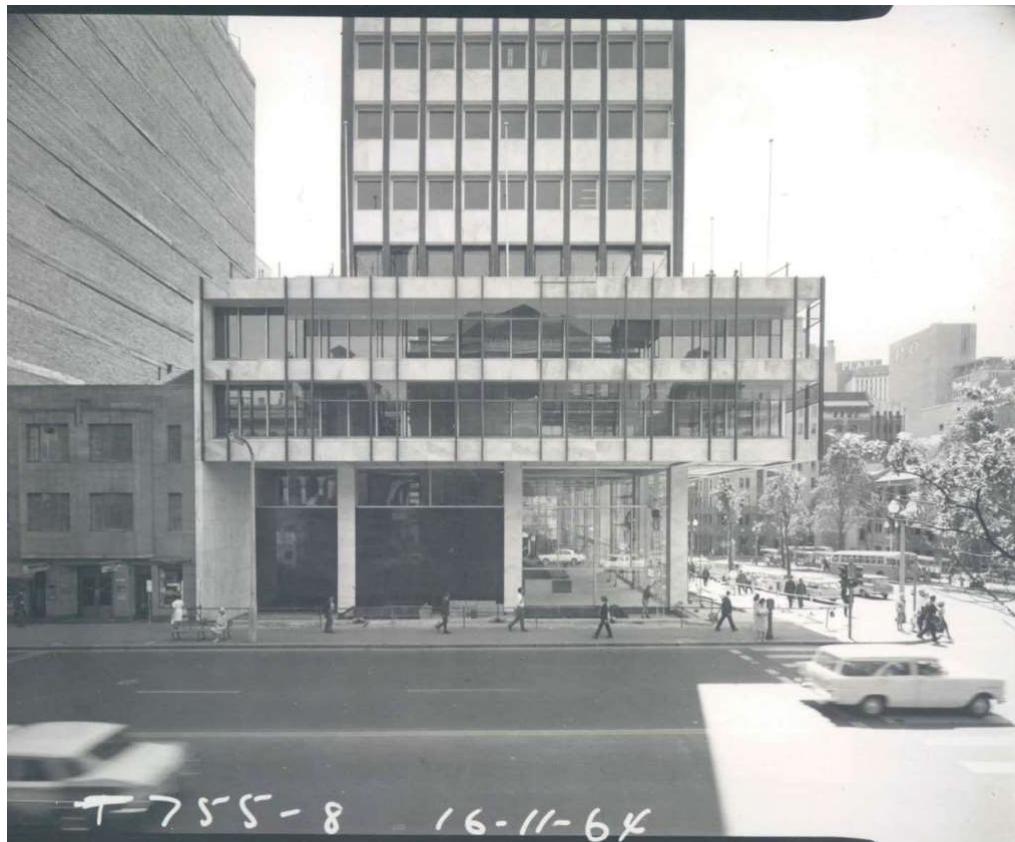
Figure 14 – Macquarie Street view of the podium during construction. Note that Martin Place had not yet been created. (RBA Archives)

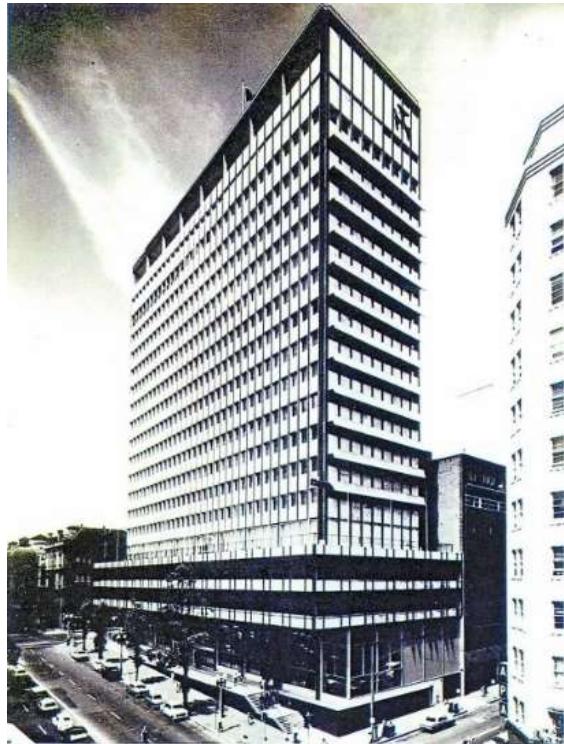
Figure 15 - View of the Reserve Bank of Australia Head Office Sydney, looking southeast from the Phillip Street corner, c1964. Note that prior to Martin Place being constructed the sloping topography was managed via a plinth and set of stairs. (Source: Australian Archive)

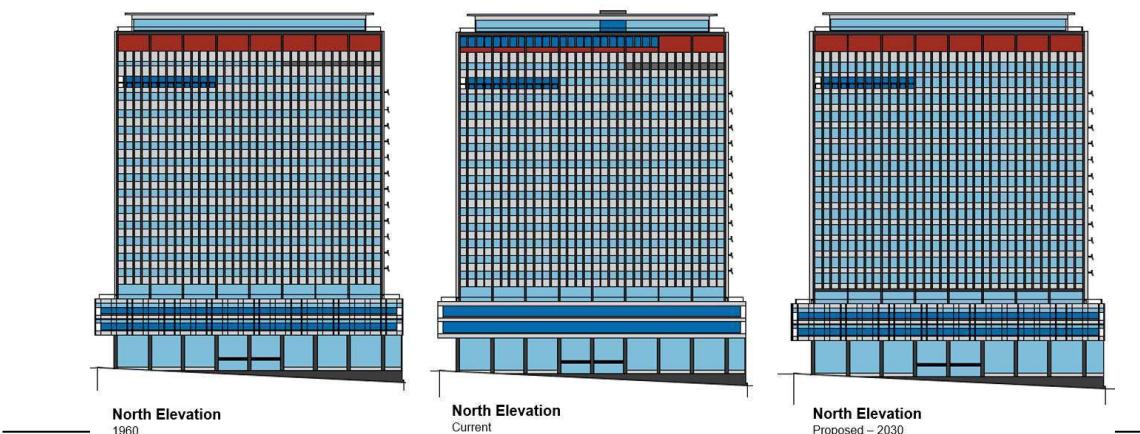
The proposal to install a new façade, designed to interpret the aesthetic of the original International Modernist 'tartan' pattern, also recaptures lost detailing from the original design. The overall form of the building, including the distinctive double height ground floor lobby visible to the public, the podium and tower elements, will be retained. The building will maintain its existing form, scale and presentation. The comparison diagram below shows primary northern façade facing Martin Place.

Figure 16 - These comparison diagrams illustrate the changes to the primary façade presentation to Martin Place, firstly the original design, the second version following the overcladding, window changes and stripping back of original detailing to the podium. The third diagram demonstrates that the original form and aesthetic is retained, along with recapturing important podium detail. (Source; Architectus)

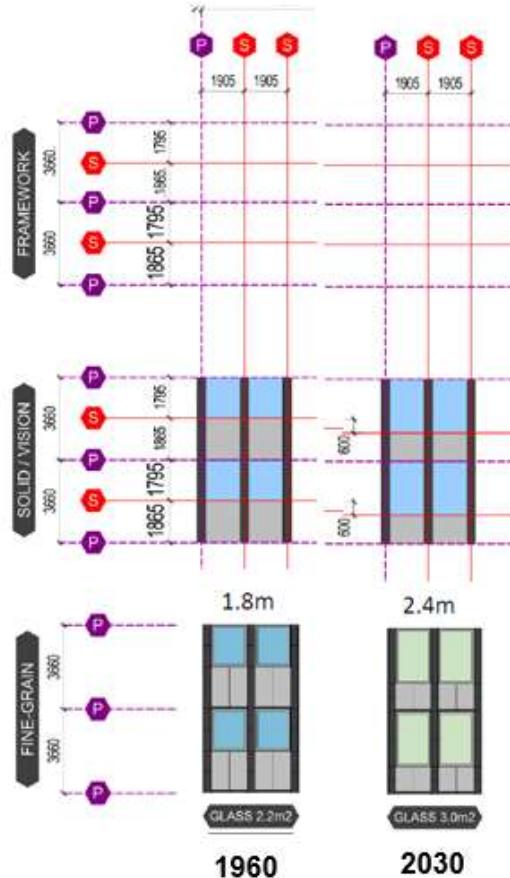
The proposed new sill height is based on retaining the key grid lines that underpin the set-out grid of the 'tartan' pattern, ensuring the visual character of the building is retained. The diagrams below provide an analysis of the original construction, the impact of the extensive changes carried out in the 1990s and proposed 2030 scheme.

Figure 17: Proportion study diagram. (Source: Architectus)

The sections below describe the original window arrangement. Originally, the sill height was designed to house a fan coil unit, a technology that has been superseded. The 1990 section includes the overclad, which retains the fan coil unit while increasing the depth of the window recess to accommodate additional framing and cladding. With the proposed upgrade to the aged air conditioning system throughout the building, the fan coil units are now redundant, allowing the sill to be lowered. This results in a more aesthetically pleasing window design and increases natural light penetration into the interior spaces. Modern mechanical cooling systems, which are more energy-efficient and easier to maintain.

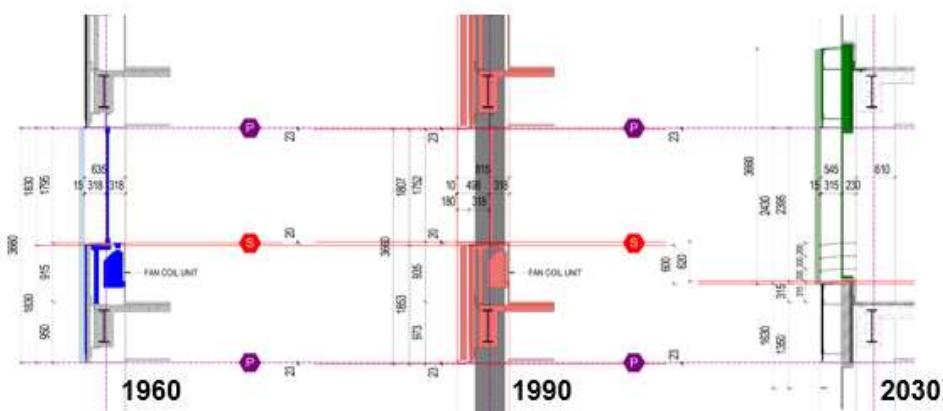
Figure 18 - Section - Typical, comparing the original, existing and proposed window sections. (Source: Architectus)

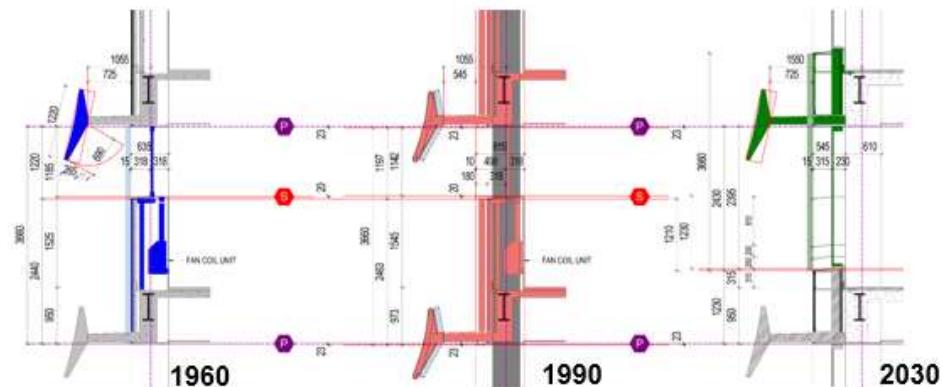
Below is a similar comparison of the windows to the western elevation. The proposal also includes reconstructing the original profile of the western sunhoods, which had been replaced to an altered profile during the 1990's overcladding project.

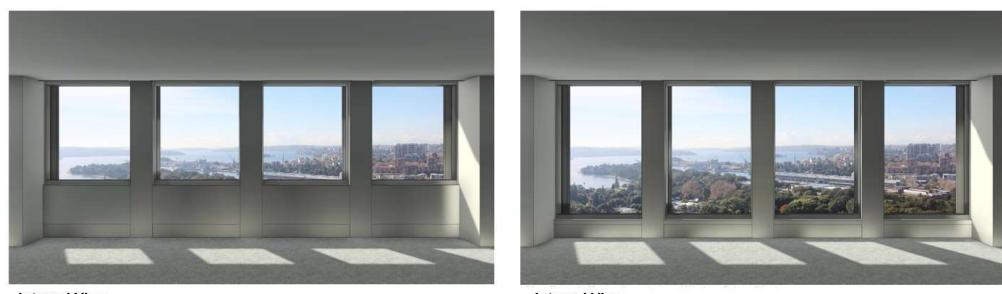
Below is an image demonstrating the impact of lowering the sill from the interior of the building. This change supports the provision of a contemporary level of office amenity.
