**PRELIMINARY DOCUMENTATION
ADDITIONAL INFORMATION REQUEST
EPBC (2024/10052)**

**Reserve Bank of Australia Head Office
65 Martin Place, SYDNEY NSW 2000**

3 July 2025

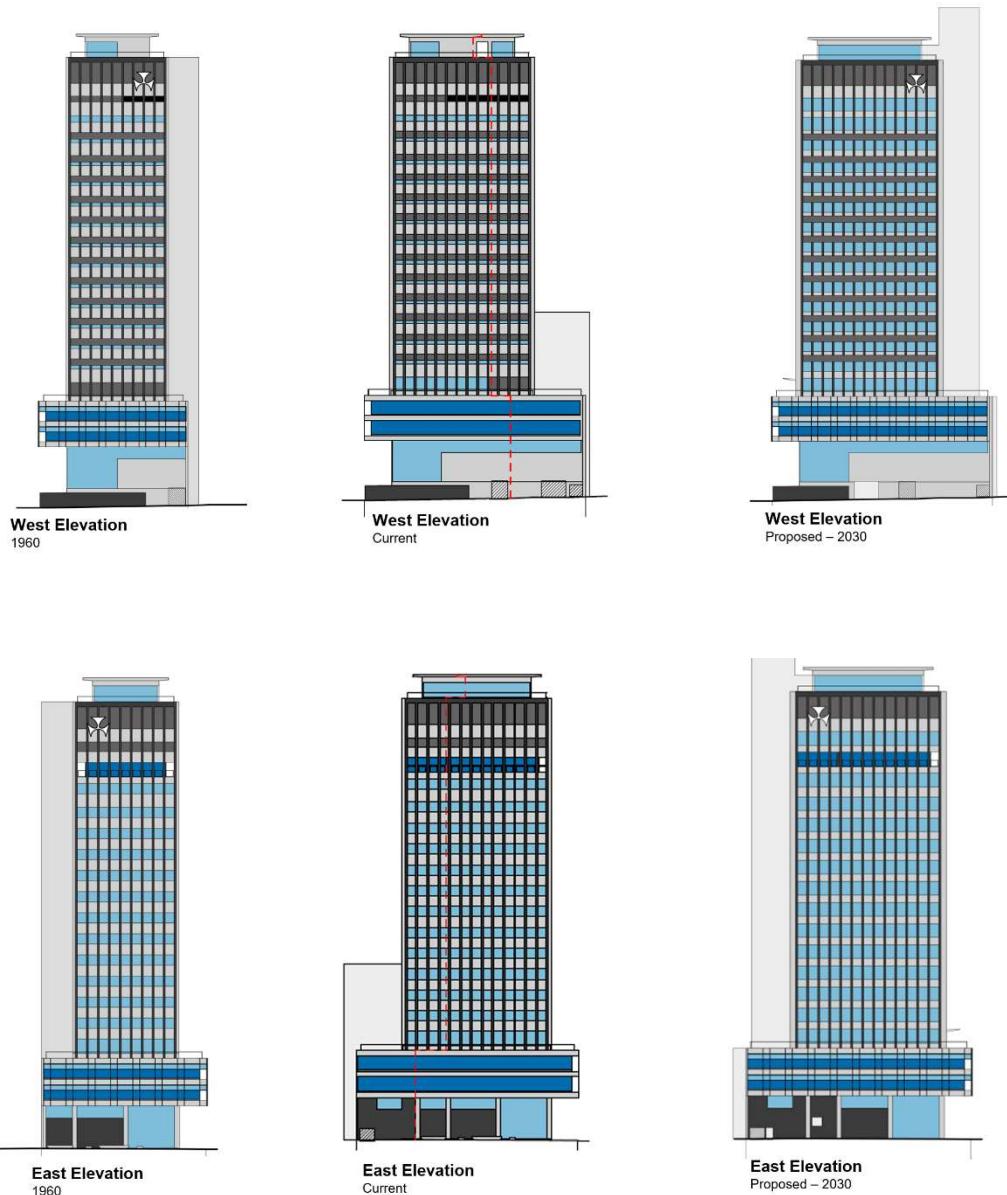
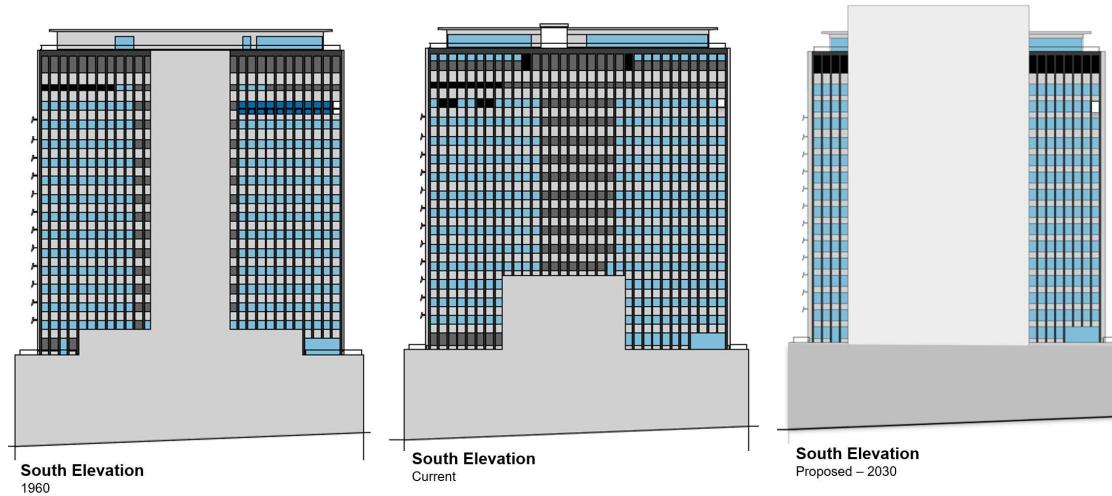
Below are additional comparison diagrams, shown in Figure 39, that describe the proposed changes to the remaining three elevations. The 2030 scheme includes the alteration to the sill height and the restoration of lost external features, such as the Gordon Andrews-designed RBA logo to the eastern and western elevations, as well as the reconstructed sun blades on the podium.

The red dashed line shown through the western and eastern elevations indicate the 1970s addition to the south. The grey form to the south of the building marks the location of the services core. An increased passenger lift overrun is required because the existing lift did not service the upper floors, requiring people to change lifts at Level 16. The previously approved Workplace upgrade project includes the addition of two new passenger lifts to service the whole of the building; with the 2030 scheme proposing a refinement to the location of the lift core, discussed further in section 6.5.

Other external modifications will include changes to the openings at ground level in line with the construction of a new electrical substation, which is a requirement of Ausgrid. There will also be minor changes to vehicular access locations to the building loading dock off Philip Street.

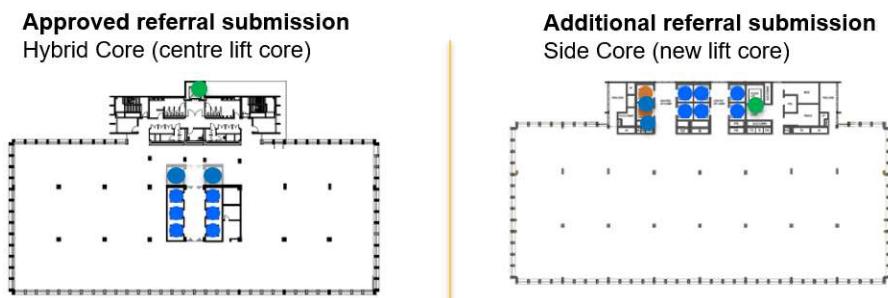
The current proposal includes modifying the approved Hybrid Core to bring the services and lifts together on the southern boundary, as original design designed. This reorientation of the lifts supports the rationalisation of services throughout the building, between Basement Leve 3 to Level 20. This enables the construction of new lifts that service all floors and updates the basement loading dock and vehicular access without the need to undertake major changes to the original B3 Strongrooms.

This arrangement also conserves the double height spatial character of the existing ground floor entry spaces. It is a recommendation of this report that the location of the original lift location would be interpreted at ground level.

Figure 19 - Two plans showing the changes proposed between the approved Hybrid Core (referred to as Option B) arrangement (LHS) and the proposed Side Core layout (RHS). (source: Architectus)

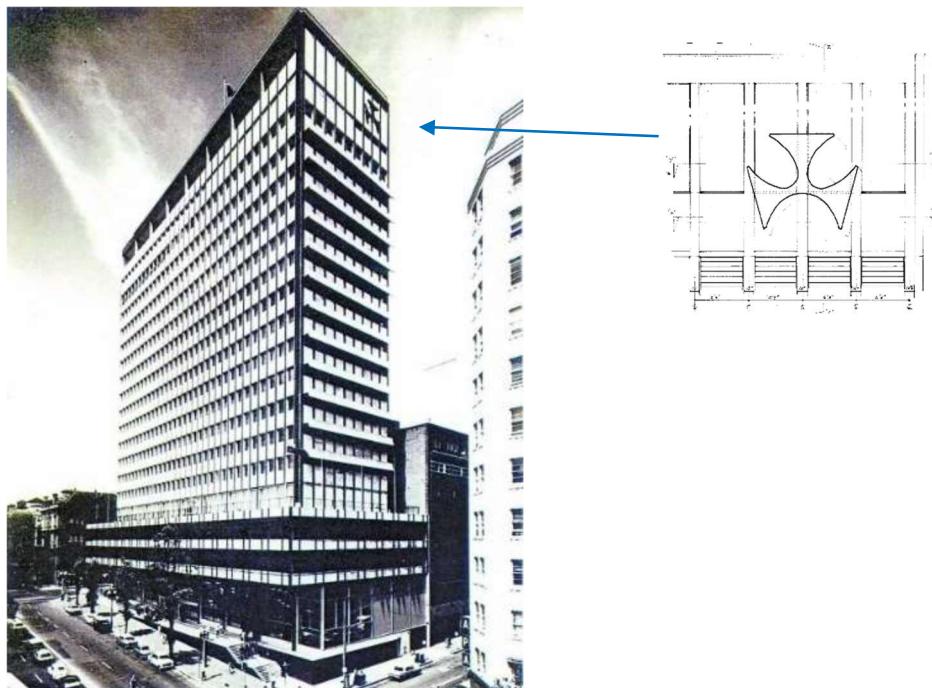
Figure 21 - Historic image of the recently completed building showing the location of the western RBA logo. One of the original logos has been retained on site and is proposed to be repaired and conserved for reinstatement. The adjacent sketch has been reproduced from the original drawing.

These elements were mounted at high level on the top right-hand corner of the eastern and western elevation. Although these elevations are now wider due to later additions, the intention is to retain this position on each elevation.

Podium sun blades and screens	As shown in Figure 21, and in more detail in Figure 24, pairs of vertical blades wrapped round the podium, the intention is to reconstruct these elements.
Reintroduction of Australian stone to the facade Reconstruction of the sun hood (western elevation)	As noted in section 6.4, the intention is to reintroduce a suitable Australian material into the façade cladding. The existing western sun hoods are a later, inaccurate, reproduction. The intention is to reconstruct these elements more accurately based on the original architectural documentation.

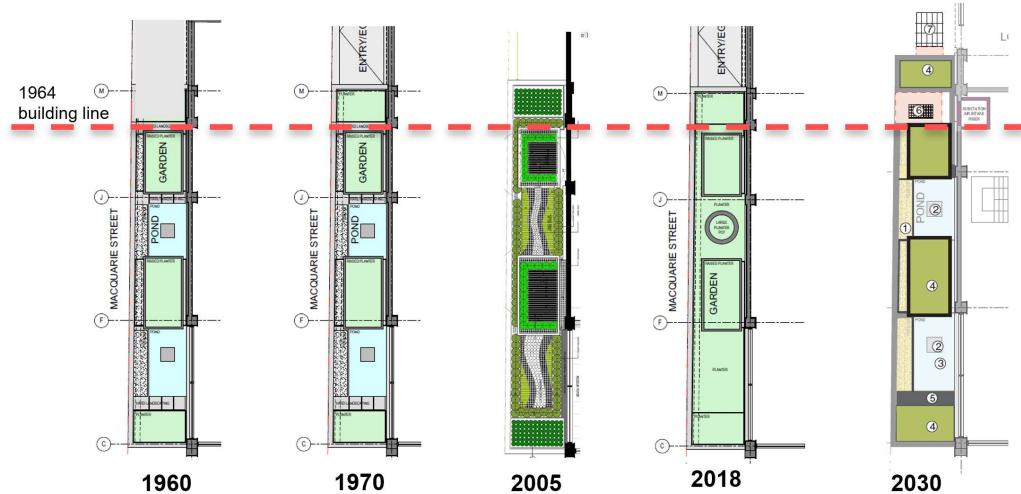
Figure 25 - This diagram charts the changes to the garden over time, including the additions to the south. (Source: Architectus)

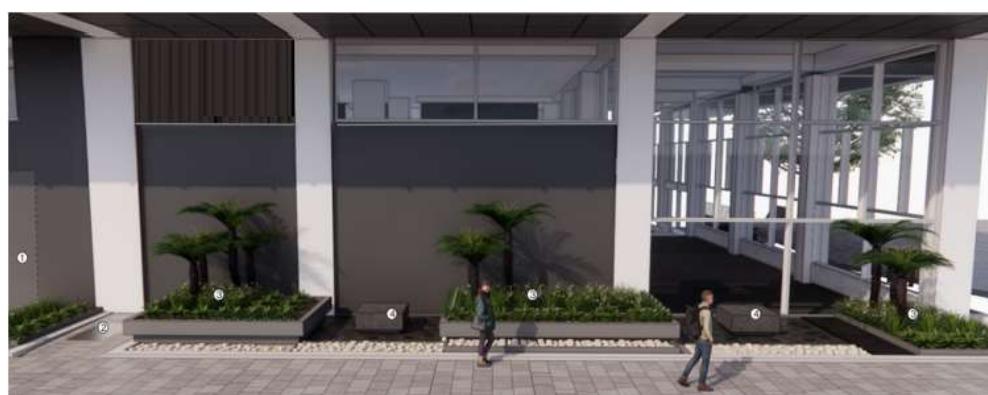
Figure 26 - Illustration describing the refurbished Michael Munro gardens. (Source: Architectus)

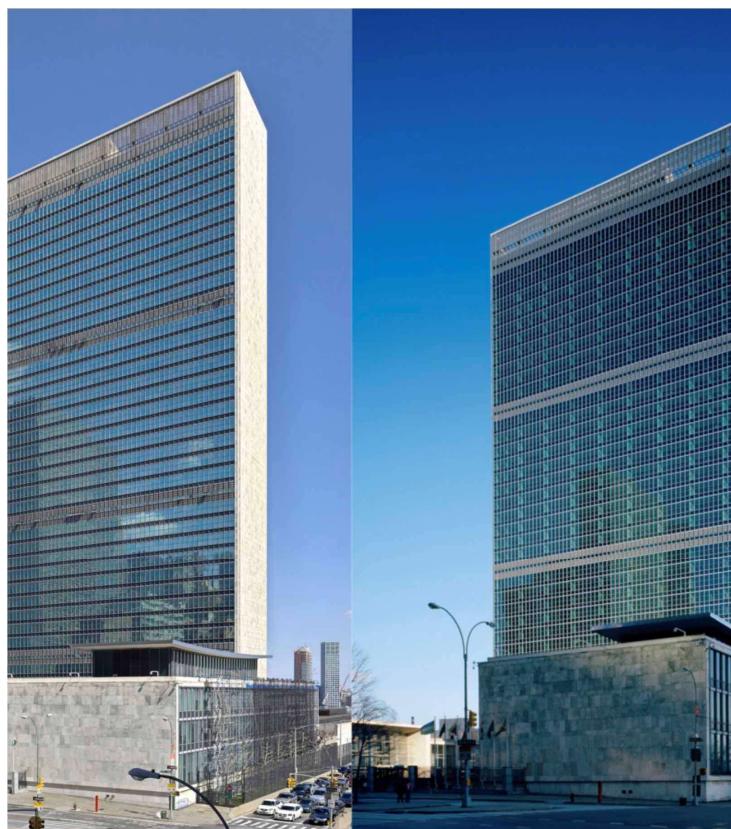
Figure 32: UN Secretariat Building, New York. The west elevation before (left) and after (right) renovation. The original transparency and hue were restored (Source: DOCOMOMO US and Heintges & Associates, United Nations Headquarters Campus Renovation of Facades, 17 April 2017, <https://docomomo-us.org/news/united-nations-headquarters-campus-renovation-of-facades>)

During the refurbishment, 95 per cent of all construction waste was recycled.¹¹⁵ The roof served as a staging area, with derricks raising and lowering the work platforms along the façade, and a construction hoist was used to transport the materials.¹¹⁶ The new curtain wall was installed from the top down. The renewal of the building envelope resulted in a lowering of energy consumption for heating and cooling by 65 per cent and a decrease in greenhouse gas emissions by 45 per cent.¹¹⁷ The Secretariat Building reached the standard for LEED (Leadership in Energy and Environmental Design) Platinum and was a finalist in the 2014 CTBUH (Council on Tall Buildings and Urban Habitat) Best Tall Building Award.¹¹⁸

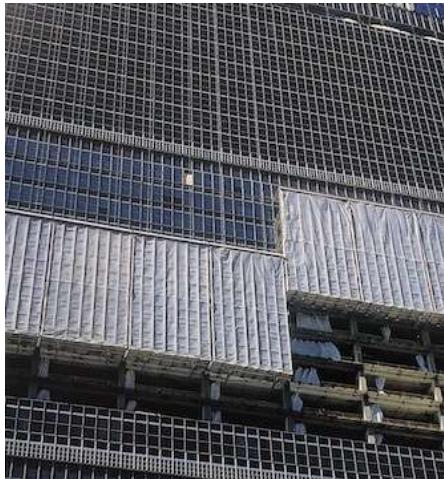
Figure 33: Curtain wall replacement at the UN Secretariat Building in New York (Source: United Nations, The United Nations at 70, 73)

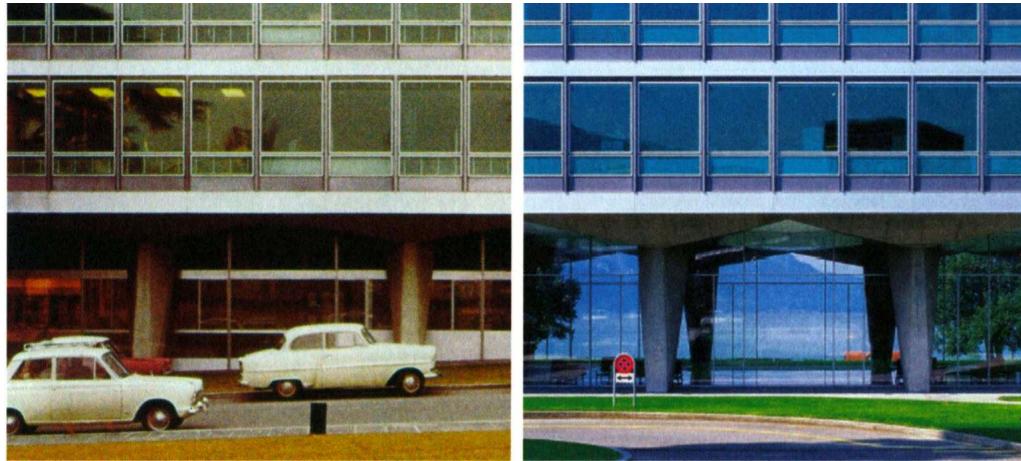
Figure 37: Nestlé Headquarters, Vevey, Switzerland. The ground floor before (left) and after (right) the refurbishment (Source: Schläppi 2010, 53)¹³⁰

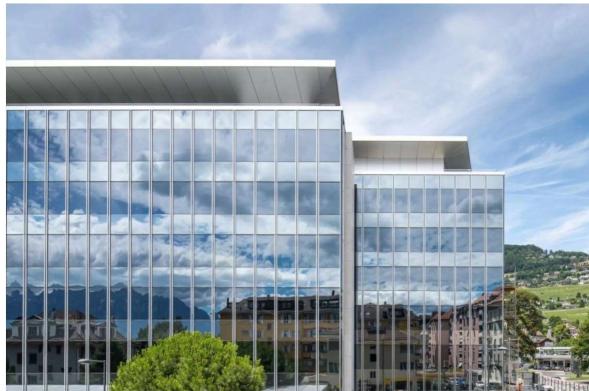
Figure 39: Nestlé Headquarters, Vevey, Switzerland. Exterior of Building B after renovation (Source: Andreas Müller, 'Renovierung bei Nestlé: Was die neue Verglasung leistet', *Bauen Aktuell*, 6 August 2021)¹³¹

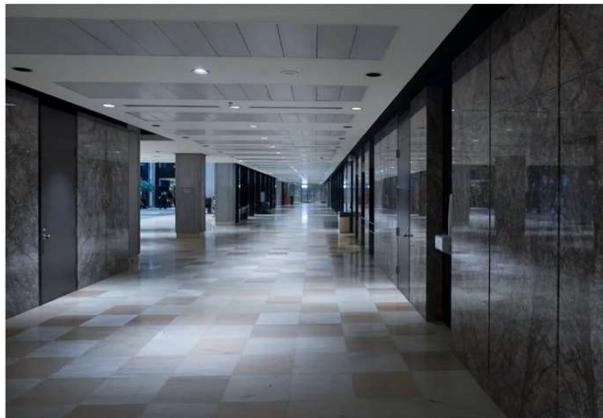
Figure 43: Grey Bancroft granite and Marmora marble tiles in the Macdonald Block, Toronto, Canada, 28 November 2018 (Source: *The Globe and Mail*, 8 December 2018. Photo by Fred Lum)¹⁵⁴

Work on the stone-clad external facades has primarily consisted of repair and restoration while upgrading all windows to more energy-efficient standards.¹⁴⁷ This has included masonry repair of the limestone cladding and black granite façades, removal of lead in mortar joints, replacement of deteriorated stone panels, and recaulking and cleaning of the façade.¹⁴⁸ The project has involved upgrading all core building systems, including electrical, mechanical, water, cooling and heating, and updating office accommodation to meet modern accessibility standards.¹⁴⁹

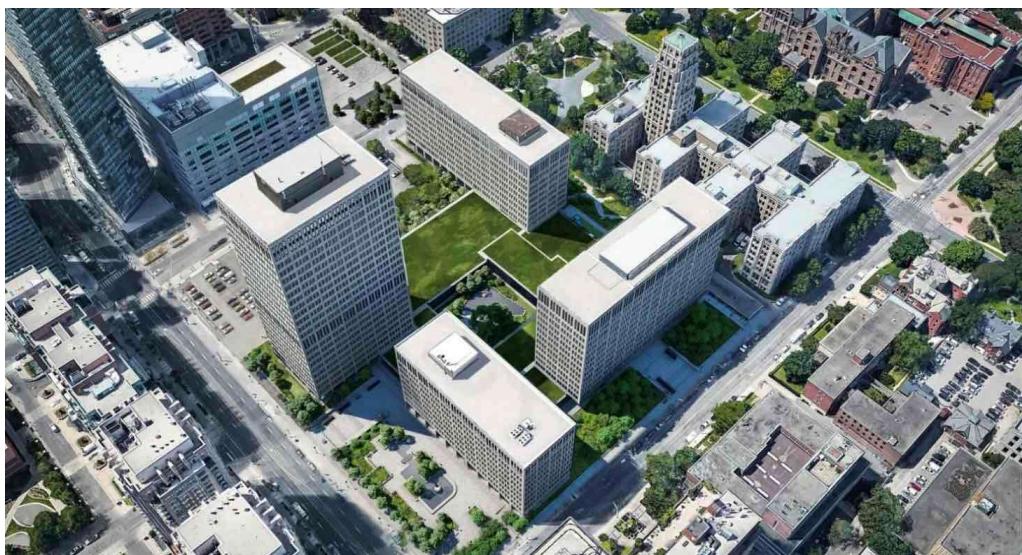
Figure 44: Aerial render showing the Macdonald Block, Toronto, Canada, after redevelopment (Source: Infrastructure Ontario, 'Community Update', December 2022)¹⁵⁵

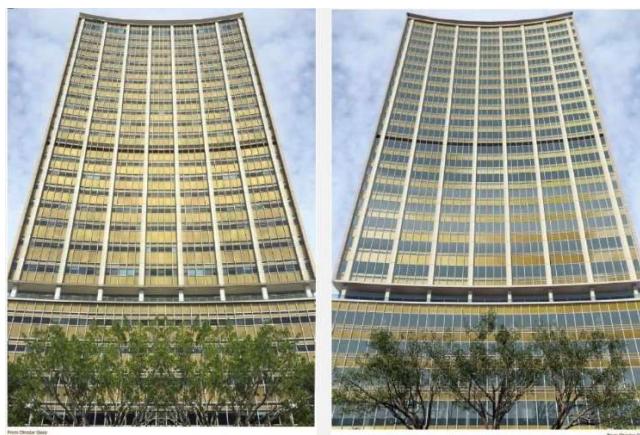
Figure 46: Render showing the façade of the AMP Building as existing and after the proposed replacement (Source: Urbis HIS 2017, 82, original prepared by JPW)

The refurbishment of the building, designed by Johnson Pilton Walker (JPW) architects, has involved replacing the existing curtain wall façade with a new façade. A review of the building fabric by an independent façade consultant concluded that the curved façade had areas that did not meet “today’s minimum requirements including hazardous materials and health and safety, public safety (including from spontaneous glass failures) and BCA compliance including strength in wind loads and deflection and thermal performance.”¹⁶⁸

The new façade was designed to incorporate “systems and materials that are consistent with the original visual character while addressing non-compliances.”¹⁶⁹ The façade’s ‘tartan pattern’ of stainless steel clad columns, mullion fins and alternating horizontal bands of grey and gold glass between fine secondary lines of aluminium framing was to be reinstated. But while consistency with the original building was sought, it was not entirely achieved.

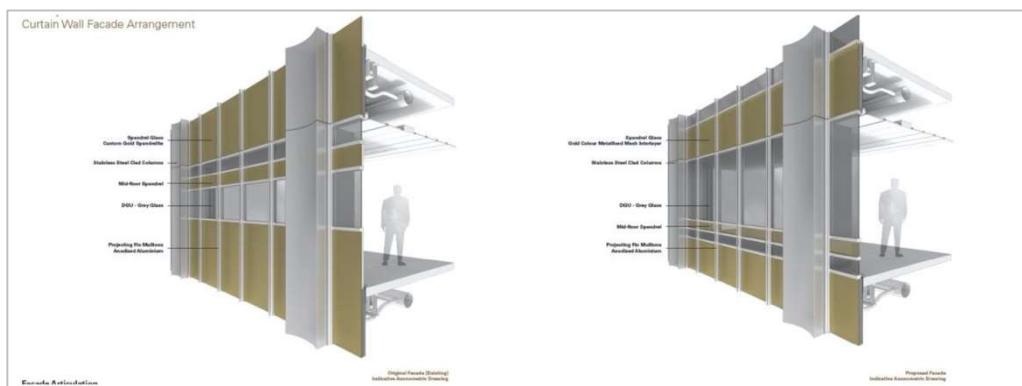
Figure 47: Details of the existing (left) and proposed (right) curtain wall façade (Source: Urbis HIS 2017, 6)

As the proprietary gold glass spandrels are no longer produced, a similar contemporary product was to be used for their replacement, while the new vision glass was to be a high-performance glass with a low Solar Heat Gain Coefficient.¹⁷⁰ The provision of external louvres on the facade for ventilation of premium grade services has resulted in further differences from the original façade design.¹⁷¹

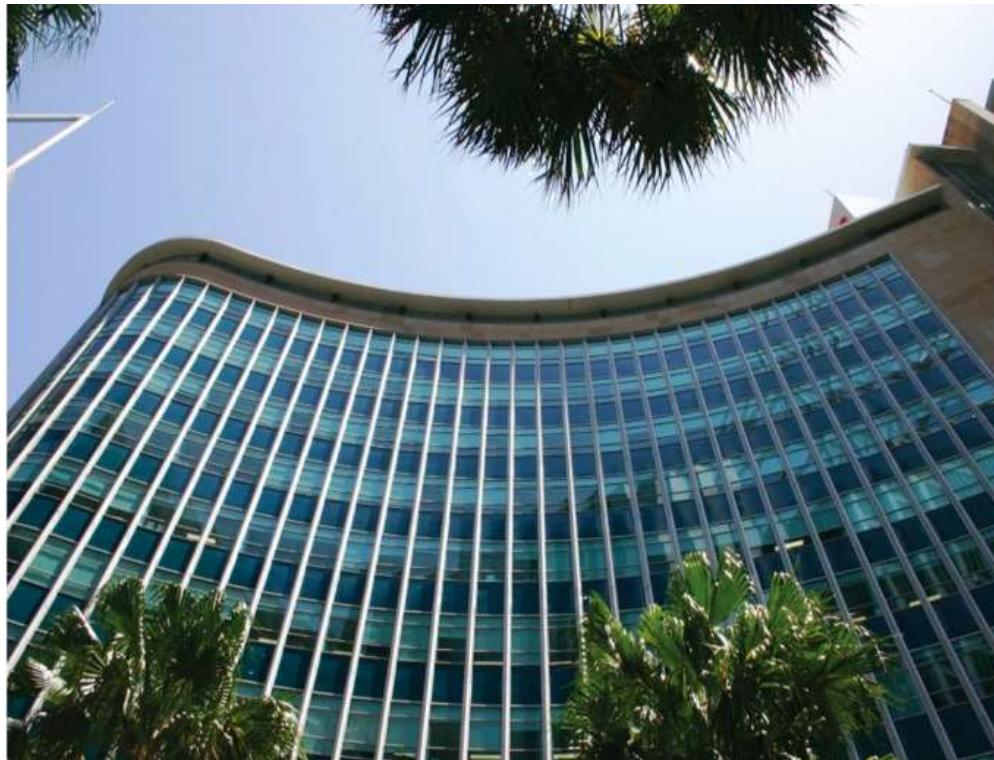
Figure 48: The exterior of the former Qantas House at 1 Chifley Square, Sydney, in 2015, prior to restoration (Source: GBA, 1 Chifley Square HIS, 2015, fig. 2)

The Conservation Management Plan for the building prepared by Godden Mackay Logan (2002) and updated by Graham Brooks and Associates (GBA) in 2008, graded the façade as being of exceptional significance. However, the ageing façade had started to deteriorate, causing a long history of water ingress. In 2003, internal 'gutters' were installed by Arup, collecting water from the spandrel areas and discharging it at the bottom of the curtain wall, and all internal areas were sealed.¹⁷⁹

Due to ongoing issues, Arup carried out investigative works from 2011 to 2014 which involved trials with replacement spandrel panels. Prensa undertook further testing, revealing that the glazing mastic and putty were contaminated with asbestos. A comprehensive façade conservation and refurbishment proposal was subsequently developed by Arup, with input from GBA, which involved the replacement of heavily deteriorated and/or contaminated glass units and steel spandrel panels with new units matching the existing exactly in appearance, material and substrate thickness.¹⁸⁰

The new glazed porcelain enamel spandrel panels, sourced from HH Robertson, were a visually close match to the original panels, as verified in trials.¹⁸¹ Cracked vision glass units were replaced with new float glass. New penetrations into the aerofoil mullions and side frames were required to install new breather pipes for pressure equalisation and mitigation of water ingress. Spandrel panels were resealed, and aluminium cover strips were removed, altered and reinstated. All asbestos was removed, and all finishes of the façade were cleaned and repaired, where required.¹⁸² The works were largely confined to bays 37 to 48 on the south elevation facing Hunter Street.

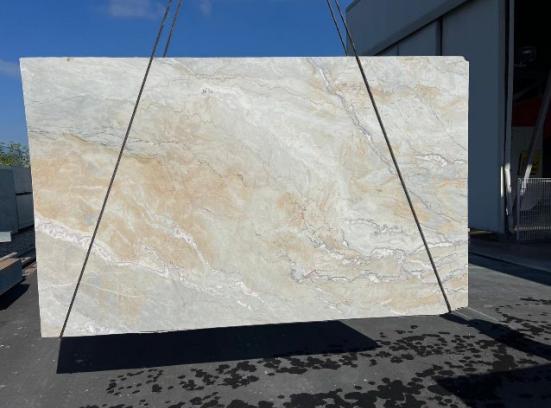
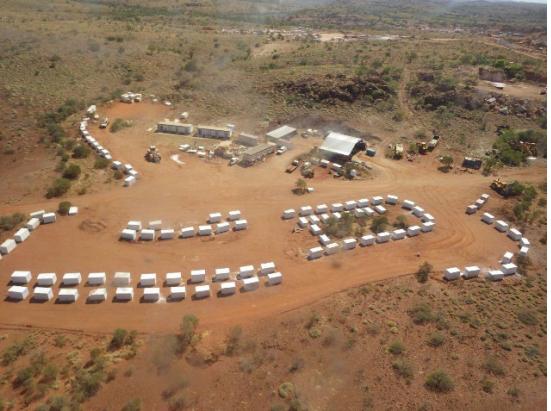
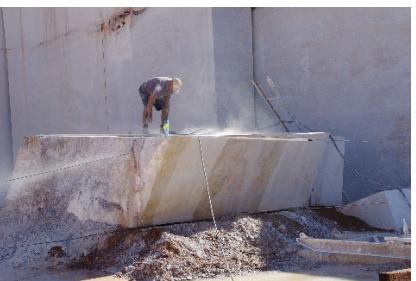
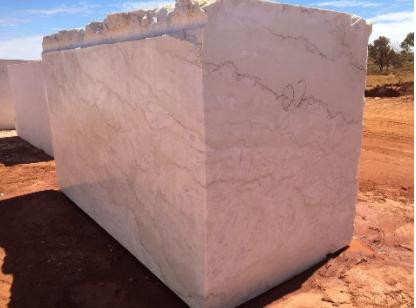
STONE TYPE	STONE DETAILS	NOTES
<p>Austral Dream Marble</p> <p>Also known as. -Pilbara Cream -Pilbara Dreamtime -Dolce Vita</p>

<p>Resource availability: Current stock on ground - 141 blocks Quarry still operating with access to more material in ground.</p>

<p>Location: Pilbara, WA</p> <p>Material: Dolomitic Marble</p> <p>Colour: Austral Dream is a Creamy White marble that can have warm hues flowing throughout the material and has blue and grey undertones.</p> <p>Movement: Austral Dream does not have a specific vein direction but has more of a rugged coastal landscape appearance.</p> <p>Strength: As a Dolomitic Marble this stone is denser and less porous than most marbles and therefore is more resistant to external elements and scratch/acid resistant.</p>	<p>Austral Dream is currently an in-demand product due to its dolomitic marble properties that are superior in strength to most marbles and yet still provide the aesthetics of a marble.</p> <p>Stock on the quarry floor is expansive and therefore suitable for a project of this size. Large quantities allow for colour selection amongst blocks to best suit the project.</p> <p>Due to the material's natural properties, it lends itself to a longer lasting option that can weather the external environment for this project.</p> <p>Test results from 2012 indicate compressive strength is twice the strength of Carrara. It is expected that any new deposit test would be more favourable the further into the deposit.</p> <p>Negligible silica is present throughout Pilbara marble deposits</p> <p>Tests results provided as of 2012.</p> <p>Recommend full set of testing based on current deposit.</p>

Parameter	Comment
Source	Pilbara, Western Australia
Visual appearance	Creamy white marble with warm hues and blue/grey undertones.
Availability	Quarry currently operating and removing material from the ground.
Quantity	141 blocks currently in stock.
Dimension	<i>Unknown at time of writing.</i>
Durability	Dolomitic marbles are denser and less porous compared to many other marbles. They are typically resistant to weathering and abrasion.
Performance	<i>New testing required to demonstrate suitability.</i>
Safety	The presence of silica or other potentially harmful substances should be confirmed through petrographic examination.
Built examples	<i>External façade built examples to be confirmed.</i>

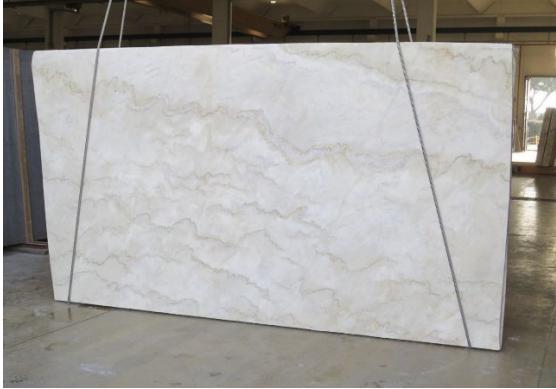
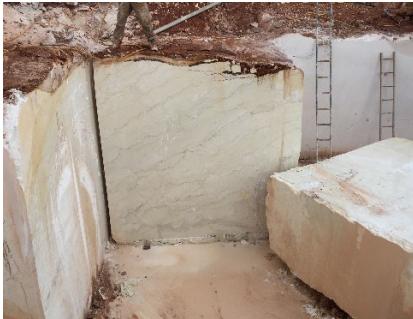
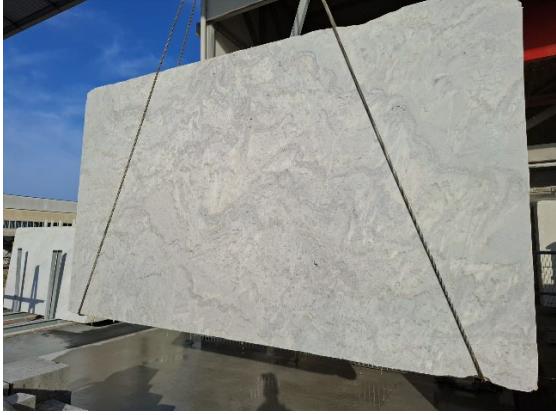
STONE TYPE	STONE DETAILS	NOTES
<p>Austral Pearl White Also known as. -Bianca Dolce Vita</p>

<p>Location: Pilbara, WA</p> <p>Material type: Dolomitic Marble</p> <p>Colour: Austral Pearl is a Bright White to Cream marble.</p> <p>*Variant option – Austral Pearl Grey – Light blue/grey to white.</p> <p>Movement: It has a wavy linear movement across the material.</p> <p>Strength: As a Dolomitic Marble this stone is denser and less porous than most marbles and therefore is more resistant to external elements and scratch/acid resistant.</p> <p>Resource availability: Austral Pearl White- current 50 blocks out of the ground and further resource in ground with Quarry still in operation.</p> <p>*Austral Pearl Grey – current blocks on quarry floor more than 15 block however the Quarry is in operation and expansive resource available in ground.</p>

<p>Austral Pearl is currently an in-demand product due to its dolomitic marble properties that are superior in strength and yet still provide the aesthetics of a marble.</p> <p>Stock on the quarry floor is expansive for both colour variants however further resource is currently being quarried out on demand. Large quantities allow for colour selection amongst blocks to best suit the project.</p> <p>Due to the uniform movement across the material and neutral palette, it lends itself to use across a large project.</p> <p>Negligible silica present throughout Pilbara marble deposits</p> <p>Austral Pearl Grey – appears to be tonally close in nature to the Wombeyan Blue Marble currently in-situ.</p> <p>Recommend new testing data be obtained</p>

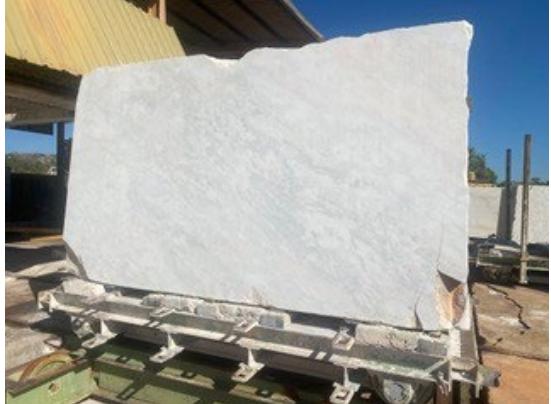
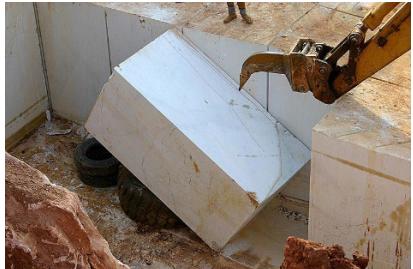
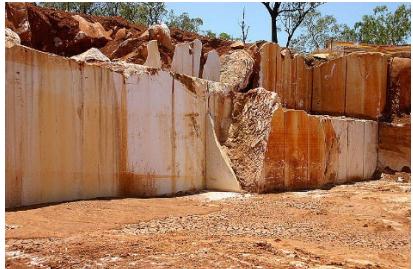
STONE TYPE	STONE DETAILS	NOTES
Bianca Mist Marble

<p>Location: Chillagoe, QLD</p> <p>Material type: Crystalline Marble</p> <p>Colour: Pristine White with subtle Grey cloud like Intrusions - fine grain marble. Blush tones can be present from time to time</p> <p>Movement: predominantly white with grey intrusions washed across the slab</p> <p>Strength: The material is quite hard for a crystalline marble.</p> <p>Resource availability: Current stock on ground – around 50 blocks are available on the quarry floor. Inspection would be required to check the tonality of the blocks and structure as the blocks were quarried out some years ago. Quarry is owned by Cairns Marble however quarry is not currently in operation.</p>

<p>Most similar in design to the Wombeyan Marble currently on the façade at the RBA. Slightly whiter.</p> <p>Due to the pristine white crystal it does have an opaque nature and therefore would require backing to avoid any rear structure showing through.</p> <p>The small crystal structure can chip easily along edges.</p> <p>The current block availability is varied in colour. With some pink undertones more prominent in some blocks. Careful selection of material will be required.</p> <p>Blocks have been exposed to the elements for some time. Testing and inspection required.</p>

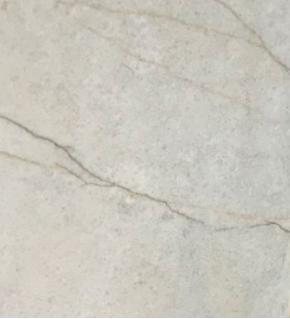
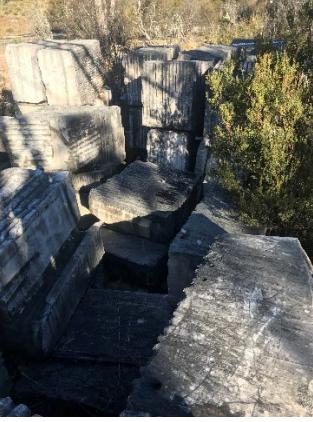
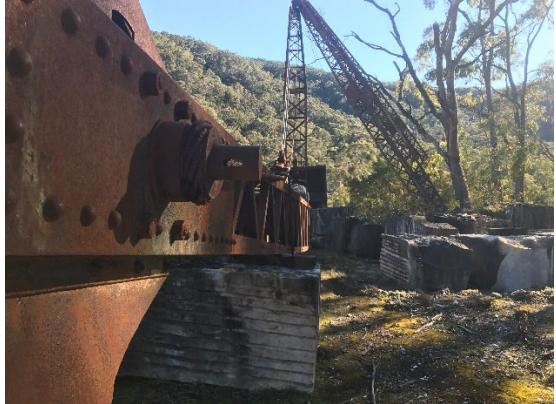
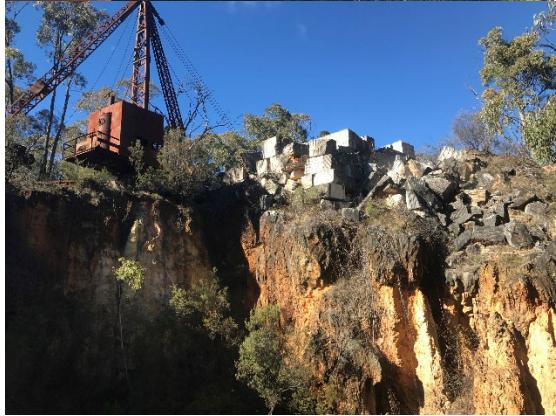
STONE TYPE	STONE DETAILS	NOTES
<p>Wombeyan Marble Blue/Grey</p>

<p>Location: Wombeyan, NSW</p> <p>Material type: Crystaline Marble</p> <p>Colour: Ranges from White to blue/grey with blue veining. Blush tones can be present amongst blocks with the Wombeyan blue/Grey found in and amongst the Wombeyan Cream.</p> <p>Movement: Blue Grey veining throughout the material. Pink veining can be found where the Wombeyan Grey combines with Wombeyan cream</p> <p>Strength: Material is softer than others recommended in this report and is known to be brittle when under stress. It is susceptible to fractures along veins if the material is exposed to the weather for some time.</p> <p>Resource availability: Previously Quarried Blocks on the Quarry floor are now within National Park are not accessible.</p>

<p>Due to the Quarry being closed and within a national park, access to sufficient material in uniform colour range will require a make safe of the quarry and inspection of current blocks for useability. To date this has not been granted.</p> <p>Material on Ground could be compromised due to being exposed to the elements for some time and therefore an inspection and testing would need to be done.</p> <p>The deposit varies between mostly white background to a blue/grey background.</p> <p>Favourable blocks previously were the whiter blocks and therefore it's unclear how much of the blocks remaining within the national park would be of the lighter colour variation within the deposit.</p> <p>Failure of the previous façade is speculated to have originated from the contributing issues below:</p> <ul style="list-style-type: none"> -The previous test results for Wombeyan marble were considered standard for a marble, however it is known to weaken around the veins (mud veins) with exposure to weather. The material is also considered to be brittle under stress. -Inconsistency between the microscopic structure of the marble crystals allowed moisture and possible organic matter into the marble, leaving the marble vulnerable to expansion, softening and failure. -Due to concrete cancer in the building, spalled concrete chips where dislodged and gathered into the rear cavity of façade fixing brackets, eventually forcing pressure on external cladding in the pin locations. -Pin installation further weakened the material allowing to open and crack and allow debris into crevices. -Original elastomeric jointing material failed by hardening, allowing ingress of water to track behind the stone worsening the above issues.

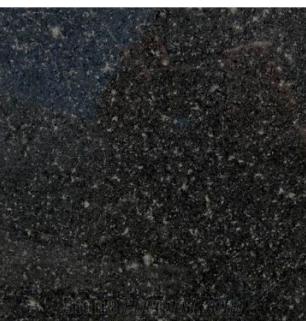
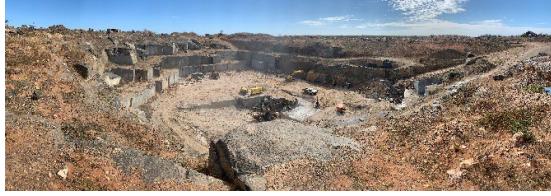
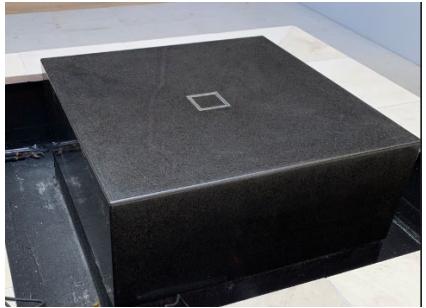
STONE TYPE	STONE DETAILS	NOTES														
<p>Adelaide Black – Imperial</p> <p>Also known as Imperial Black, Imperial Select Black, Adelaide Black Select</p>

<p>Resource availability: Large resource with abundant quarried blocks available and further resource in ground</p> <p>TYPICAL PHYSICAL PROPERTIES This specification is intended as a guide only. The properties of the granite specified must be assessed from the selected batch for the project as there will be variation in properties from seam to seam.</p>

Bulk Density:	2.94 – 2.97 t/m ³	Compressive Strength (dry/wet):	189 – 217 MPa/146 - 193 MPa	Flexural Strength (dry/wet):	15.5 - 16.9 MPa/16.6 - 17.7 MPa	Water Absorption by weight:	0.03 – 0.06%	Abrasion Resistance:	132.3 (Mean Abrasion Index)	Slip Resistance: (Exfoliated/Flamed)	AS/NZS 4586: Appx A. V – Very Low Risk of slipping when wet. BPN (Wet) 61	(Honed – 220 Grit Finish)	AS/NZS 4586: Appx A. X – Moderate Risk of slipping when wet. BPN (Wet) 43	<p>Location: Black Hill, NSW</p> <p>Material type: Granite</p> <p>Colour: Dark Black with highlight grains</p> <p>Movement: Occasional flare, but can be selected out. Fine grain</p> <p>Strength: High Strength Granite</p>	<p>Adelaide Black Imperial Granite has been used in the original façade at the RBA and the current RBA reception desk.</p> <p>This material is often used for memorial work, and high-grade commercial work due to its fine grain, consistency and darker shade.</p> <p>Material is abundant on ground and in the quarry.</p> <p>Adelaide Black Austral is a variant of this material. Often lighter flecks flares throughout the stone and a fine-medium grain. This variant is used throughout Sydney City for paving.</p>
Bulk Density:	2.94 – 2.97 t/m ³															
Compressive Strength (dry/wet):	189 – 217 MPa/146 - 193 MPa															
Flexural Strength (dry/wet):	15.5 - 16.9 MPa/16.6 - 17.7 MPa															
Water Absorption by weight:	0.03 – 0.06%															
Abrasion Resistance:	132.3 (Mean Abrasion Index)															
Slip Resistance: (Exfoliated/Flamed)	AS/NZS 4586: Appx A. V – Very Low Risk of slipping when wet. BPN (Wet) 61															
(Honed – 220 Grit Finish)	AS/NZS 4586: Appx A. X – Moderate Risk of slipping when wet. BPN (Wet) 43

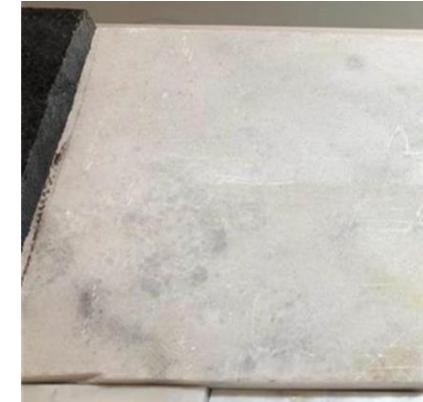
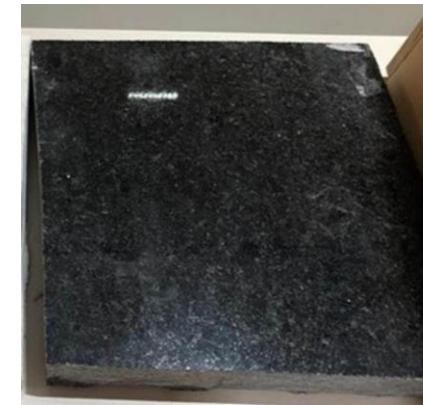
Figure 2: Samples of stone currently used in the façade of 65 Martin Place. Top: Wombeyan Marble Blue/Grey. Bottom: Black granite, unidentified.

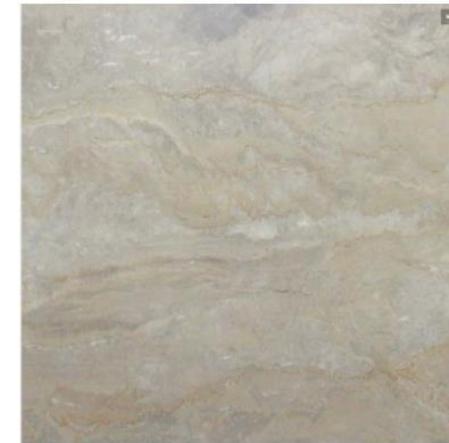
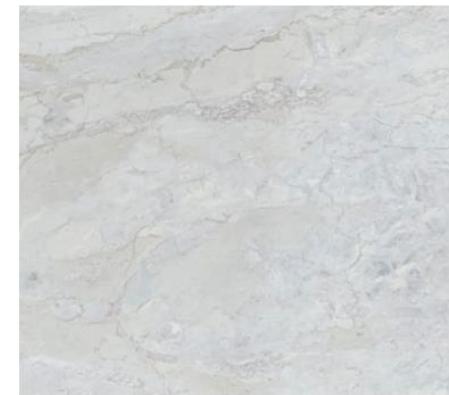
Figure 3: Austral Dream / Dolce Vita. Source: StonePlus.

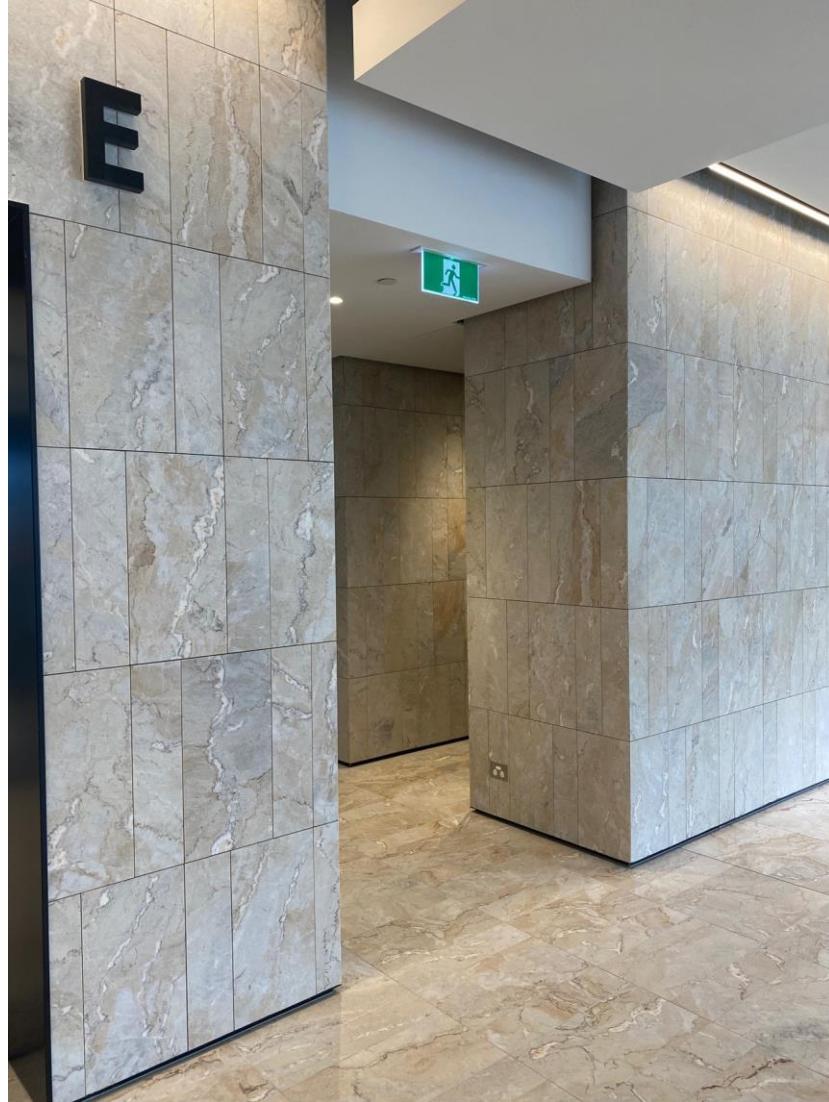
Figure 4: Jubilee Centre Brisbane – Pilbara Dreamtime. Source: Stone Dimensions Australia

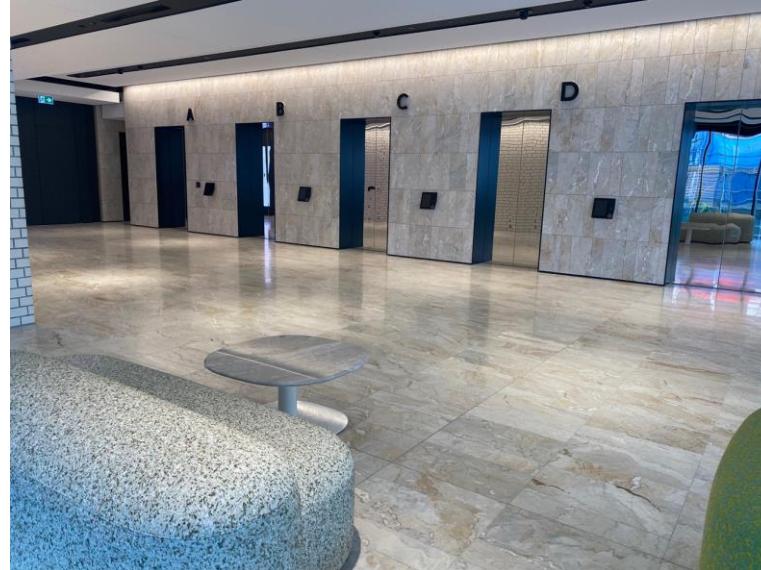
Figure 5: Jubilee Centre Brisbane – Pilbara Dreamtime. Source: Stone Dimensions Australia

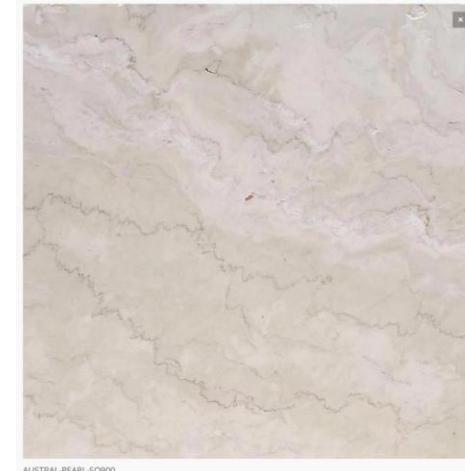
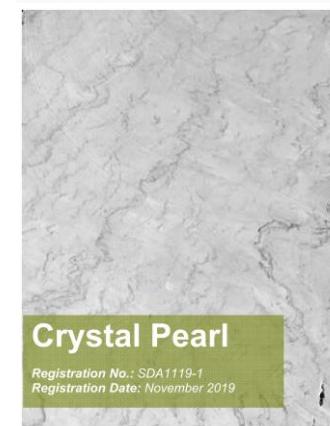
Figure 7: Austral Pearl White (top) and Grey (bottom).
Source: courtesy of supplier.

Parameter	Comment
Source	Pilbara, Western Australia
Visual appearance	Creamy white or grey tones, with thin, defined grey linear movement throughout.
Availability	Quarry currently operating and removing material from the ground.
Quantity	StonePlus identified 50 blocks currently in stock (Austral Pearl White). Only 15 blocks available of Austral Pearl Grey. More of both in ground.
Dimension	<i>Unknown at time of writing.</i>
Durability	Dolomitic marbles are denser and less porous compared to many other marbles. They are typically resistant to weathering and abrasion.
Performance	<i>New testing required to demonstrate suitability.</i>
Safety	The presence of silica or other potentially harmful substances should be confirmed through petrographic examination.
Built examples	<i>External facade built examples to be confirmed.</i>

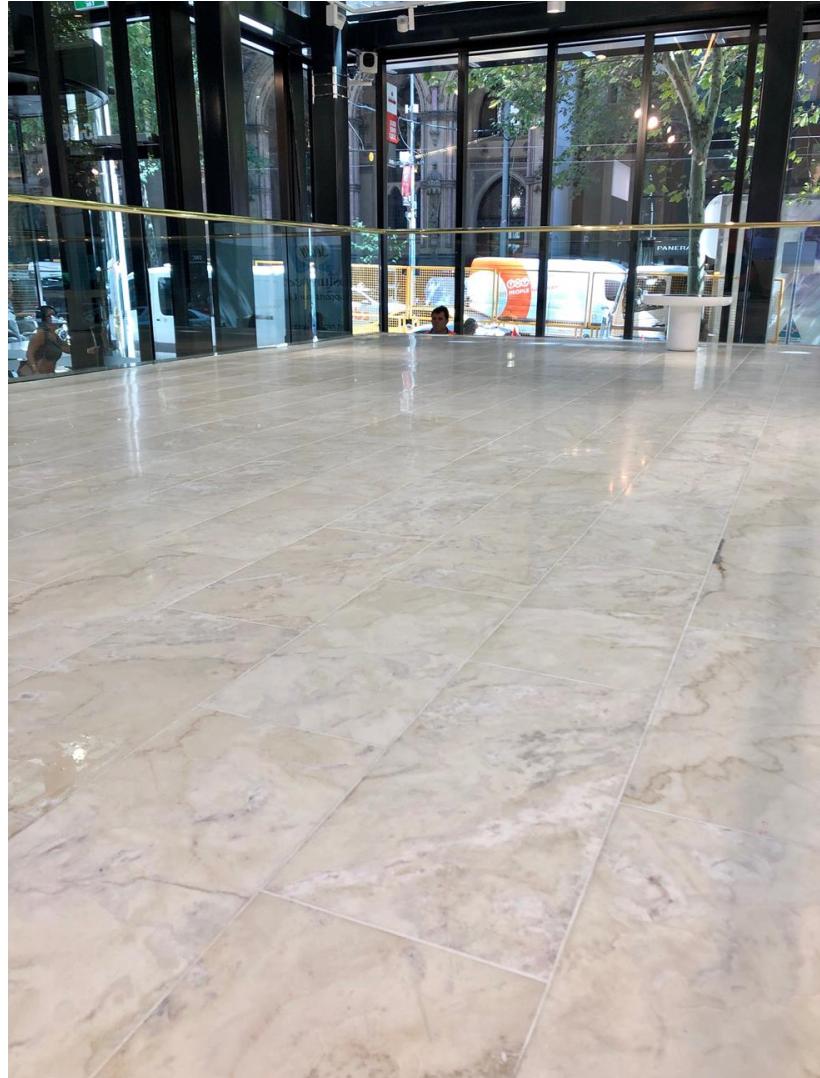
Figure 8: Brickworks Melbourne Design Studio – Crystal Pearl. Source: Stone Dimensions Australia

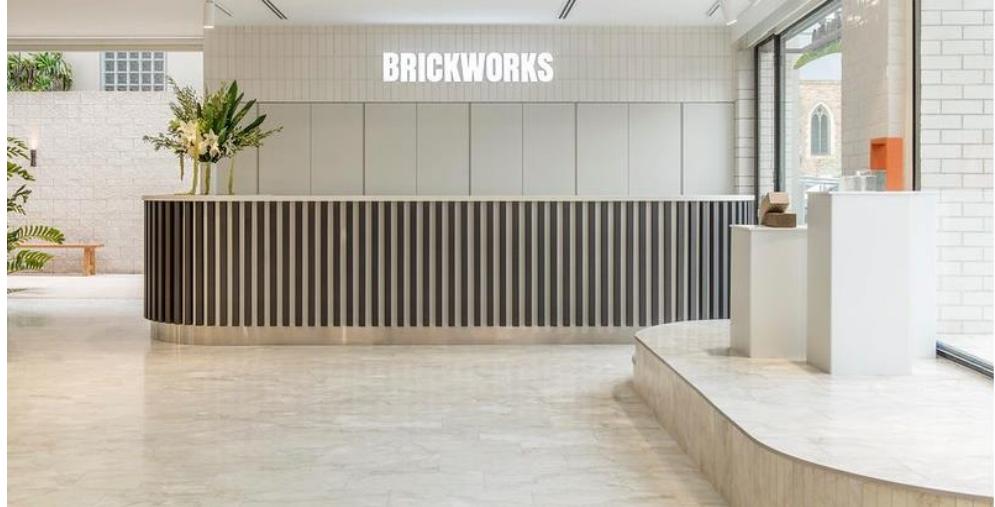
Figure 9: Brickworks Brisbane Design Studio – Crystal Pearl. Source: Stone Dimensions Australia

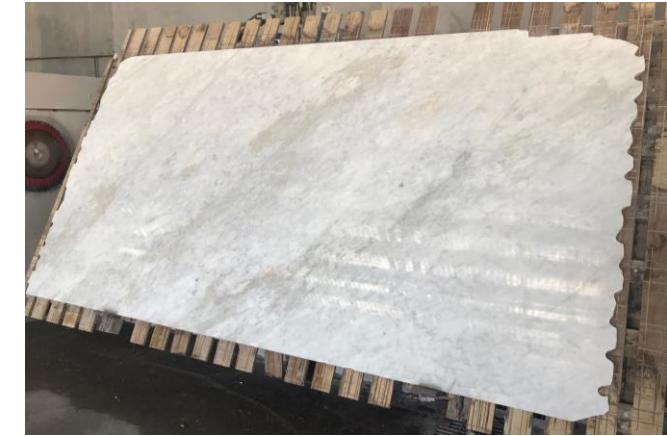
Figure 11: Bianca Mist Marble. Source: courtesy of supplier.

Parameter	Comment
Source	Chillagoe, Queensland
Visual appearance	A ‘pristine’ white marble with grey cloud-like intrusions. Fine grain. Some blush tones.
Availability	Quarry is no longer in operation.
Quantity	StonePlus identified 50 blocks currently in stock, however no new material will be available. Tonality of stock unknown.
Dimension	<i>Unknown at time of writing.</i>
Durability	Not adequate for the project.
Performance	<i>New testing would be required to demonstrate suitability.</i> Susceptible to sugaring and bowing. Not appropriate for use in external environments.
Safety	ASAA Manual indicates typically 0.14% silica. The presence of silica or other potentially harmful substances should be confirmed through petrographic examination.
Built examples	<i>External facade built examples to be confirmed.</i>

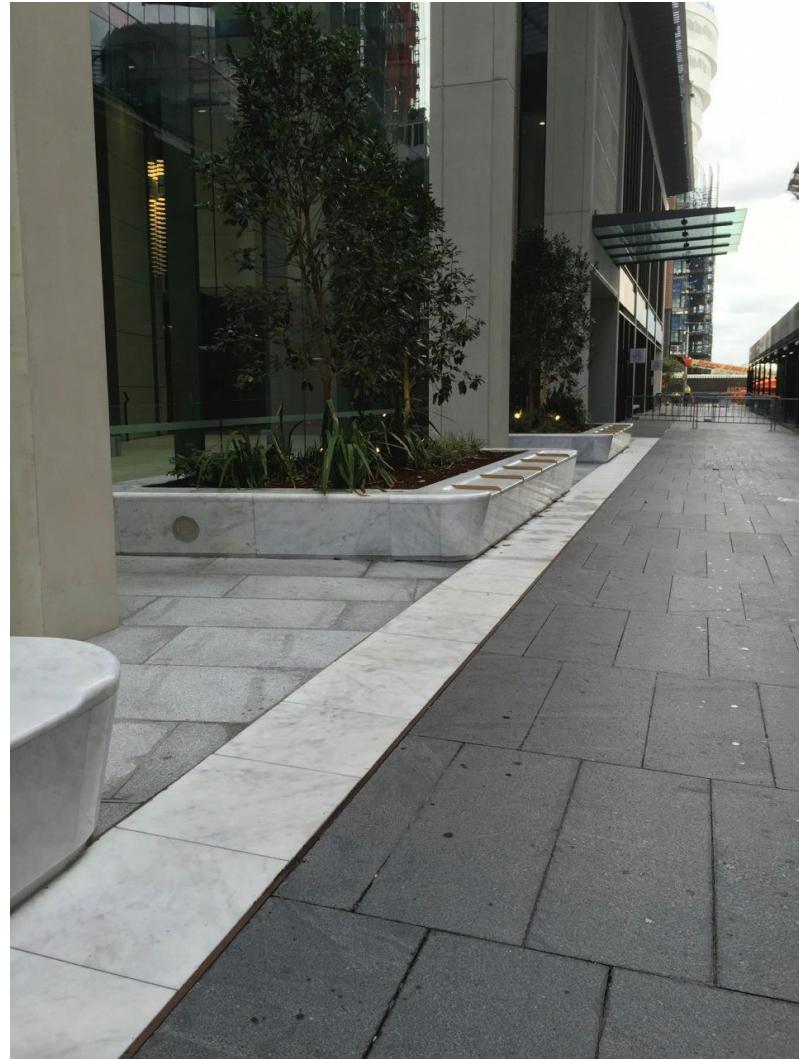
Figure 12: Unidentified project – Bianca Mist. Source: Cairns Marble Australia

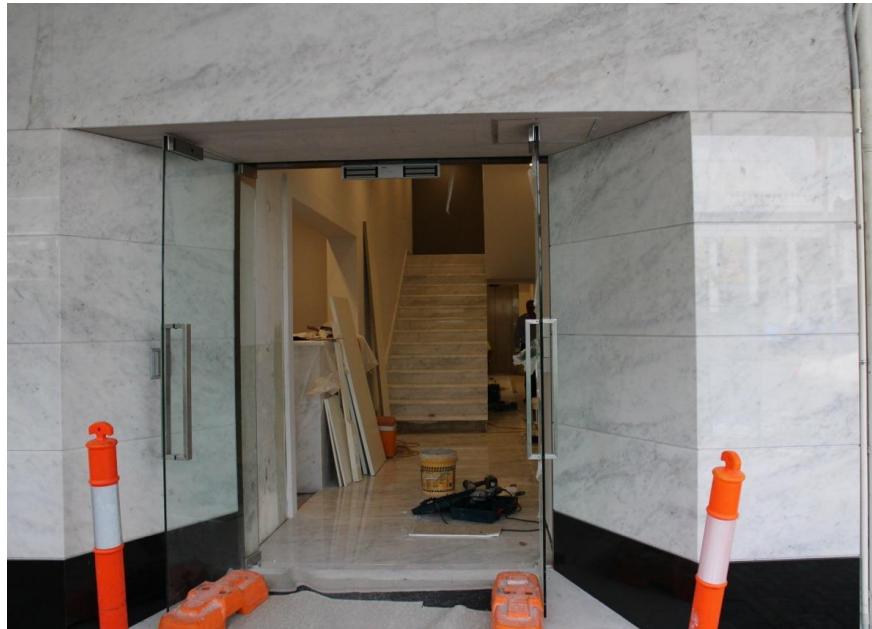
Figure 13: Unidentified project – Bianca Mist. Source: Cairns Marble Australia

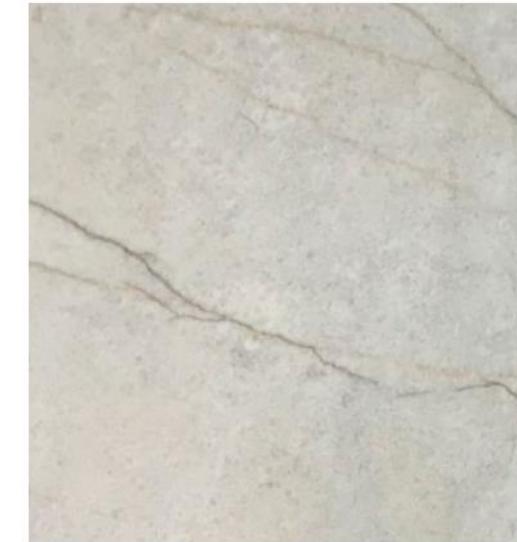
Figure 15: Wombeyan Marble Blue/Grey. Source: StonePlus.

Due to both the inaccessibility of the stone and the complications arising from the existing cladding - specifically the need for overcladding caused by stone delamination - Arup has concluded that the original Wombeyan Marble Blue/Grey is not a viable option and does not meet the technical requirements of the project.

Parameter	Comment
Source	Wombeyan, New South Wales
Visual appearance	This is the existing stone. StonePlus note that appearance of blocks quarried yet unused would need to be checked.
Availability	Quarry is no longer in operation and is located within Blue Mountains National Park.
Quantity	Quarried blocks cannot be accessed for use.
Dimension	
Durability	In service, Wombeyan marble deteriorated and was overclad in the 1990s to improve the appearance of 65 Martin Place.
Performance	It is noted that material is susceptible to fractures along veins especially when weathered.
Safety	No information on silica content available. The presence of silica or other potentially harmful substances should be confirmed through petrographic examination.
Built examples	Reserve Bank of Australia
