**PRELIMINARY DOCUMENTATION
ADDITIONAL INFORMATION REQUEST
EPBC (2024/10052)**

**Reserve Bank of Australia Head Office
65 Martin Place, SYDNEY NSW 2000**

3 July 2025

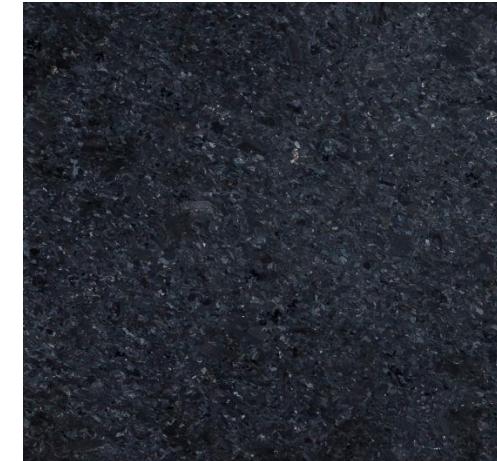
Figure 16: Adelaide Black, honed. Source: courtesy of supplier.

Parameter	Comment
Source	Black Hill, South Australia
Visual appearance	Fine-grained, dark black with light highlight grains
Availability	Good. Quarry is in operation.
Quantity	Resource is available as blocks and in the ground.
Dimension	<i>Unknown at time of writing.</i>
Durability	This stone is used as external paving across the City of Sydney and is in wide use as a part of memorials and landmarks in Australia. Likely to be suitable.
Performance	<i>Likely to be suitable for project requirements. New testing required to demonstrate suitability.</i>
Safety	No information on silica content available. Petrographic examination will be required, as for all stones.
Built examples	<i>External facade built examples to be confirmed.</i>

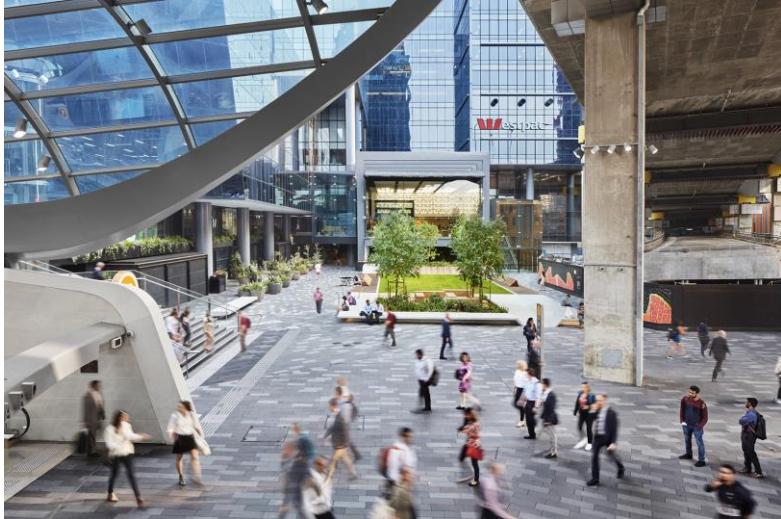
Figure 17: Adelaide Black – Imperial pavers, 275 Kent St, Sydney. Source: courtesy of supplier

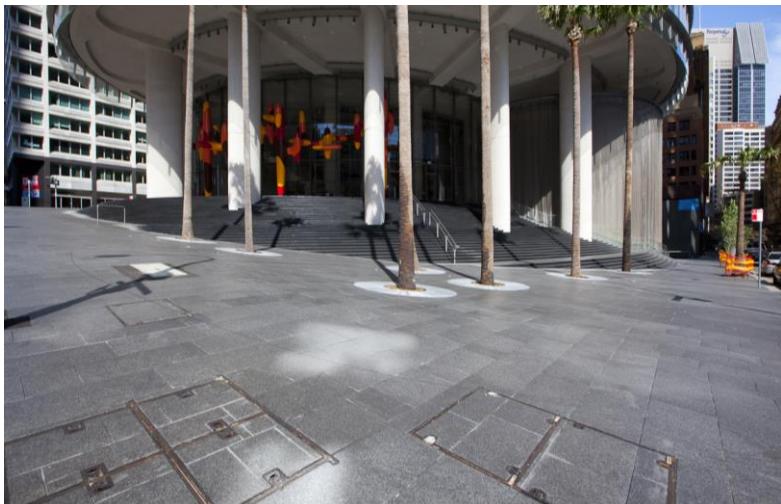
Figure 19: Adelaide Black – Imperial pavers, Bligh St, Sydney. Source: courtesy of supplier

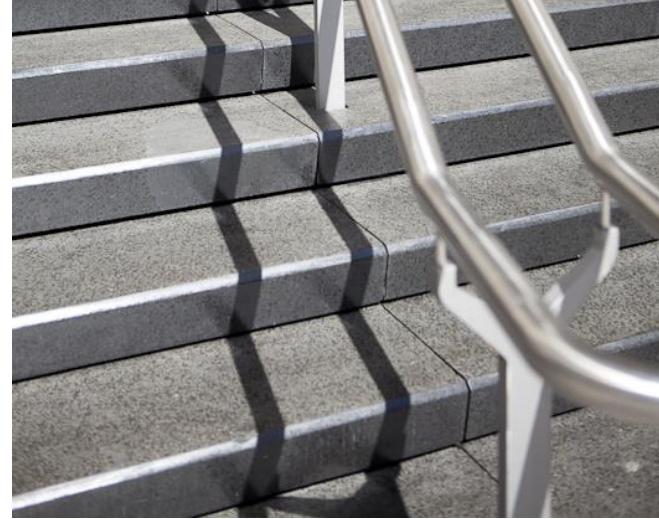
Figure 18: Adelaide Black – Imperial pavers, Bligh St, Sydney. Source: courtesy of supplier

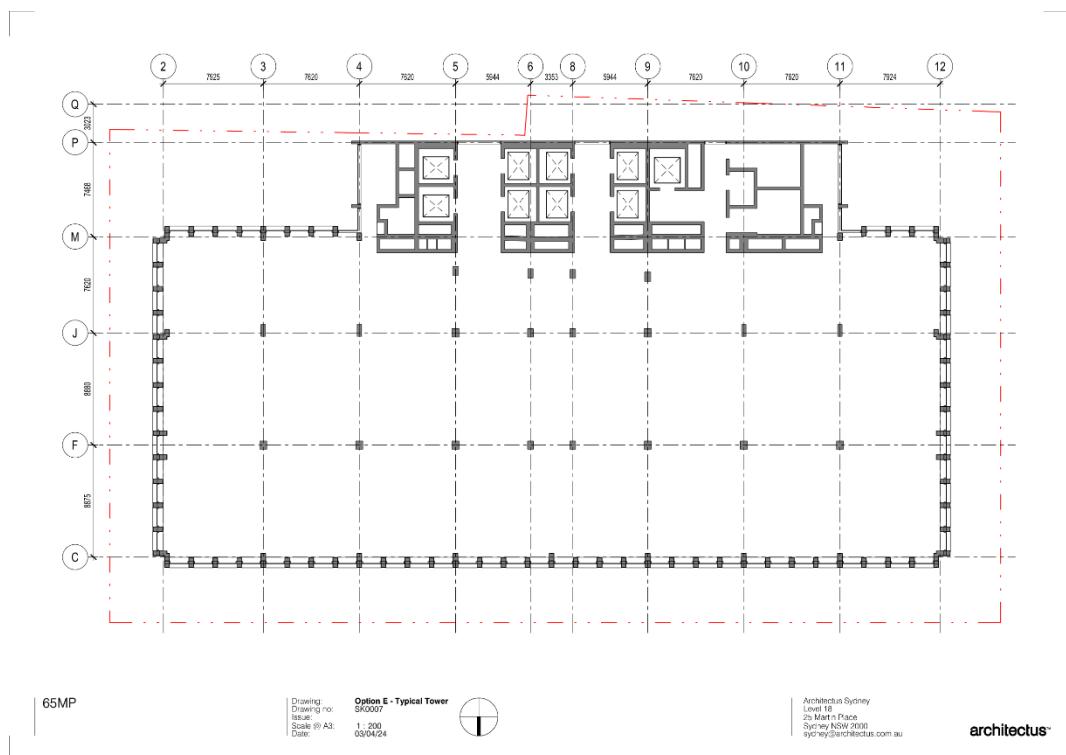
Figure 2: Typical tower level floor plan shown. North towards bottom

The RBA is an existing building located in the north east of the Sydney CBD in Martin Place. To the east of the building is Macquarie Street and to the west is Phillip Street. Directly adjacent to the south façade of the building are high rise buildings, and to the north is Martin Place, a main pedestrian avenue in the CBD. Beyond the roads and pedestrian walkways mentioned are numerous mid- and high-rise buildings, typical of an urban environment. This site is shown in Figure 1 and a ground floor plan of the building is shown in Figure 2.

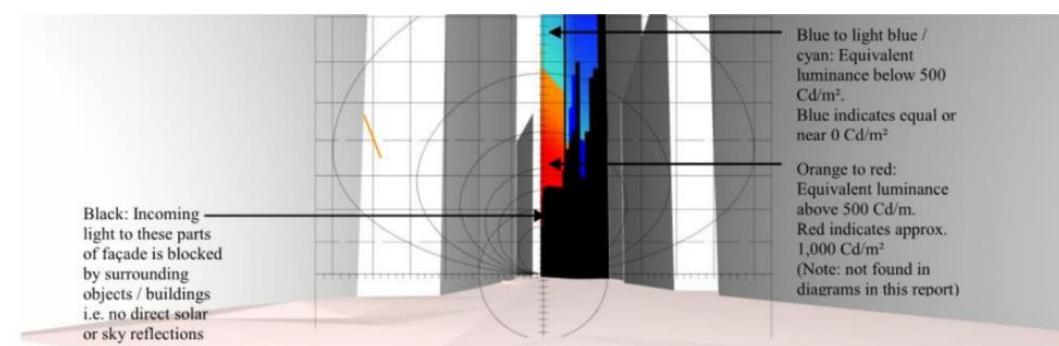
Figure 3: Key to peak reflection diagrams

Figure 3 shows the legend that is used throughout the images in this report:

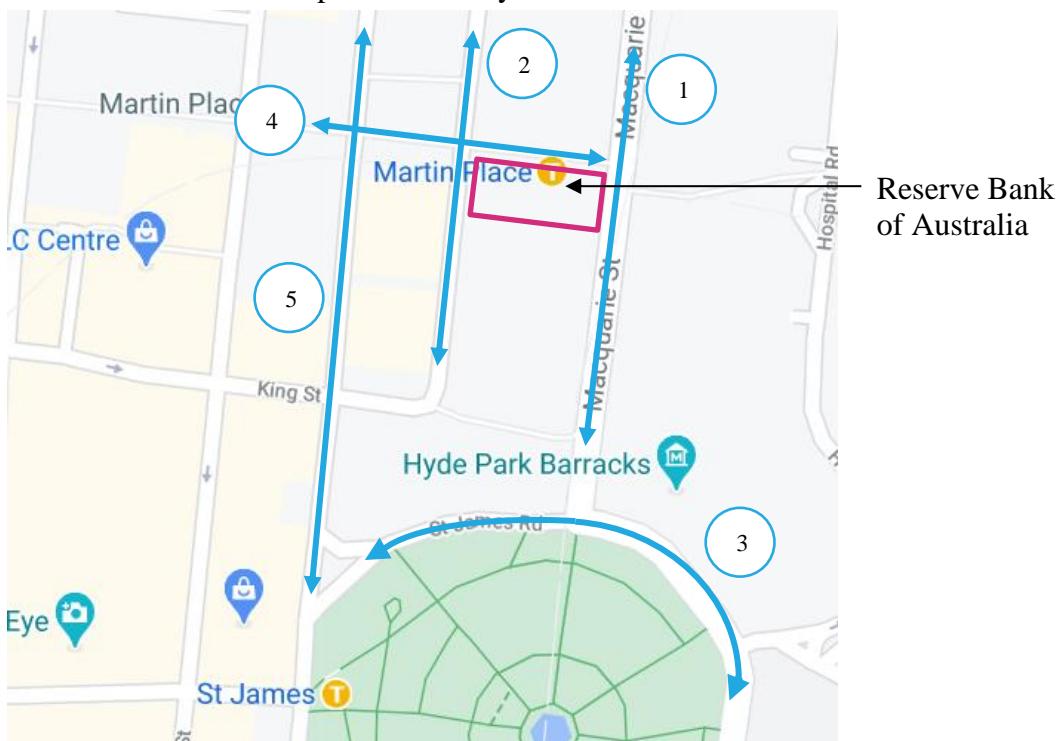
Figure 4: Assessed observer paths (1. Macquarie St, 2. Phillip St, 3. St James Road, 4. Martin Place, 5. Elizabeth St).

Figure 4 highlights the observer paths that were assessed as part of this study, where Martin Place is a pedestrian only zone.

Based on the method in Section 3 and the observation paths in Figure 4, Arup have made observations and judgements about the predicted locations of glare potential around the site. Where the maximum luminance value is greater than 500Cd/m², the 20° windscreens vision cut off angle and 5° visor angle have been marked on the reflectance maps.

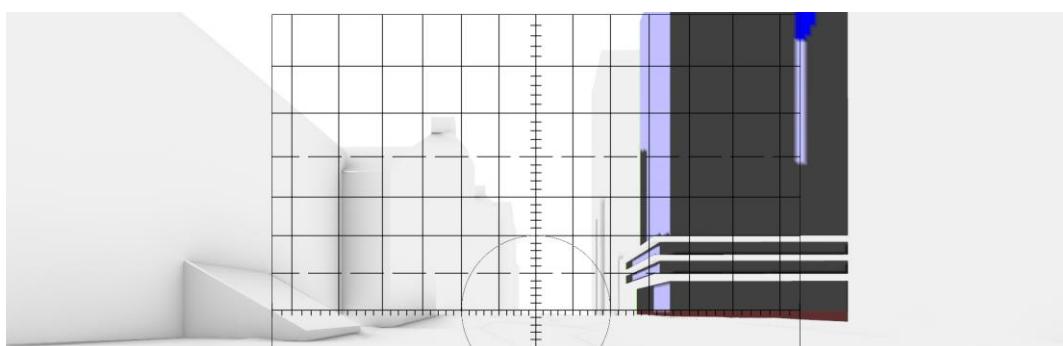
Figure 5: Macquarie Street, heading south. Maximum intensity of reflection 120 Cd/m²

This is shown in Figure 5, through Figure 9, where the reflectivity is expected to be within the acceptable limits set by Hassall.

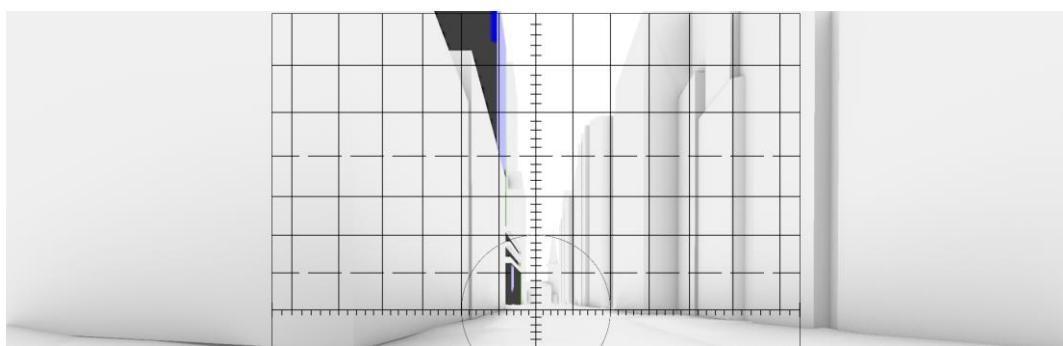
Figure 6: Phillip St, heading south. Maximum intensity of reflections 160 Cd/m²

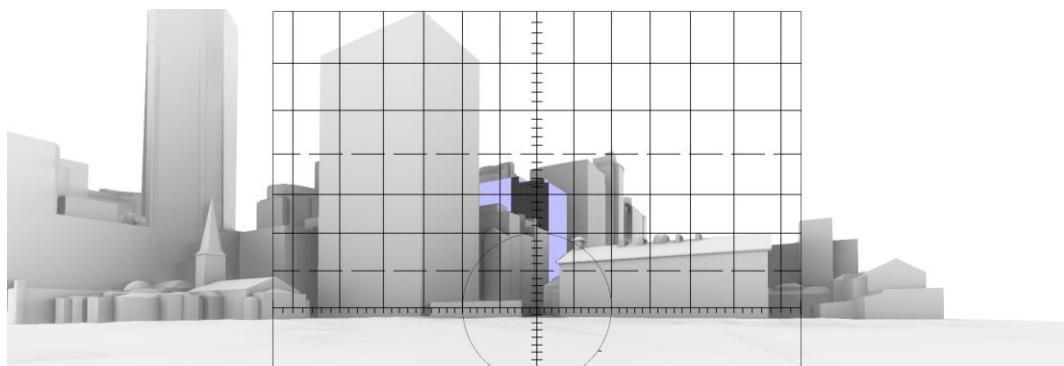
Figure 7: St James Road, heading west. Sun reflections are not visible

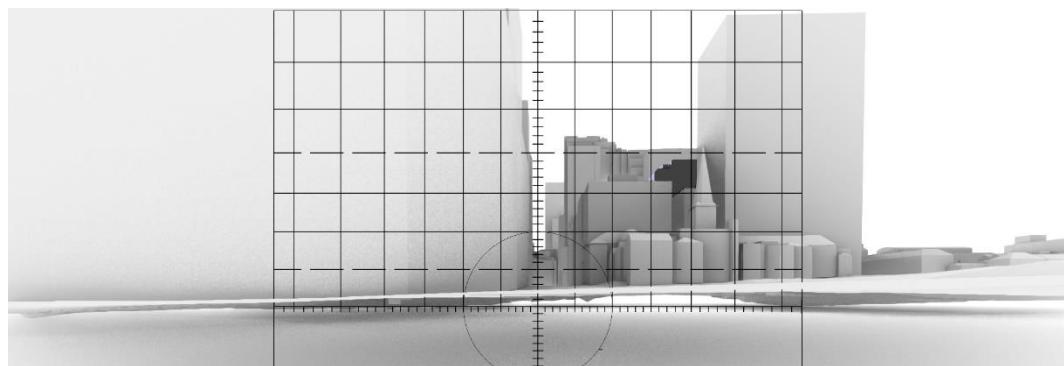
Figure 8: Elizabeth Street, heading north. Sun reflections are not visible.

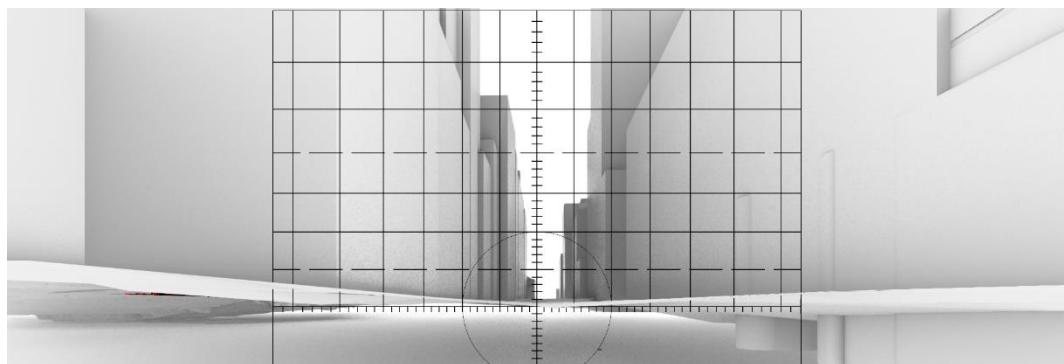
Figure 9: Elizabeth Street, heading south. Building not visible.

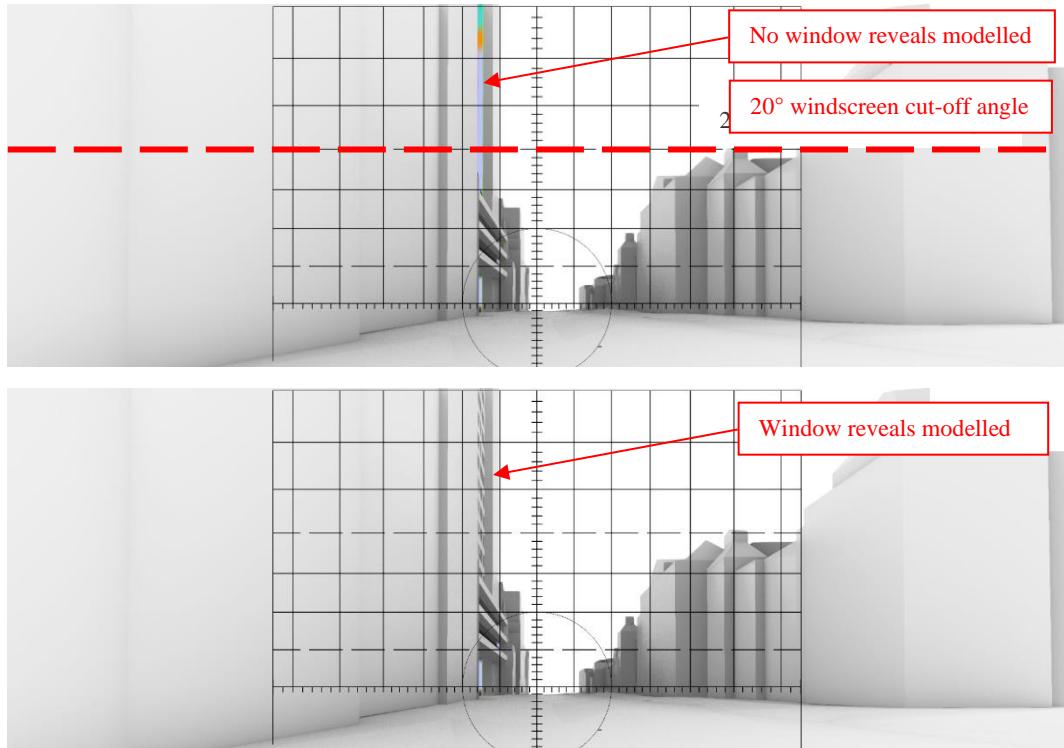
Figure 10: Macquarie St, heading north. Maximum intensity 560 Cd/m^2 (top image), though reflections are obstructed by stone window reveals (bottom image).

Assessment of the north-facing observer paths on Macquarie Street and Phillip Street (Figure 10 and Figure 11) highlights there is potential for facade reflections to have an equivalent veiling luminance greater than 500Cd/m². These would occur at glancing angles only and be blocked by the deep stone window reveals. The bottom image of these figures includes the window reveal geometry to highlight how they obstruct reflections when the façade is viewed at these glancing angles.

In addition, these small areas of high luminance are located above the 20° windscreens cut off angle, which is typically shielded by a car roof according to Hassall. Hence, these instances of equivalent veiling luminance greater than 500Cd/m² are not expected to negatively impact driver safety.

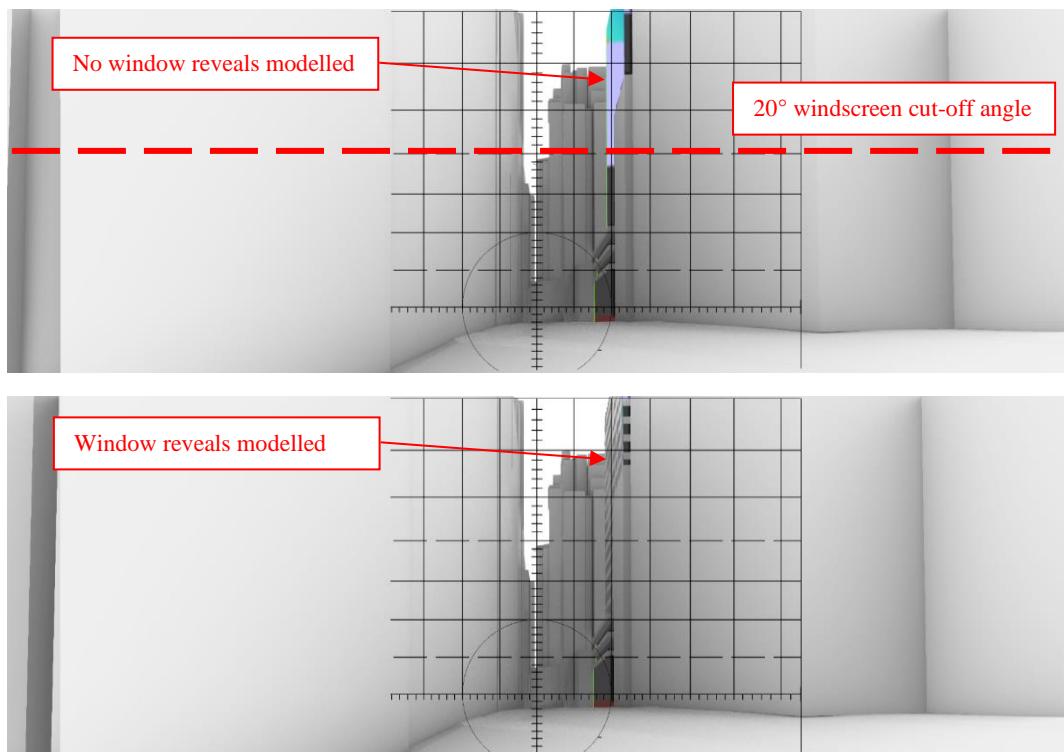
Figure 11: Phillip St, heading north. Maximum intensity of reflections 510 Cd/m^2 (top image) though reflections are obstructed by stone window reveals (bottom image).

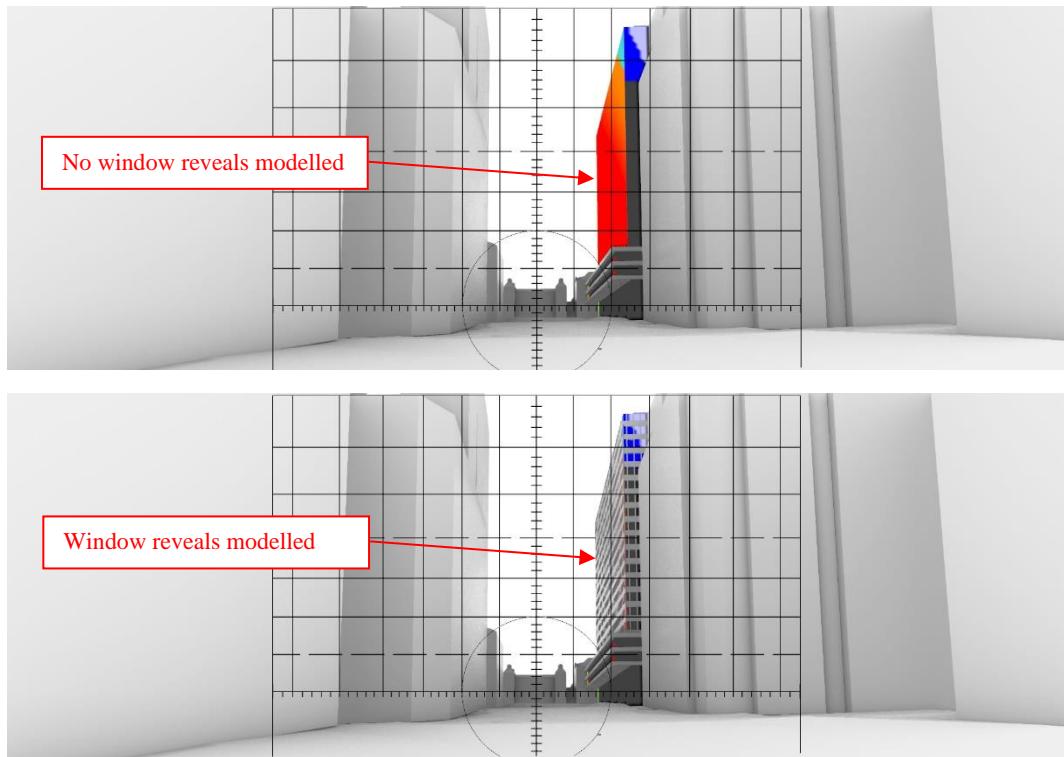
Figure 12: Martin Place, reflections from north facade glazing plane if not considering shading / obscuring facade detail (top image), though reflections are obstructed by stone window reveals (bottom image).

In addition to the roads discussed above, reflections visible to pedestrians were assessed in Martin Place. While the high-level geometry model indicates that reflections from the tower plane of glazing could in theory reach above 500 Cd/m² for observers passing parallel to the façade, this would only occur at angles of incidence of approx. 20° or less against the plane of glazing, (refer Figure 12). Again, when the deep window reveal geometry is overlaid onto these images (see bottom image of Figure 12, Figure 13 and Figure 14), critical reflections from the tower are screened from pedestrians. Reflections from lower level glazing are significantly blocked by overhangs. Arup note that glimpses of reflections at lower levels may occur similar to the in-situ glazing condition, but are not considered critical due to limited angular width indicating brief occurrence and reduced intensity.

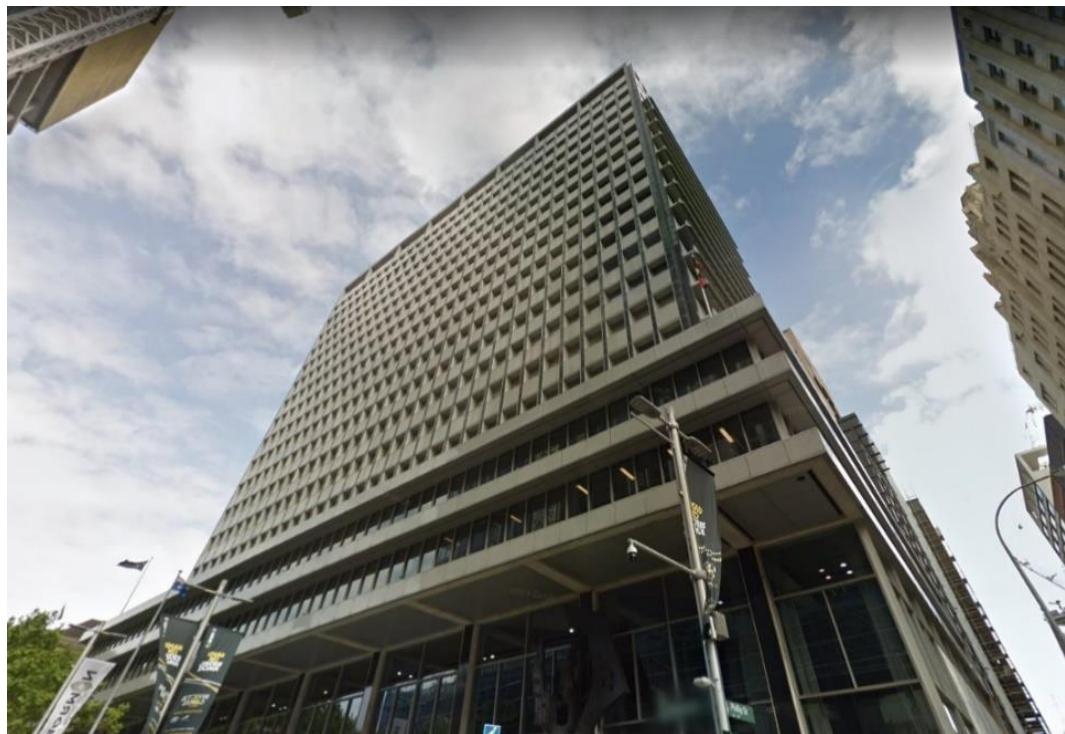
Figure 13: View of the existing building, illustrating the obscuring effect of the glazing set-back behind intermediate columns

- Horizontal reveal banding is proposed to be honed white stone which does not have any material specular reflection component.
- Vertical reveal elements are proposed to be polished black stone ~380mm width spaced at ~1905mm centres (refer Figure 13 and Figure 14). This permits the maximum veiling luminance intensity to be pro-rated to approximately 20% of its maximum value. The veiling luminance remains under the 500 Cd/m² threshold provided the polished stone has normal specular reflectance of less than 10%.

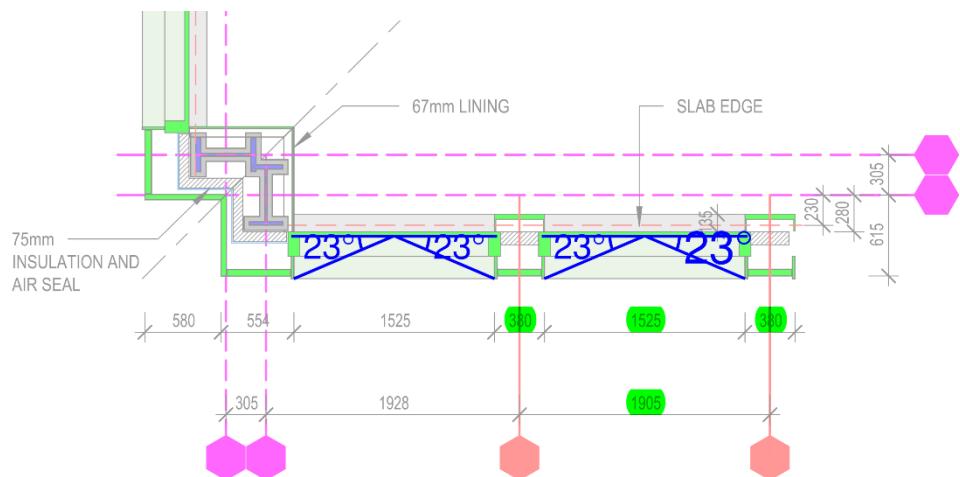
Figure 14: Architectural tower plan excerpt highlighting depth and spacing of window reveals compared with glazing line. Solar rays striking façade at greater than 23° to plane of glass will be obstructed by reveals.

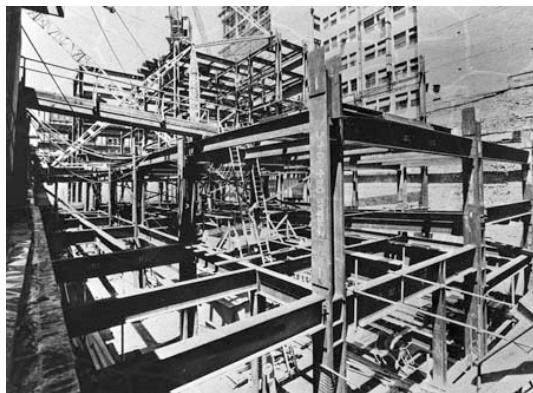
Figure 4 – View of the steel framed construction of the Reserve Bank of Australia Head office building, c1962. Source: National Archives of Australia.

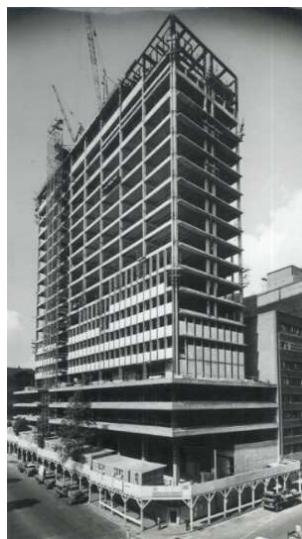
Figure 6 -View of the northwest corner of the RBA Head Office showing the original marble panels being installed to the north and west elevations, c1962. Source: National Archives of Australia.

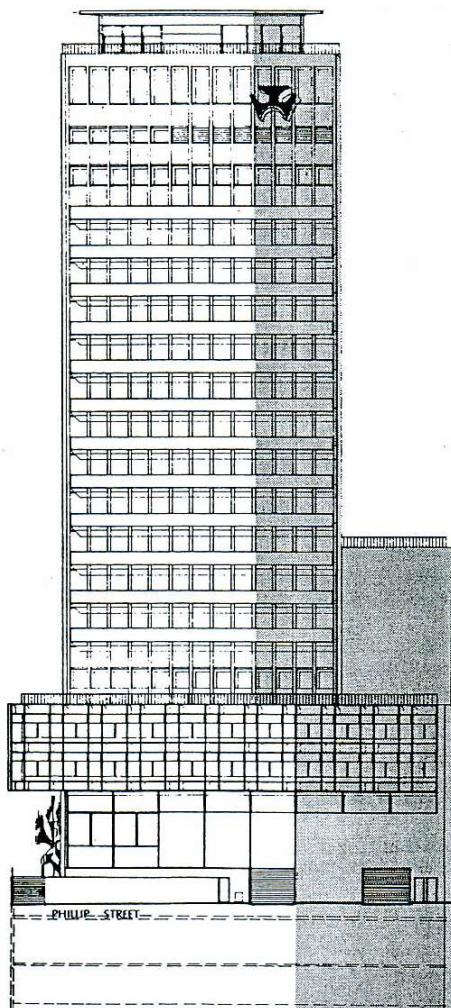
Figure 8 – Diagram showing the Phillip Street elevation. The shaded area indicates the location of the addition constructed in the late 1970s, and the dedicated services/plant spaces. Note the addition accommodating the services finished at Level 7.

Works involved substantial additions on each floor to incorporate the adjacent site to the south. The effect of the changes was to increase the depth of the building by nearly one third increasing its presence on both Macquarie Street and Phillip Street (See Figure 8) and to provide additional service areas at basement and podium levels were also provided.

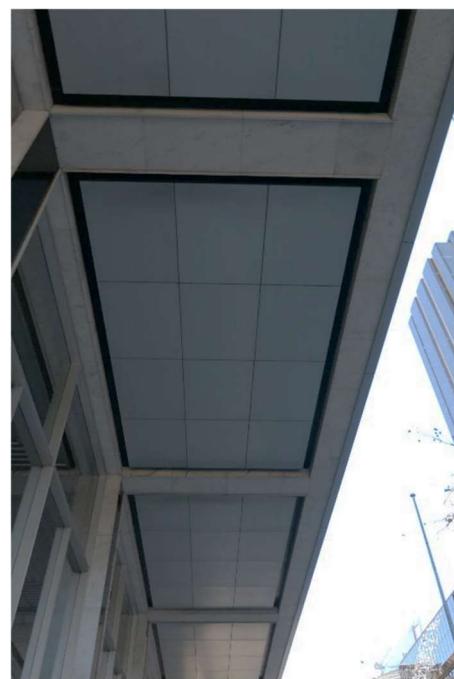
Figure 21 – General view of the podium soffit adjacent to the north side of the RBA Head Office entry. Note the original suspended marble soffit was replaced in c2001.

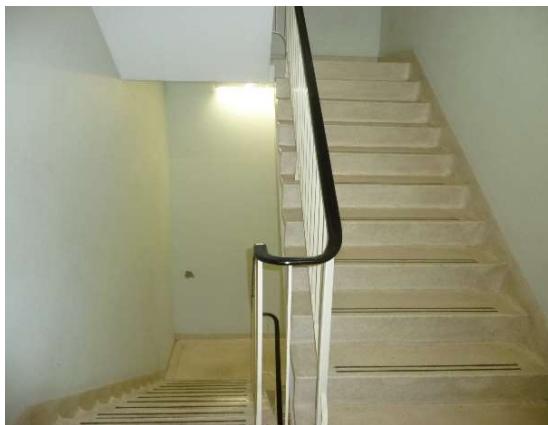
Figure 24 – Example of fire stair finishes and painted steel balustrades within the RBA Head office building.

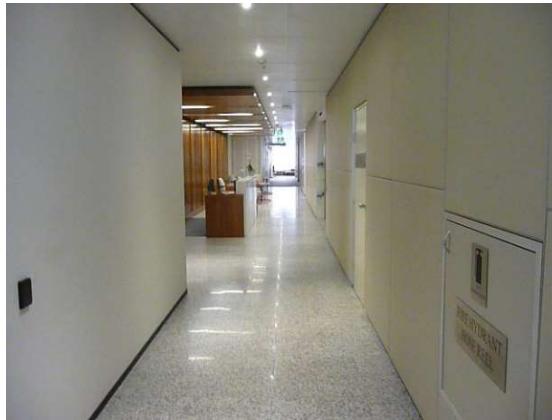
Figure 29 – Typical finishes installed in 2014 in the corridor and reception area located at the Mezzanine Level.

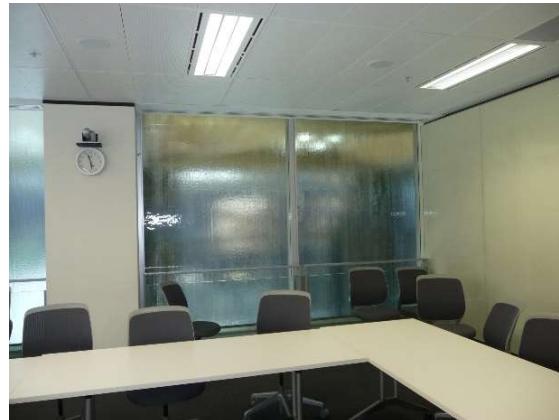
Figure 30 - Typical Mezzanine office fit out. Note the full-height textured glass forming the north wall of the mezzanine level is visible from within the ground floor vestibule.

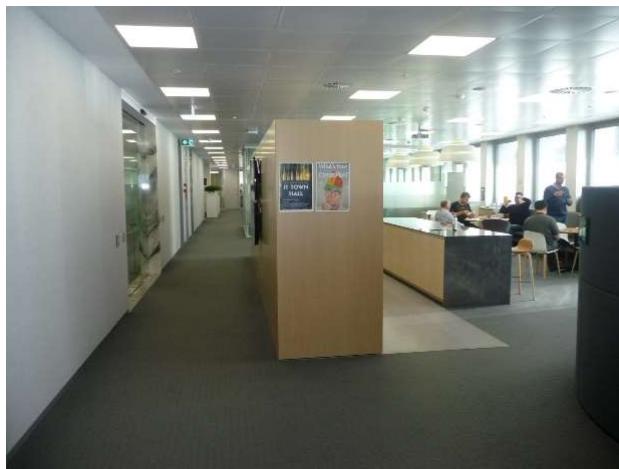
Figure 31 – Example of ceiling, wall and floor finishes at Level 6 installed in 2016.

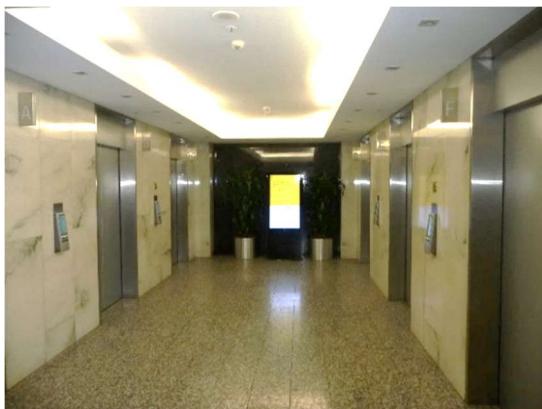
Figure 32 - Level 16 lift lobby showing the original marble wall finishes.

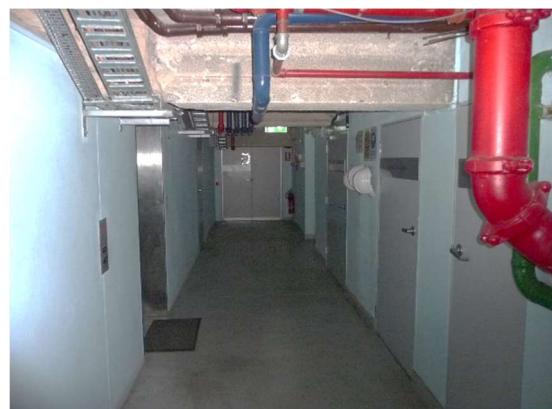
Figure 35 – Main east-west corridor located at Level 18 looking west.

These levels originally housed two squash courts and associated change rooms, together with extensive plant rooms. The squash courts (Level 17) were removed in 2001 and a new slab poured in the void above the squash courts at Level 18, other gymnasium facilities have been relocated, and the area refurbished as additional office areas and staff facilities. The plant room has been retained and occupies the whole of Level 18 (Figure 35).

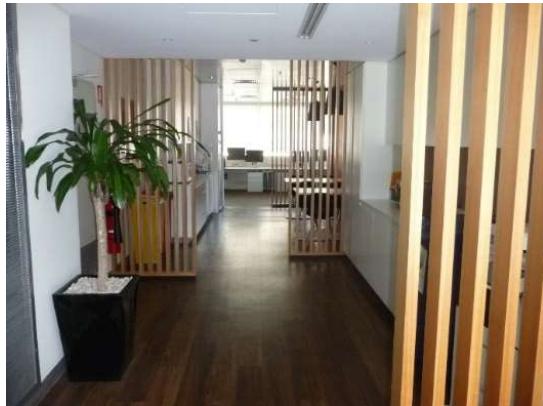
Figure 36 – Typical finishes to the office area located at the western section of Level 20.

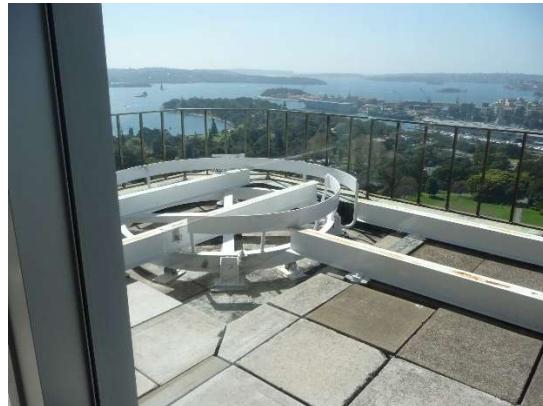
Figure 37 - General view showing the concrete pavers and access equipment for servicing the exterior of the RBA building.

This level was designed primarily as a staff amenities area, and was accessible from one lift commencing from Level 16. The floor is set back from the perimeter of the building under a cantilevered roof form. The mobile exterior maintenance cradle is located on this level.

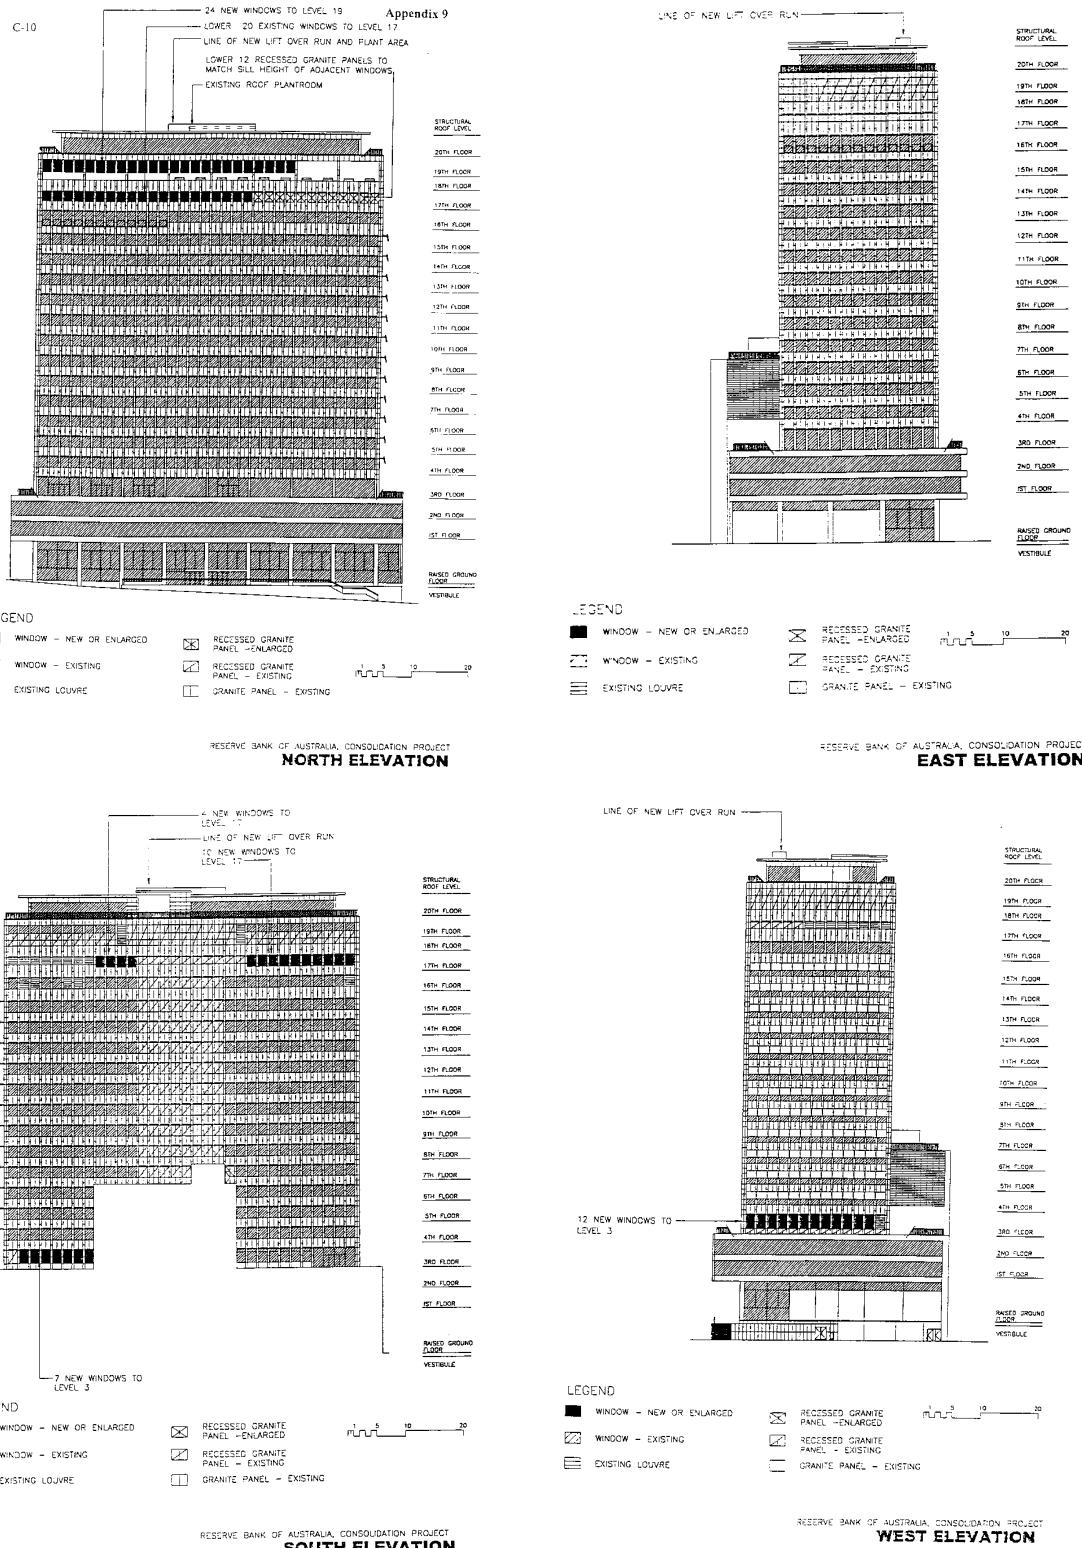
Figure 38 - Diagrams showing previous changes to the exterior of the RBA Head Office building, c2004. Source: RBA Archives.

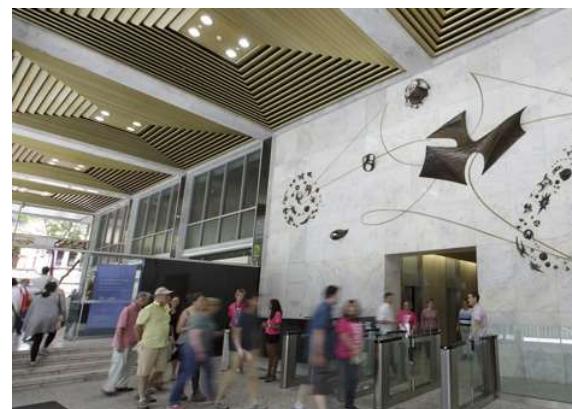
Figure 46 - View of the ground floor lobby showing security barriers installed c2015. (Source: Sydney Living Museums, 2019)

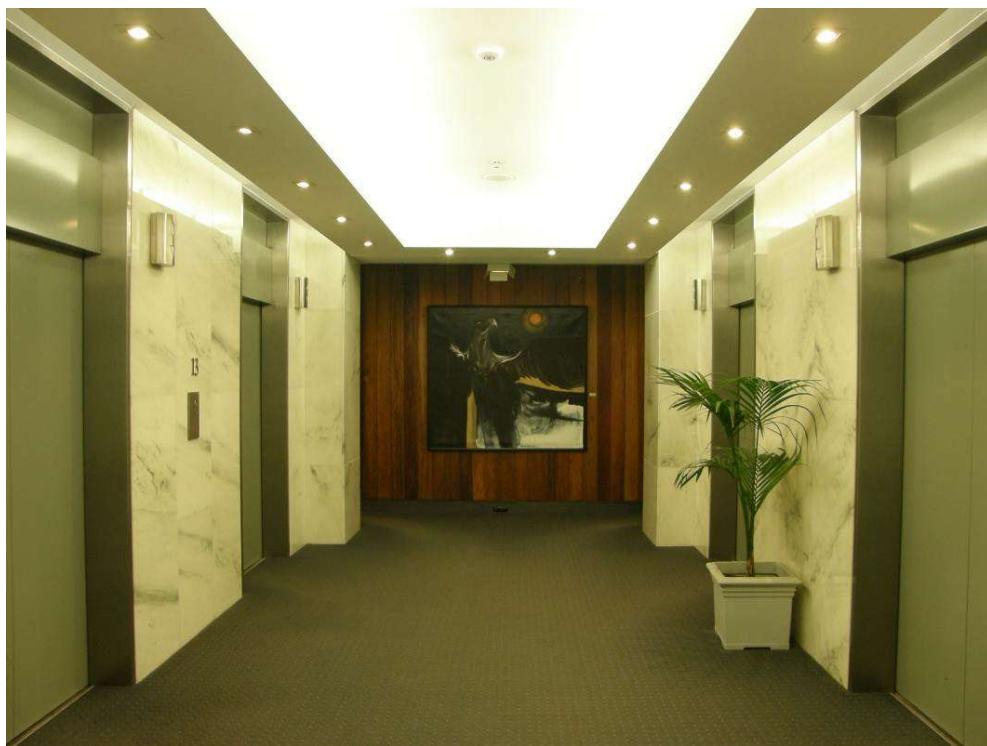
Figure 47 - Typical office level lift lobby showing original (1964) marble wall finishes and timber wall panelling. The original ceiling was replaced c2000.

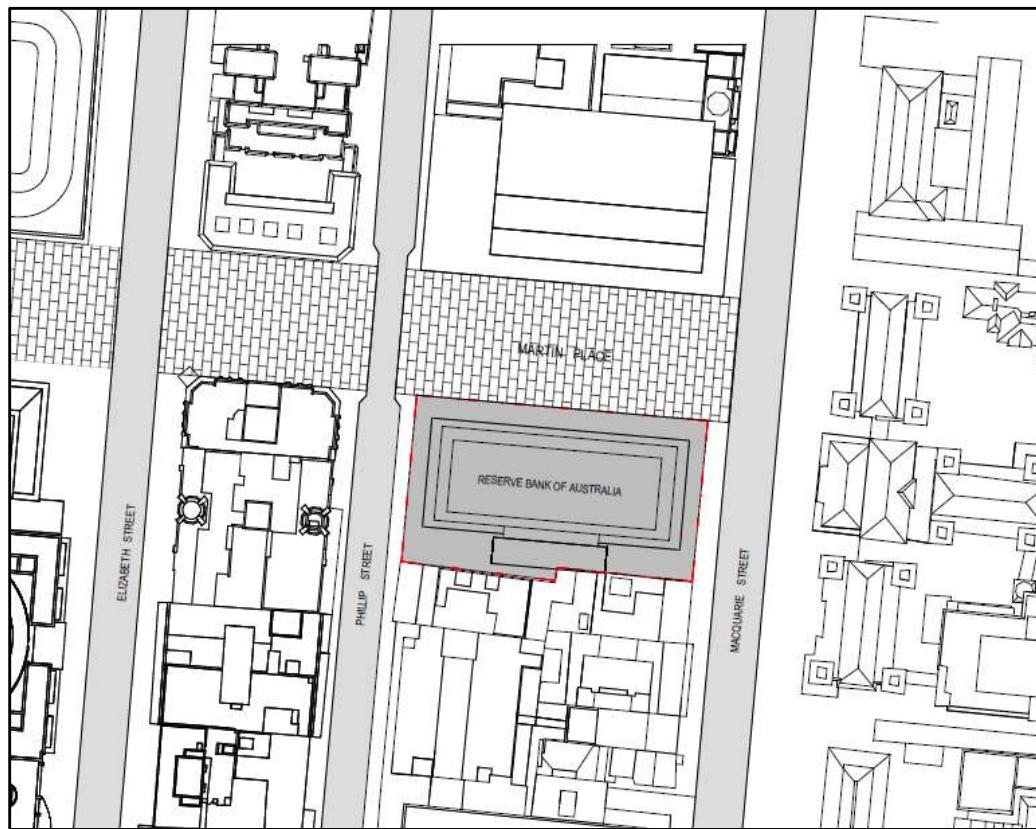
Figure 48 - Plan showing the extent of the Reserve Bank of Australia Head Office building in relation to Martin Place and surrounding buildings. Source: ARCHITECTUS, February 2020.

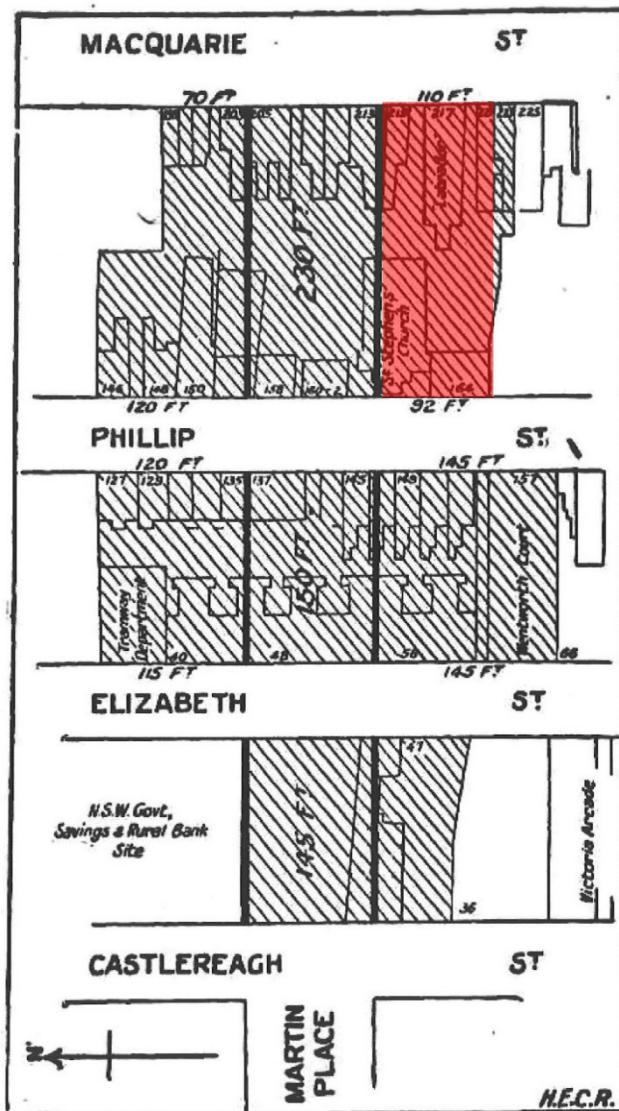
Figure 52 – Diagram showing the areas resumed by the Council of the City of Sydney in the 1920s to facilitate the eastern extension of Martin Place. The site purchased for the RBA in 1957 is shown shaded.

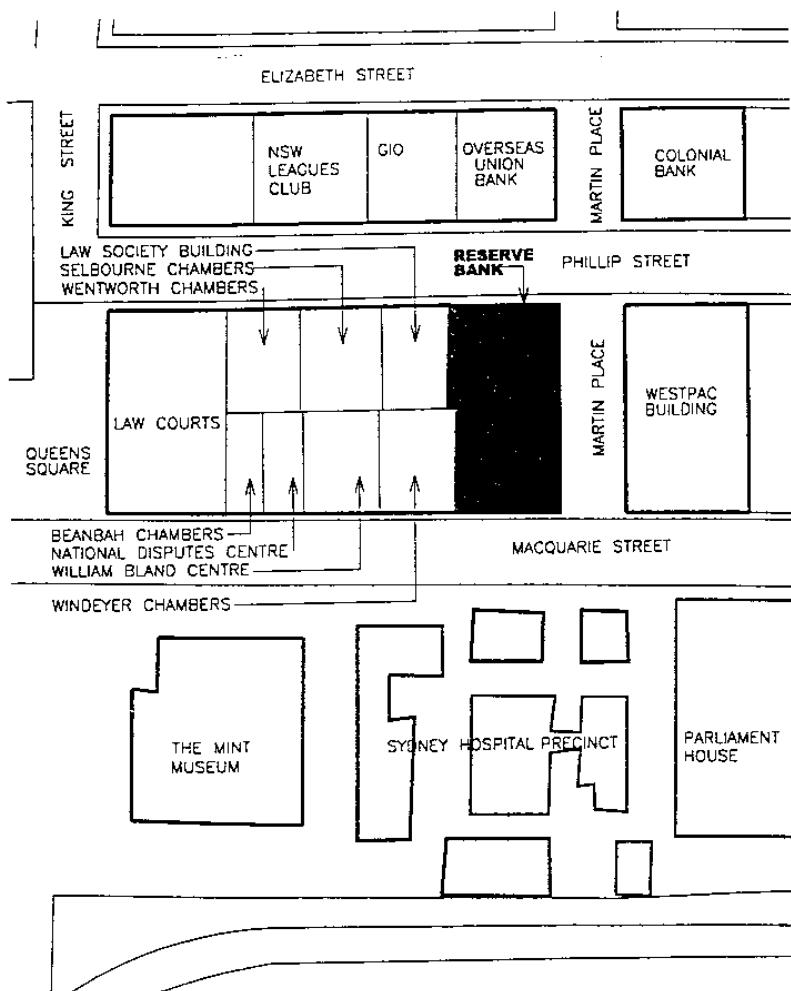
RESERVE BANK OF AUSTRALIA, CONSOLIDATION PROJECT
SITE PLAN
